June 14, 2016

04148 Version 2

Safety Recall: Front Passenger's Airbag Inflator Can Be Over-Pressurized (Phase 1)

Supersedes 16-047, dated May 25, 2016 to include Parts Information, Warranty Claim Information, and Repair Procedures

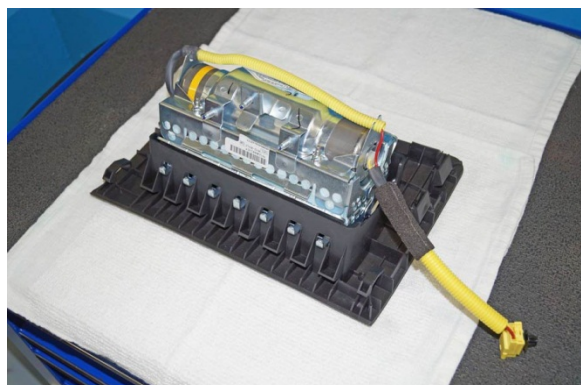
4. Place the airbag, face-down, on a clean shop towel.

- The orientation of the airbag is critical because if the inflator is installed incorrectly, the harness will be too short when you reinstall the airbag.
- The brackets between the various models are similar but may differ from the example shown.

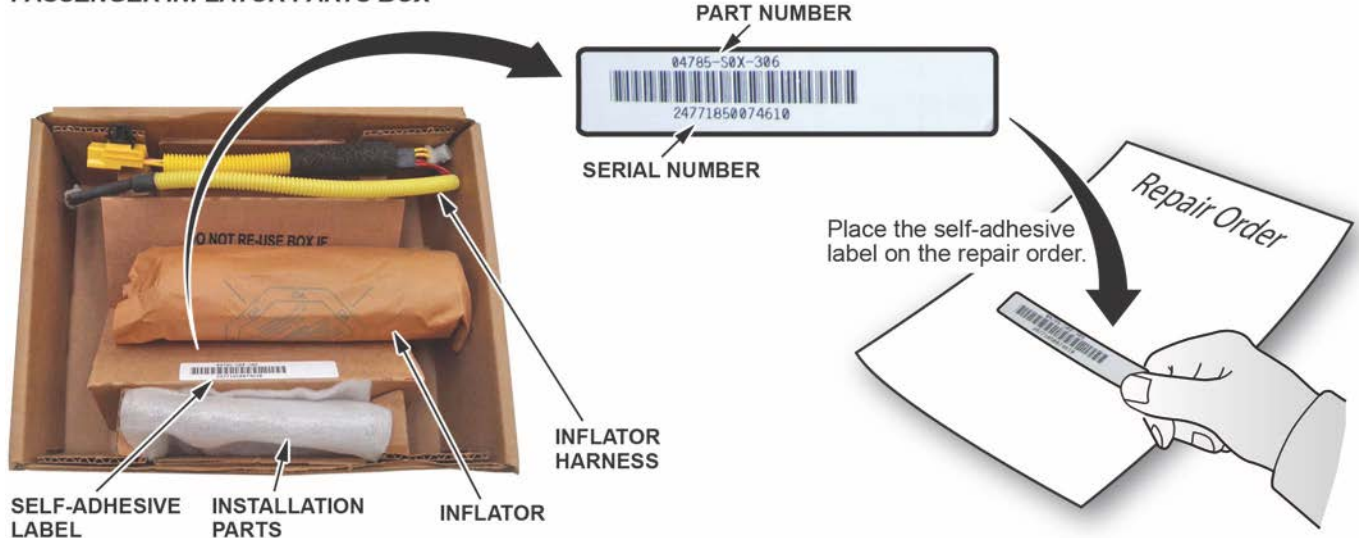
PASSENGER INFLATOR PARTS BOX

6. Peel the label located inside the inflator box from its backing and attach it to the RO. For the warranty claim to be paid, the **replacement inflator part number that you received** must be included in the warranty claim.

- The replacement part number is printed on the top part of the label and the serial number is printed on the bottom. **Make sure you attach the label to the RO and give it to the warranty clerk.**
- There may also be a colored sticker located in the kit, ignore it because it is not used.
- Not all inflator kits have a label included. In those cases, write the serial number and part number from the side of the inflator box on the RO. The part number always starts with 047.

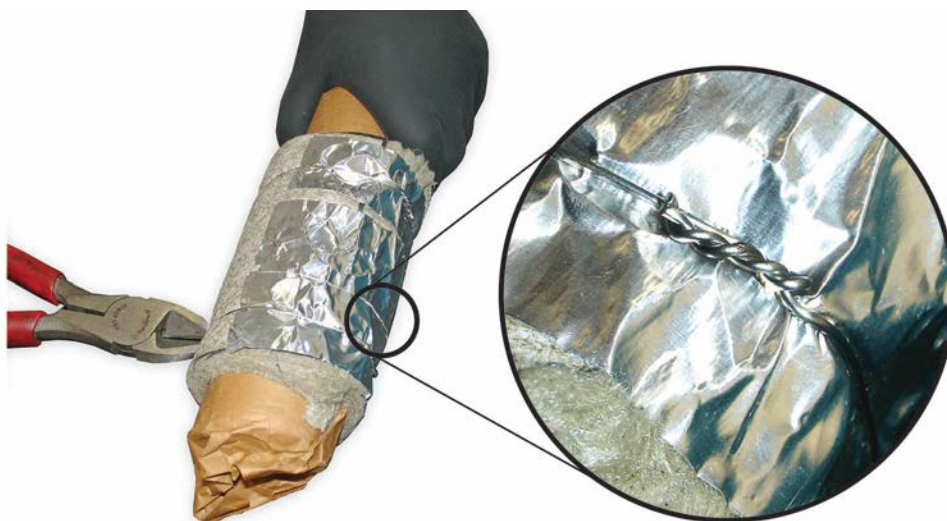
- Wear disposable gloves and protective glasses. The insulation is not toxic or dangerous, but some people may be sensitive to the insulation.
- Dispose of the insulation and wrapping paper to avoid getting the insulation dust/fibers on you or the airbag assembly.
- Do not reuse the insulation or wrapping paper. You do not need to wrap the inflator being removed from the vehicle when it is returned.
- Cut the wires off from the opposite side from where they are tied (twisted) together.

NOTE: Do not cut the insulation.

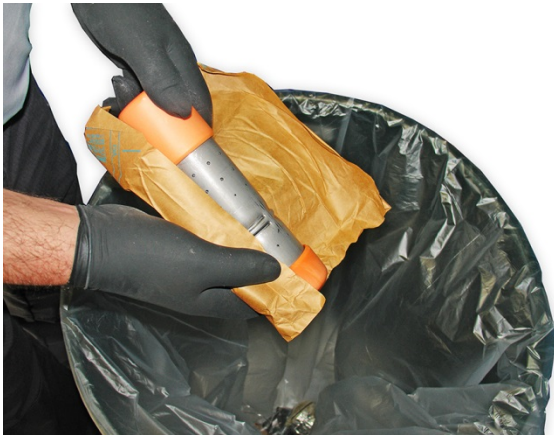
- Remove the wrapping paper and drop it into the trash.

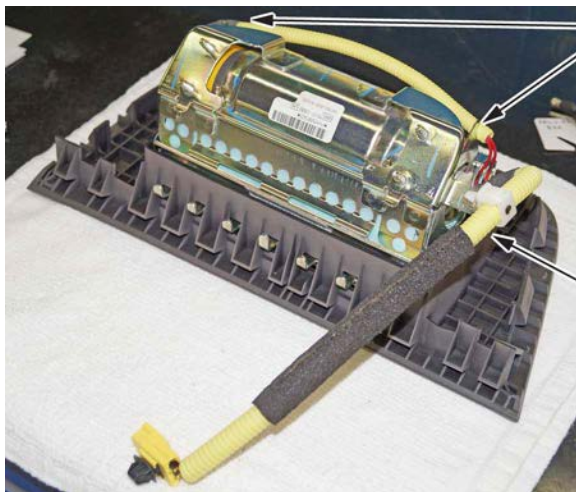
INFLATOR BRACKETS

8. Remove the harness from both ends of the inflator bracket.

Disconnect and remove the harness clip if applicable.

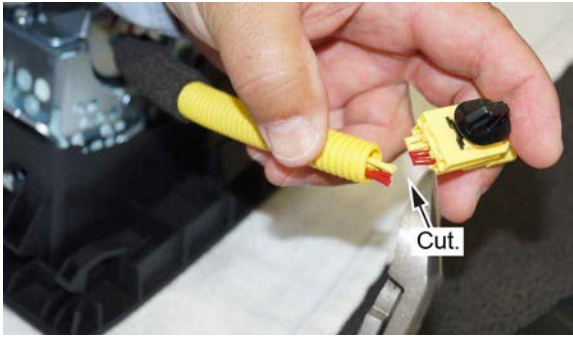
- Cut all four wires to remove the connector.

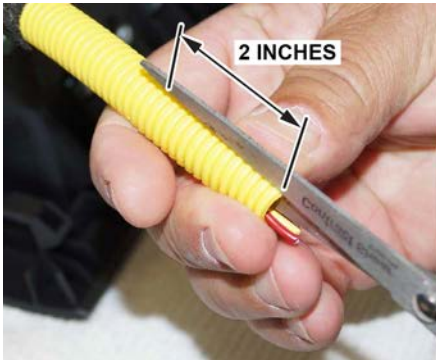
- Cut about 2 inches of the corrugated tube, then pull out the yellow wires.

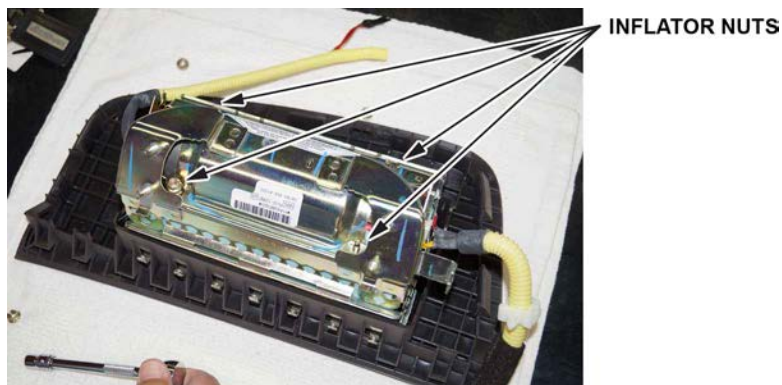
11. Remove the four inflator nuts.

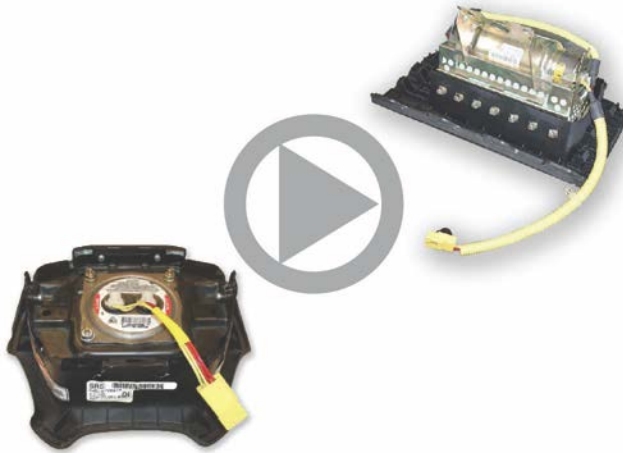
Click on the image below for a short video about the different variations of the driver's and front passenger's replacement inflators involved with the recalls related to inflators. While both the driver's and front passenger's inflators are shown in the video, this is informational only. Replace inflators only as directed by the iN VIN status inquiry.

Check your part number against the ones listed for each installation procedure. Use the correct installation procedure for the part you received.

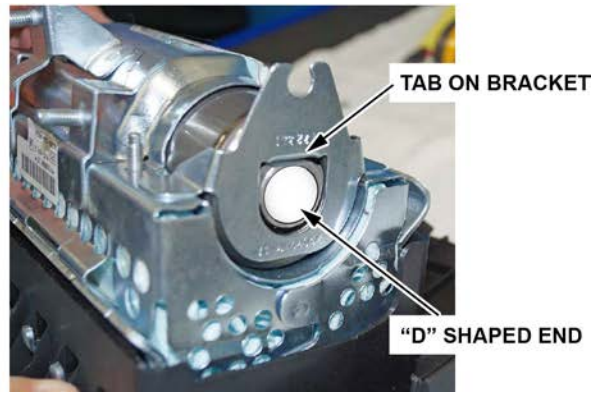
No gap.

- Slide the inflator in until the “D” aligns with the tab on the inflator bracket. There should be no space or gap between the inflator and bracket.

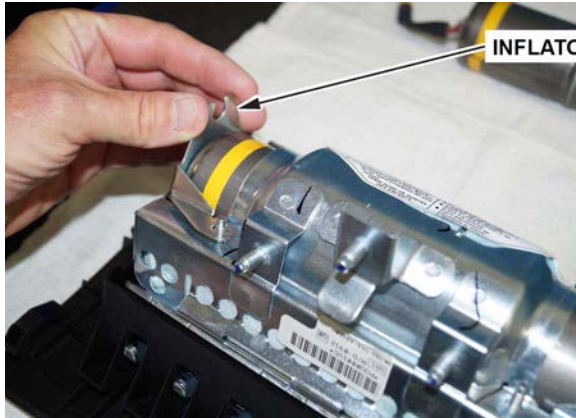
- Reinstall the inflator bracket. There should be no space or gap between the bracket and inflator.

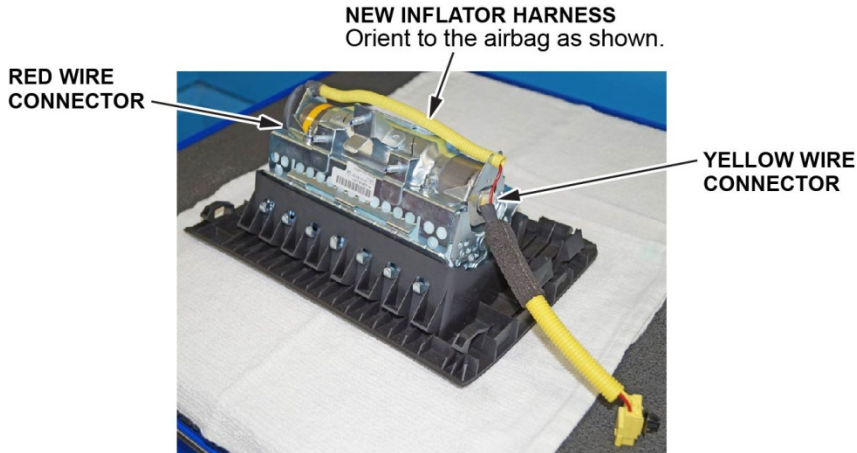
- Make sure the airbag and harness are aligned as shown.

- **Make sure you have the orientation correct as shown below.** If you connect the harness incorrectly, the harness cannot be removed, and you will not be able to reinstall the airbag because the harness will be too short.
- On the replacement inflators with plastic collars, connect the red wire connector to the connector with the red dot.
- On the replacement inflators without plastic collars, connect the red wire connector to the connector nearest the yellow band.

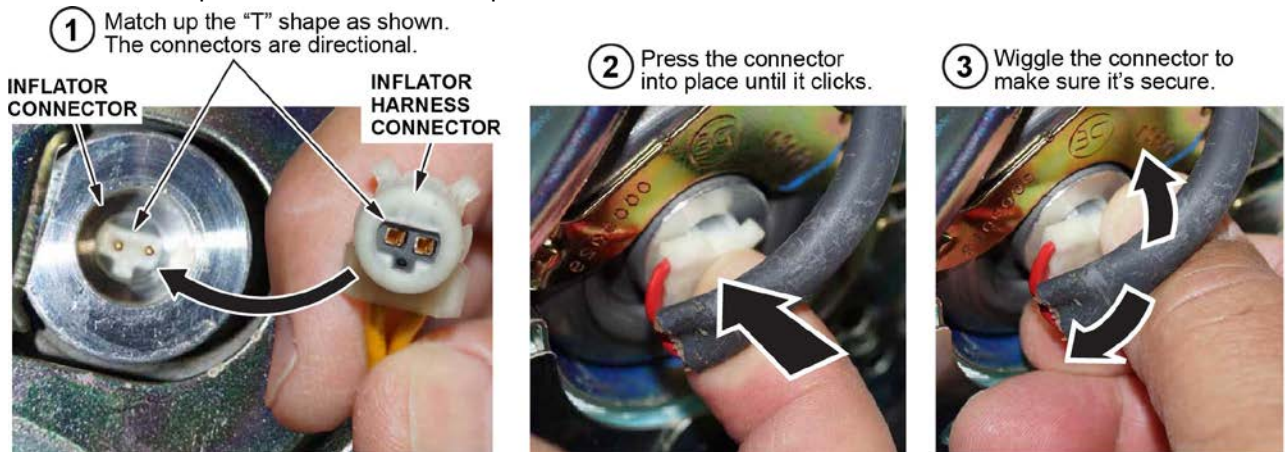
- Connect the two connectors. Align the “T” shape in the inflator harness connector with the T-shaped inflator connector, then press the connector into place.

- After you hear each connector click, wiggle it to make sure it is secure.

NOTE: If the connector is not properly aligned, it will come out.

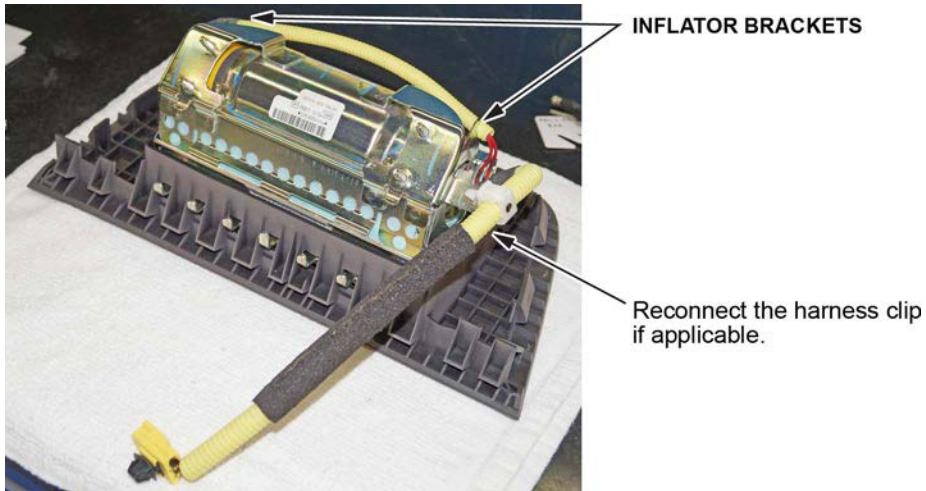
18. Connect the harness to the inflator brackets.

- Insert the side without the shrink-wrap tubing first. Insert the harness at the third “valley” in the corrugated tube.
- Insert the side of the harness with the shrink-wrap tubing into the inflator bracket. Make sure the harness is securely inserted and that it does not sag.
