#### **RECALL 16VXXX: HEAD PROTECTION SYSTEM**

F54 MINI Clubman

The head airbag (side airbag curtain) may not deploy properly in a side crash.

Remove excess wrapper material from around airbag.

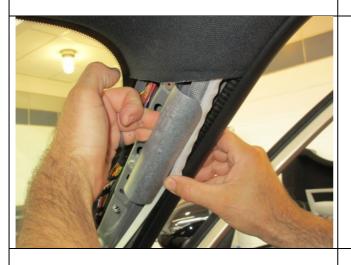
3. Carefully push the air bag package out from behind the metal bracket.

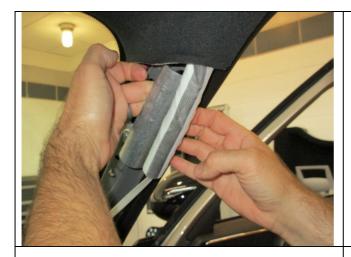
4. Squeeze the air bag package into an oval shape. This will enable it to clear the metal bracket.

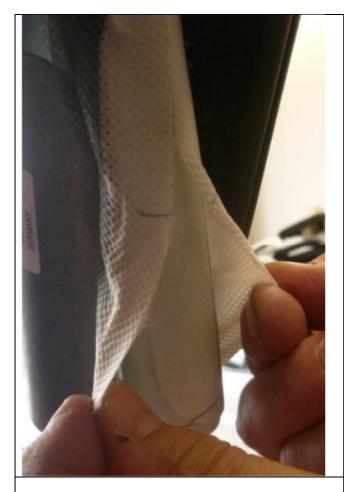
6. Tear open the wrapper, at the split line, from the end of the air bag up to the 80mm mark.

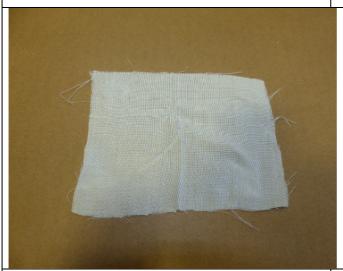
9. Completely remove and discard the scrap piece.

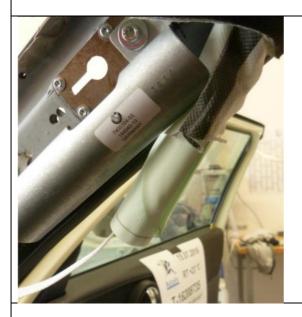
10. Confirm that all of the scrap has been removed.
