# Safety Recall

## Code: 47N3

<b>Subject</b>	<b>Brake Lines</b>
<b>Release Date</b>	March 13, 2017
<b>Revision Summary</b>	<b>Work procedure updated.</b>
<b>Criteria Repair Availability information</b>	<b>Criteria 01: Repair available March 9, 2017</b> <b>Criteria 01 and 02: Repair available March 15, 2017</b>
<b>Affected Vehicles</b>	<b>U.S.A. &amp; CANADA: 2017 MY Volkswagen Passat</b>  <i>Check Campaigns/Actions screen in Elsa on the day of repair to verify that a VIN qualifies for repair under this action. Elsa is the <u>only</u> valid campaign inquiry &amp; verification source.</i> <ul style="list-style-type: none"><li>✓ Campaign status must show "open."</li><li>✓ If Elsa shows other open action(s), inform your customer so that the work can also be completed at the same time the vehicle is in the workshop for this campaign.</li></ul>
<b>Problem Description</b>	Affected vehicles may slowly leak brake fluid. After an extended period of time, the brake fluid low warning light may illuminate. If a customer does not heed the warning, brake power may diminish on the affected brake circuit. Reduced braking power may lead to extended stopping distance and could contribute to a rear

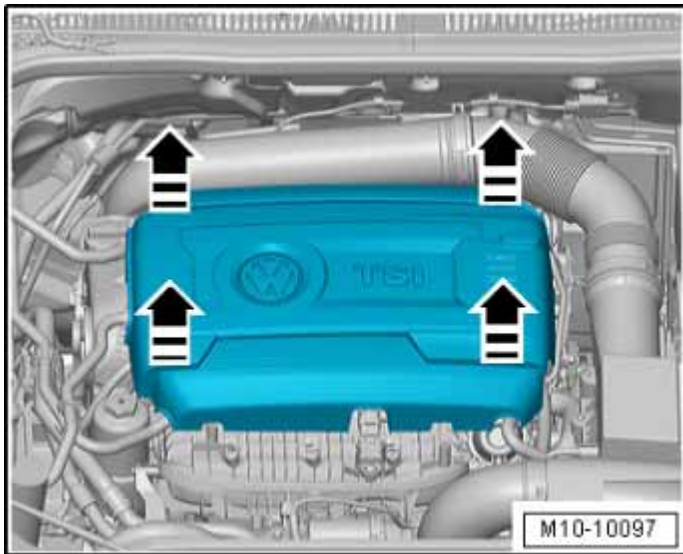
- Carefully pull the engine cover off the retaining pins in direction of <arrows> one after the other. Do not pull sharply on the engine cover or pull it to one side.

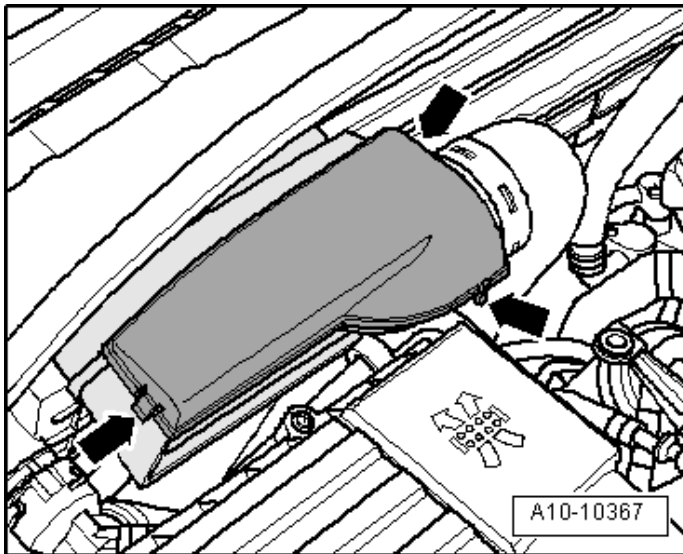
- Disengage the side clips <arrows> and remove the cover for the air duct.

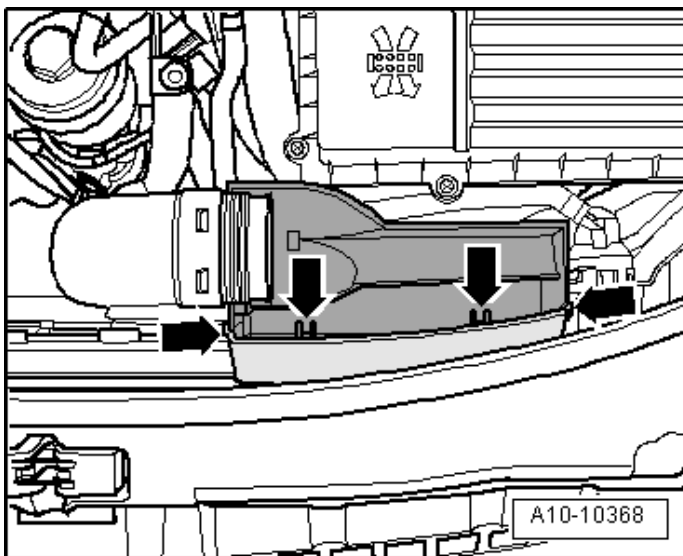
- Disengage the retainers <arrows> to unclip the lower air duct.

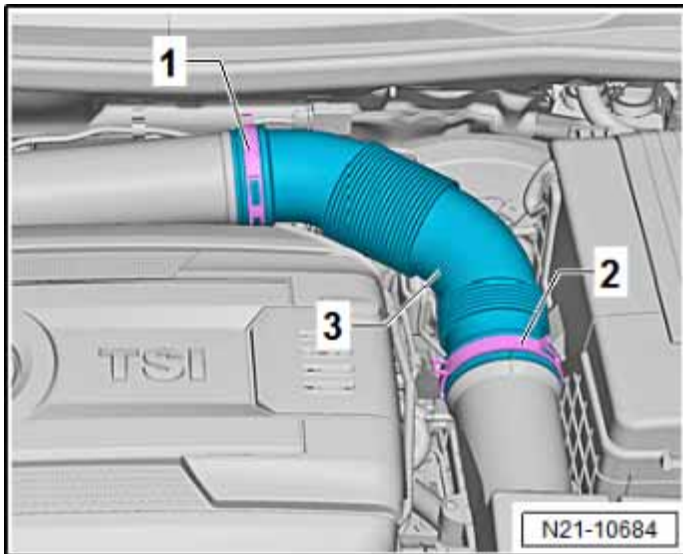
- Open the clamp <1> and move onto connecting pipe <2>.

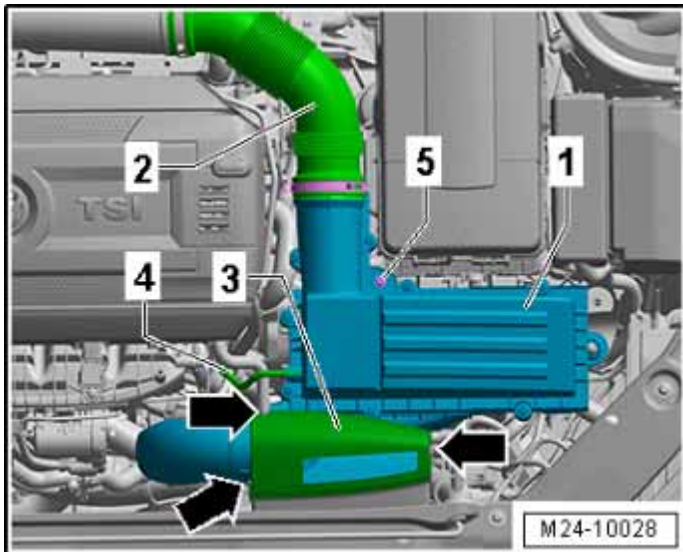
- Remove vacuum line <4> from the air filter housing.
- Loosen the bolt <5> and remove the air filter housing <1> with connecting pipe <2> upward from the attachment grommets.

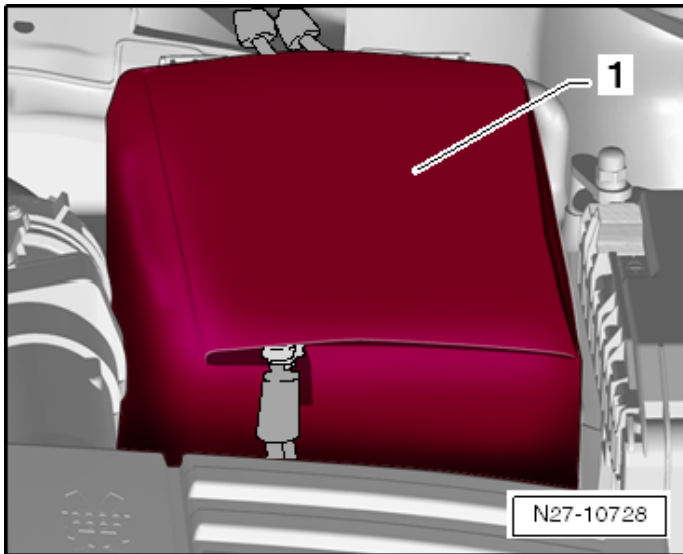
- Open the battery cover <1>.

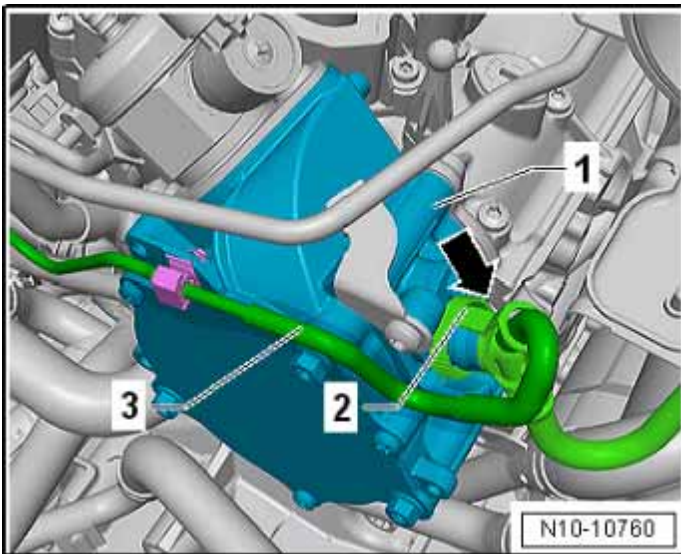
- Remove vacuum hose <3> from vacuum pump <1> by pressing the release buttons on connection <2>.
- Disconnect vacuum hose from the brake booster.

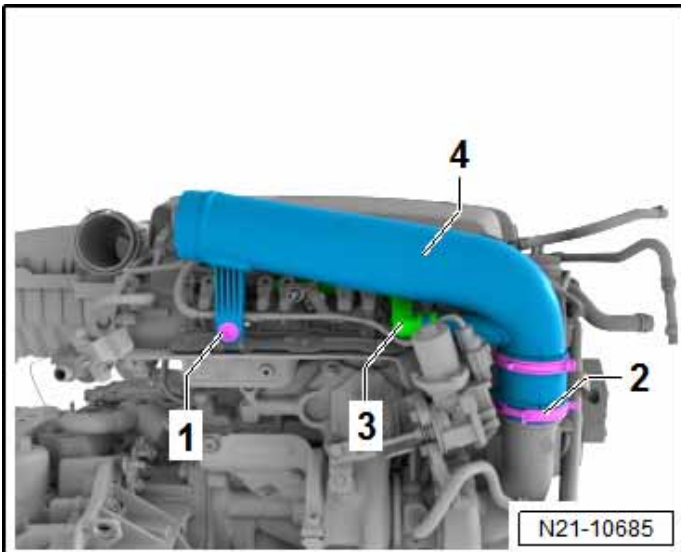
- Remove the air duct pipe bolt <1>.
- Loosen the hose clamp <2> using -VAS 6340- (or equivalent) and remove the air duct pipe from the turbocharger.
- Remove the crankcase ventilation hose <3> from the air duct pipe by pulling on the connector. Considerable effort may be required to remove the connector.
- Seal opening to turbocharger with engine bung kit -VAS 6122- (or equivalent).

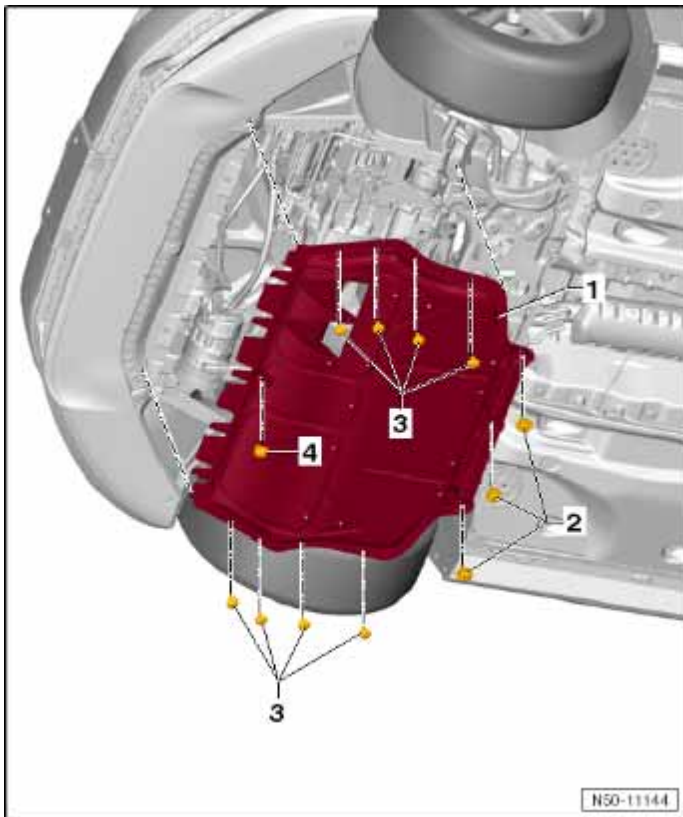
- Raise the vehicle.
- Remove the noise insulation under panel <1> by removing the screws <2> and <3>.
- Remove the noise insulation under panel <1> from the front bumper cover <4> toward the rear.
- Remove all four wheels.

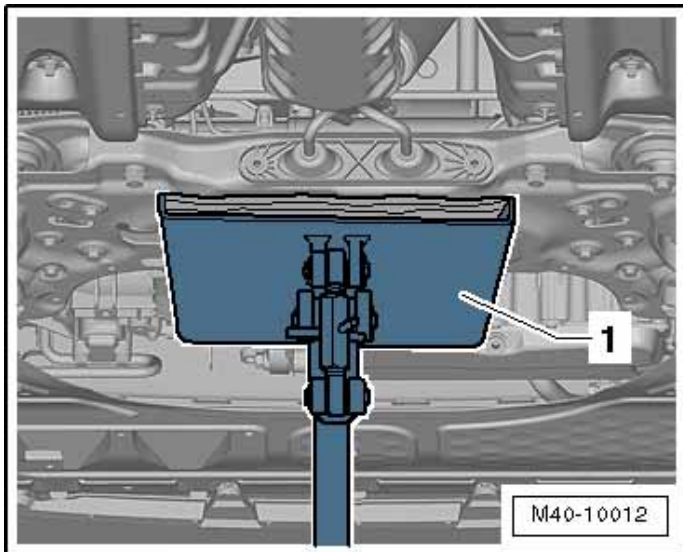
- Place the -VAS6931- Engine and Gearbox Jack <1> under the subframe.

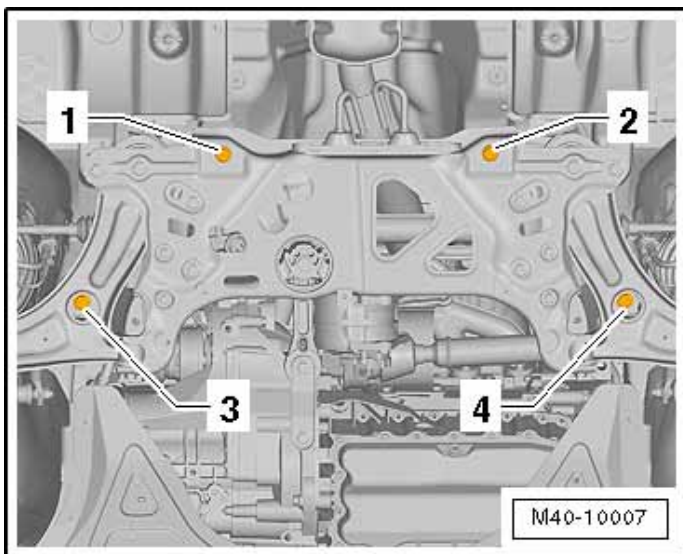
- When locating the subframe, the locating pins (-T10452- and -T10096-) must be installed one at a time. Do not remove the next subframe bolt until the locating pin is installed.
- The -T10452- and -T10096- may only be tightened to a maximum of 20 Nm, otherwise the threads of the locating bolts will be damaged.

- Remove bolt <3> and install -T10452-.
- Remove bolt <4> and install -T10452-.
- Remove bolt <1> and install -T10096-.
- Remove bolt <2> and install -T10096-.

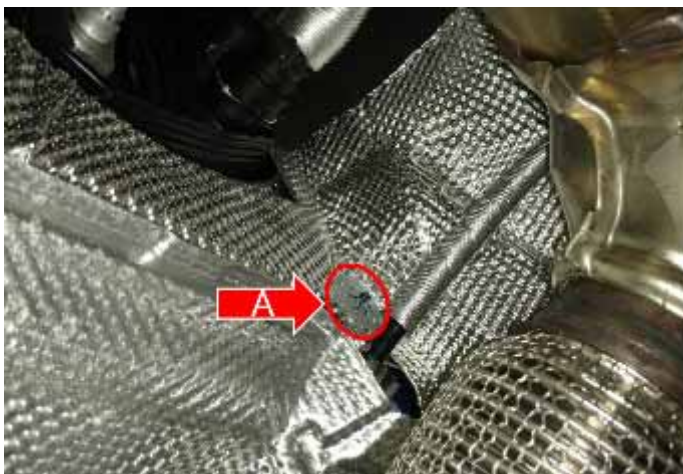
- Remove the retaining clip <A>.

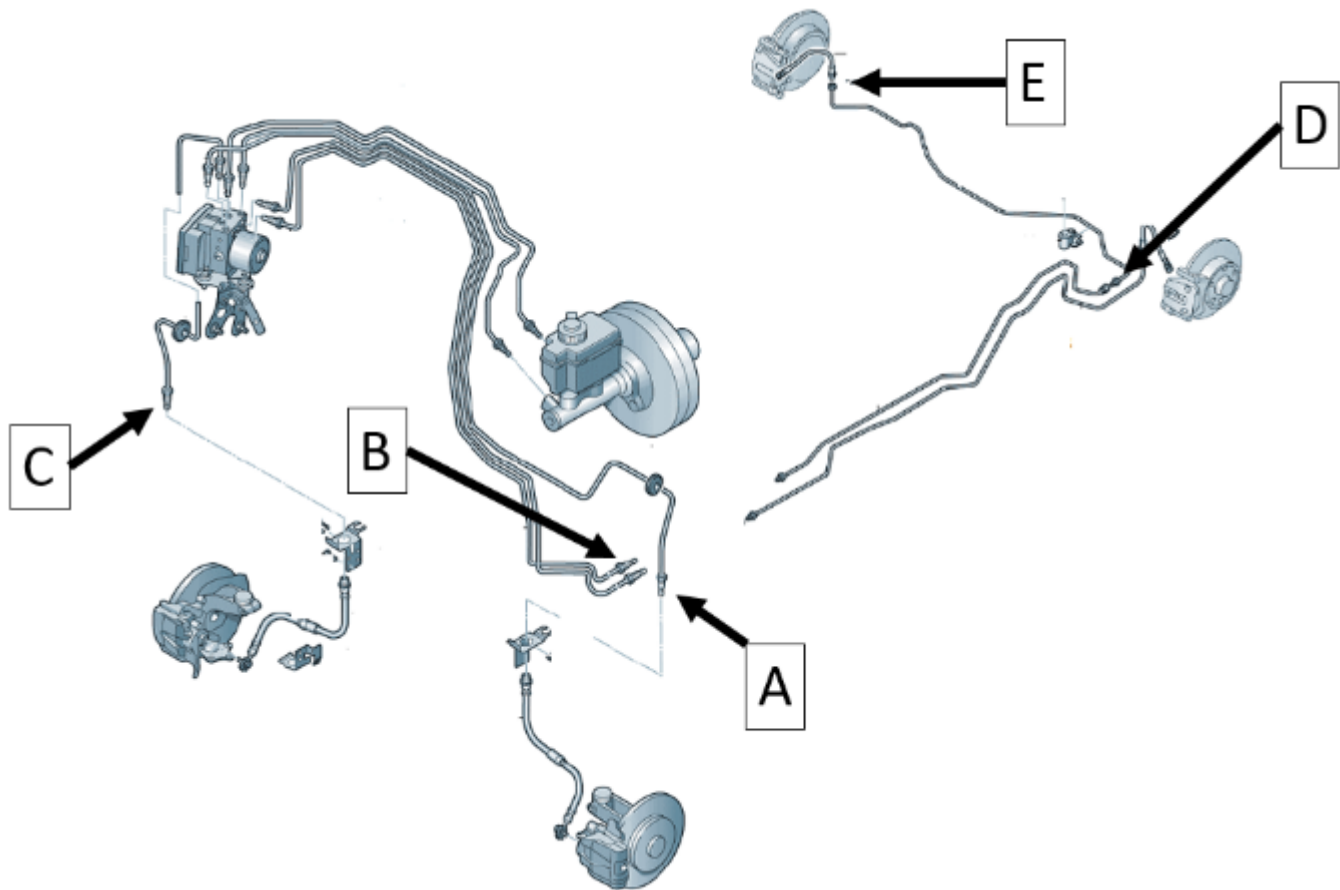
- Place a drain pan or absorbent mats on the floor to capture leaking brake fluid.
- For vehicles with only criteria 01, disconnect brake line connections <A and B> and allow the lines to drain.
- For vehicles with both criteria 01 and 02, disconnect brake line connections <A through E> and allow the lines to drain.

Be certain the correct line has been identified before disconnecting the fitting. The mid-line to RR caliper brake line is the further inboard of the two rear brake lines, and the connection fitting is located further towards the rear of the vehicle. Do not loosen the incorrect line.

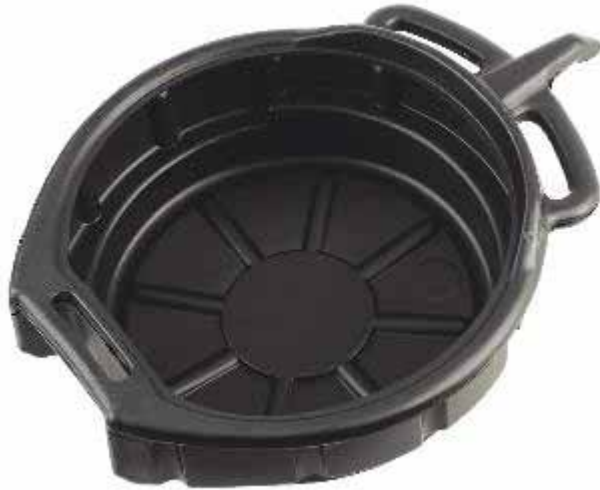
- Secure a low profile drain pan directly underneath the ABS Pump located near the passenger side firewall area.
- Lower the vehicle using caution to not contact the low profile drain pans under each wheel well area and under the ABS pump.

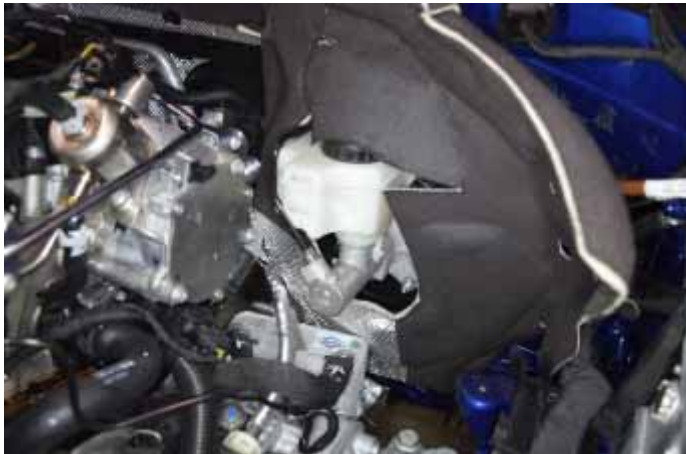
- Pull the padding clear of the brake master cylinder starting at the top, as shown.
- Carefully work the insulation padding out of the vehicle between the master cylinder and the engine/transmission.
- Once the padding is clear of the master cylinder, it can be removed from above or below.

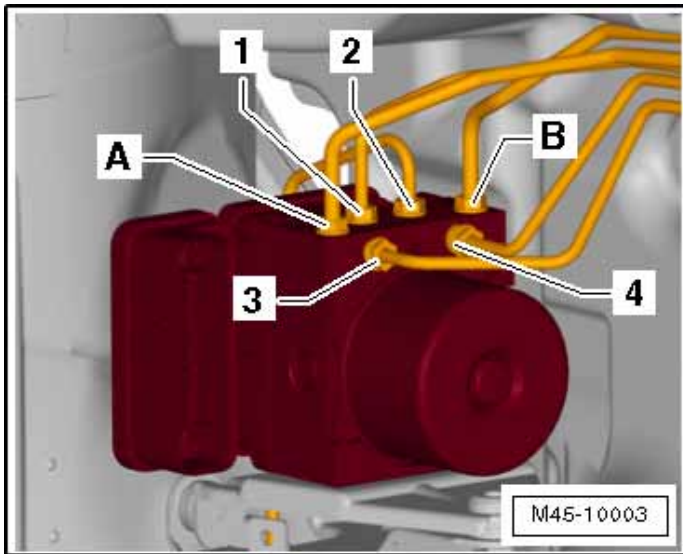
- Disconnect all of the brake lines <1, 2, 3, 4, A, and B> at the ABS Module.

- 1 – Left front caliper (criteria 01 only)
- 2 – Right front caliper (criteria 01, 02)
- 3 – Right rear caliper (criteria 01, 02)
- 4 – Left rear caliper (not replaced)
- A and B – Master cylinder (not replaced)

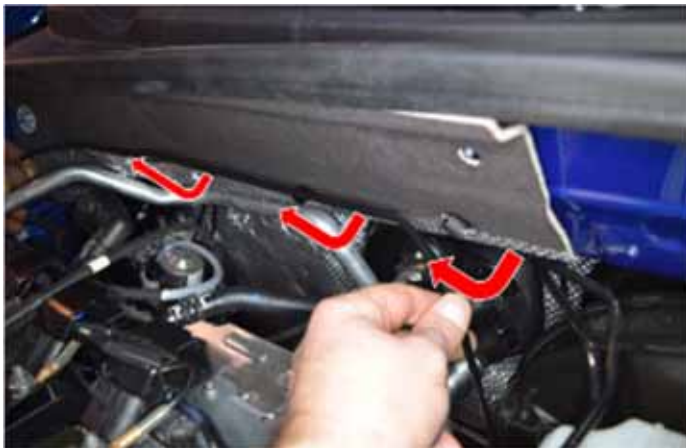
- Pivot the brake lines out of the chassis in the direction of the <arrows> starting with the right rear line.
- Begin on the passenger side and swing the lines up and over the air conditioning lines and engine. Use caution as to not kink or bend any of the brake lines.
- Remove the left front brake line by pulling the end of the left front brake line through the grommet in the chassis located in the left front wheel well.

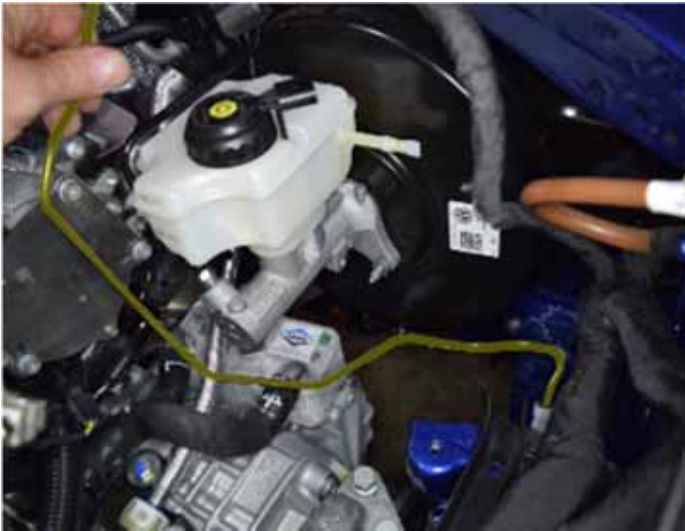
- Install the new left front brake line <highlighted> by first setting the caliper side of the line into the far left (driver's side) corner of the firewall as shown, then route the line around the brake booster and into position on the firewall.

Part Number	Part Description
5C1 614 723	Left Front Brake Line

- Insert the new left front brake line into the grommet through the chassis and into the flexible hose fitting before securing the line to the securing clips on the firewall.
- Do not tighten the fitting at this time.

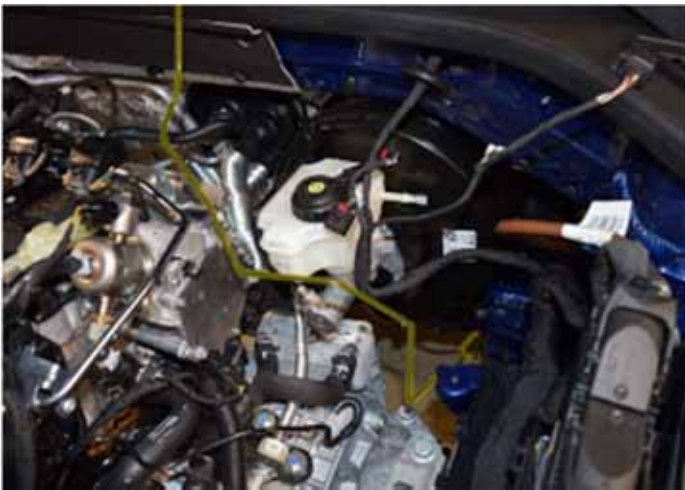
- Install the new right rear brake line <highlighted> as shown by inserting the line between the firewall and the transmission, then rotate the line into position around the brake booster and into the firewall securing clips.

Part Number	Part Description
5C1 614 726 A	Right Rear Brake Line from Distributor to Connecting Piece (ABS module to mid-pipe)

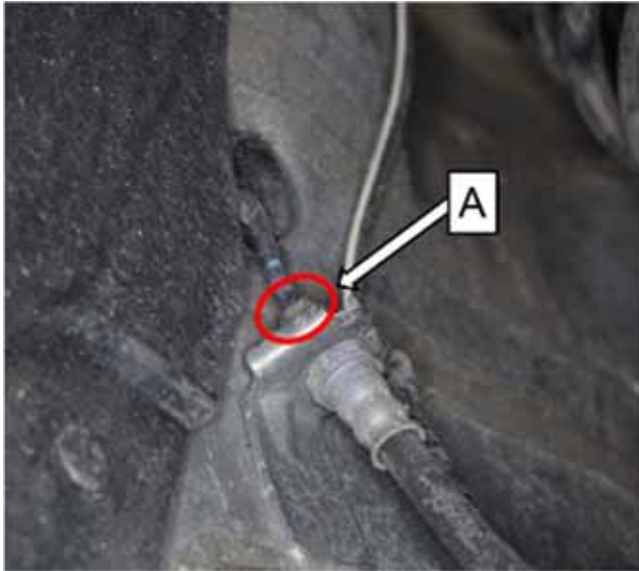
- Install the new right front brake line by first inserting the line through the grommet in the chassis.
- Insert the new right front brake line into the flexible hose fitting <A> but do not tighten the fitting at this time.

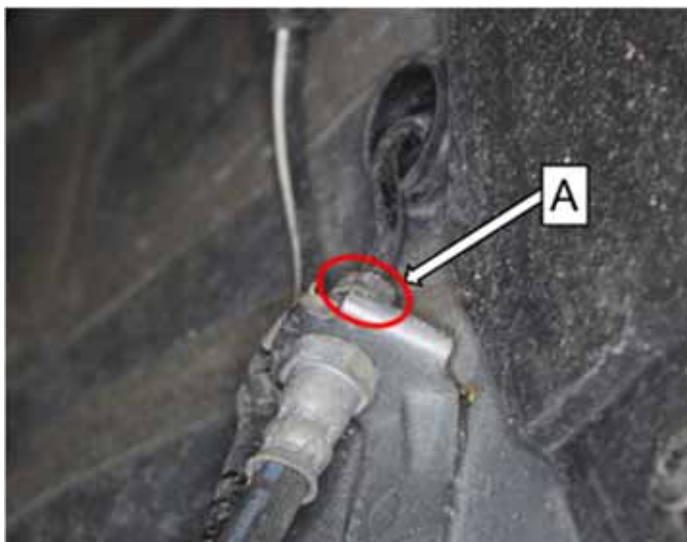
- Tighten the fitting on the left front brake line <A> by hand, and torque to 12 Nm.
- If right front brake line was replaced under criteria 01, 02, tighten the right front brake line fitting by hand and torque to 12 Nm.

Do not exceed the specified torque or damage to the brake line may occur.

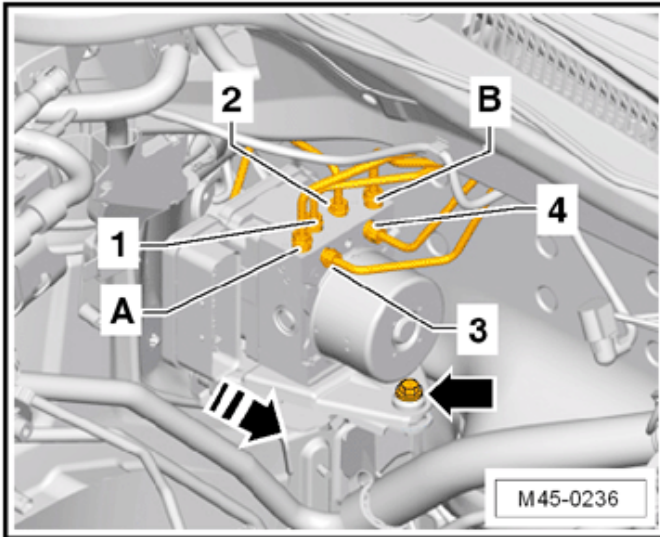
- Torque brake lines <1, 2, 3, and 4> to 12 Nm. Torque brake lines <A and B> to 14 Nm.
- Clean off all residual brake fluid.

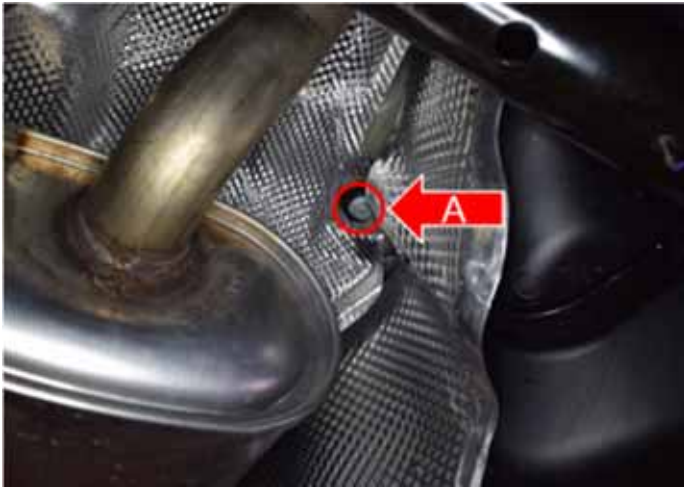
- Raise the vehicle.
- Remove the fuel tank strap bolt <A>.

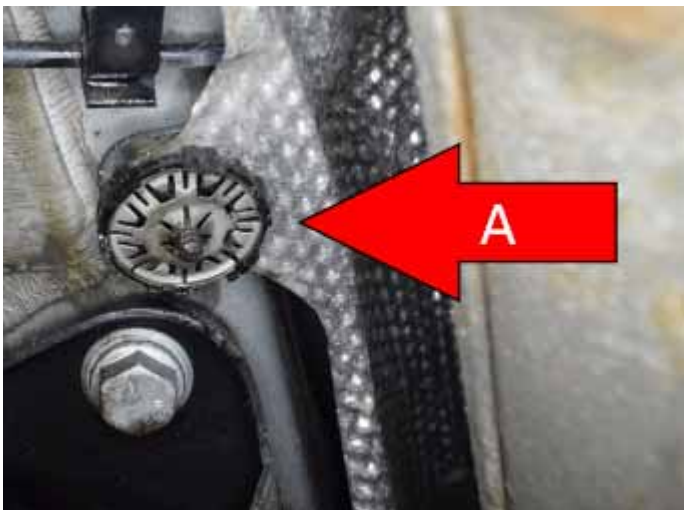
- Remove heat shield fastener <A>.

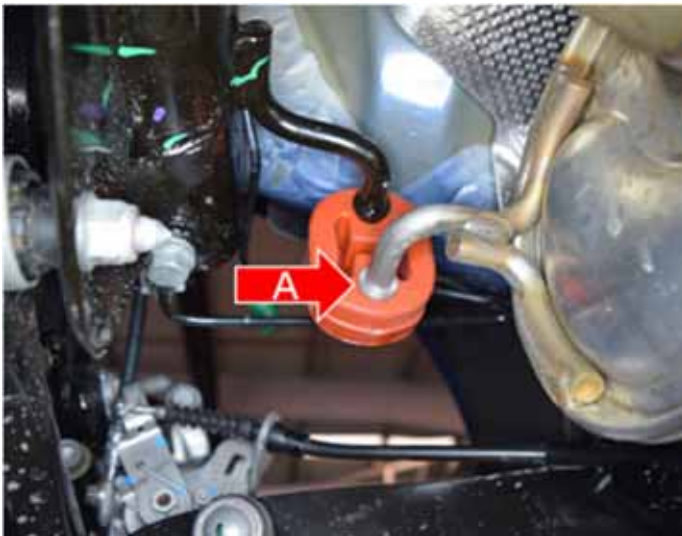
- Disconnect the rubber isolator from the muffler <A>.
- Lower the exhaust system onto the rear subframe.
- Tilt heat shield down to gain access to the brake line retaining clips.

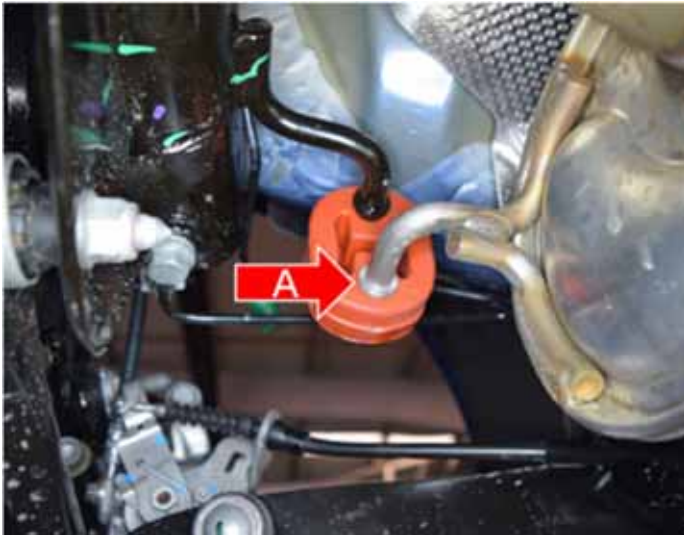
- Reconnect the rubber isolator <A>.

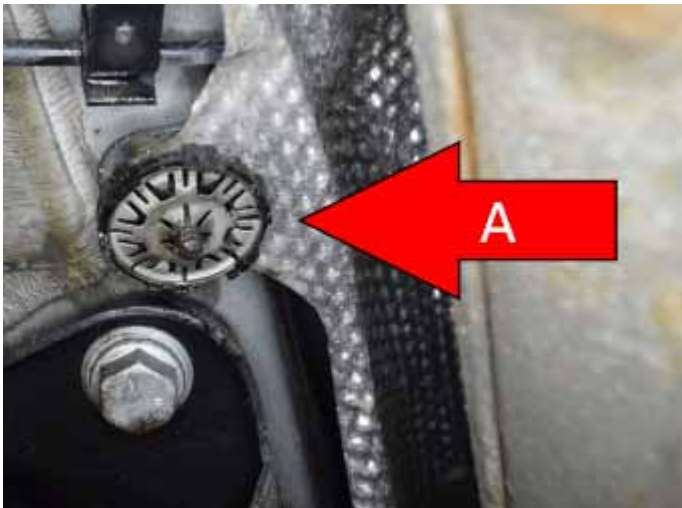
- Install heat shield fastener <A>.

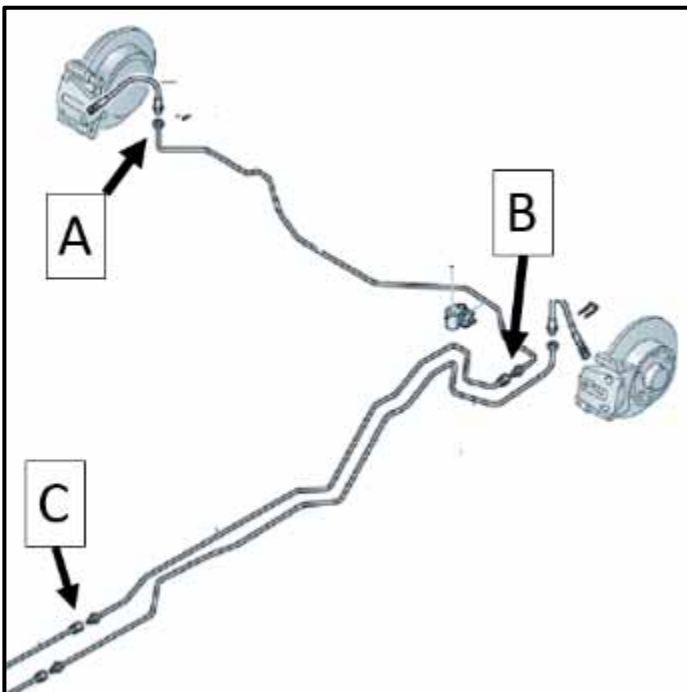
- Install brake line connections <A, B and C> and torque fittings to 12 Nm.

- When torquing connections <B and C>, be sure to counterhold the opposite fitting with a suitable wrench.
- Do not exceed the specified torque or damage to the brake line may occur.

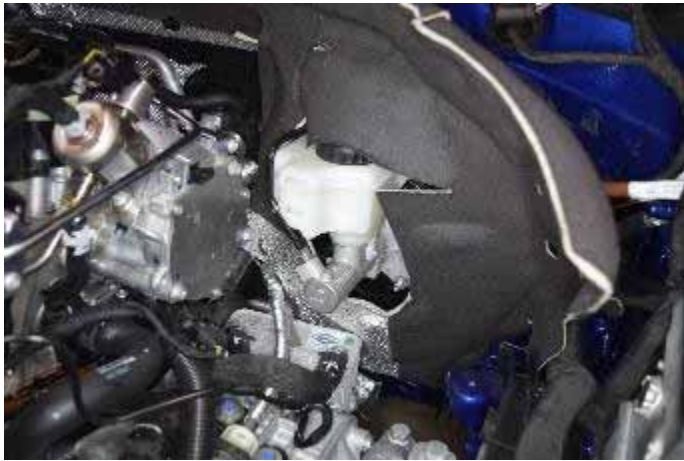
- Reinstall the brake booster insulation padding by first carefully working the insulation padding between master cylinder and the engine/transmission.
- Once in position, push the insulation padding over the top of the brake master cylinder onto the firewall.

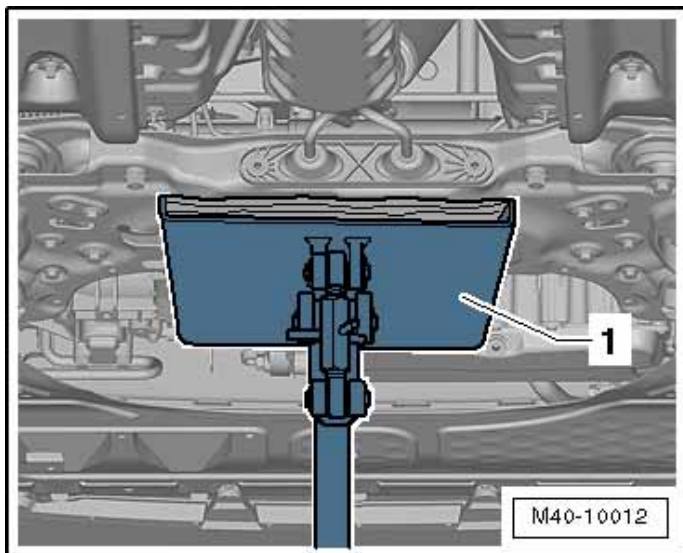
- Gently raise the subframe into position using the -VAS6931- and install new bolts <5 and 6> and tighten by hand.
- Torque the new bolts <5 and 6> to 70 Nm + 180° additional turn.

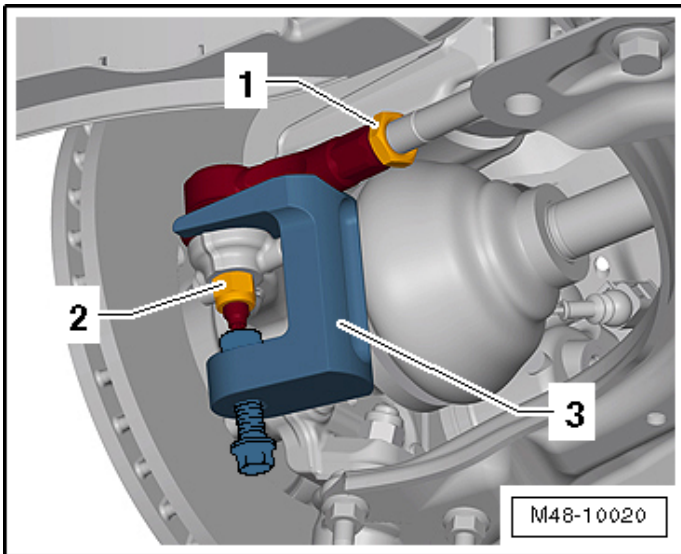
- Reinstall the tie rod end <1>.
- Install a new locking nut <2>, counterhold, if necessary, and torque to 20 Nm + 90° additional turn.

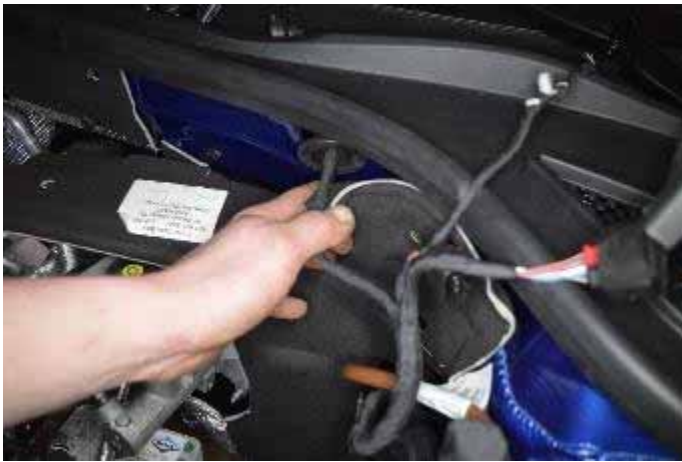
- Unsecure the electrical harness and guide it through the relief cut in the firewall insulation panel to the installed position.

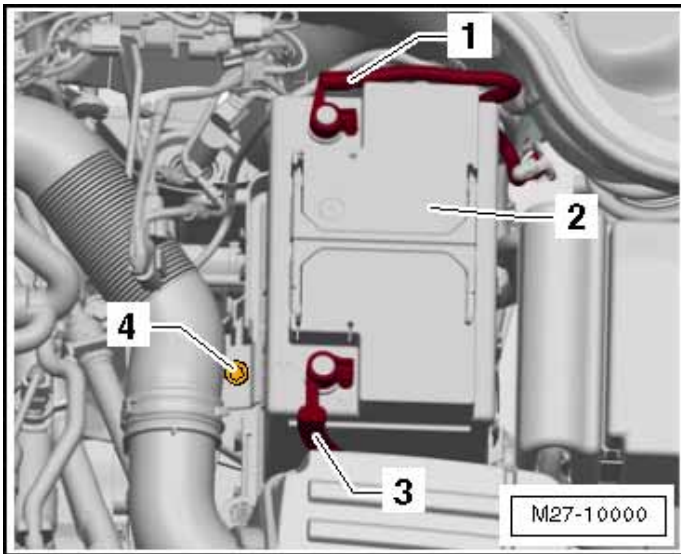
- Reinstall the battery with battery cover.
- Install the bolt <4> through the clamping plate and tighten to 20 Nm.
- Reconnect the battery positive cable terminal clamp <3> and torque the nut to 6 Nm.
- Reconnect the battery ground cable terminal clamp <1> and torque the nut to 6 Nm.

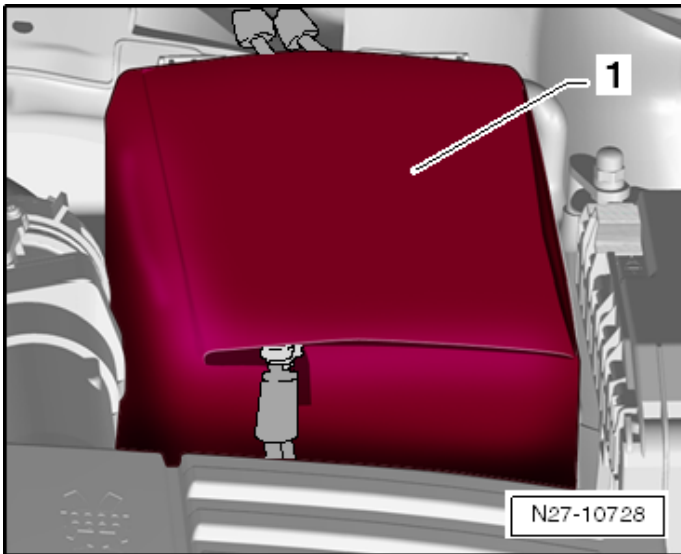
- Secure the battery cover <1> and close the cover.

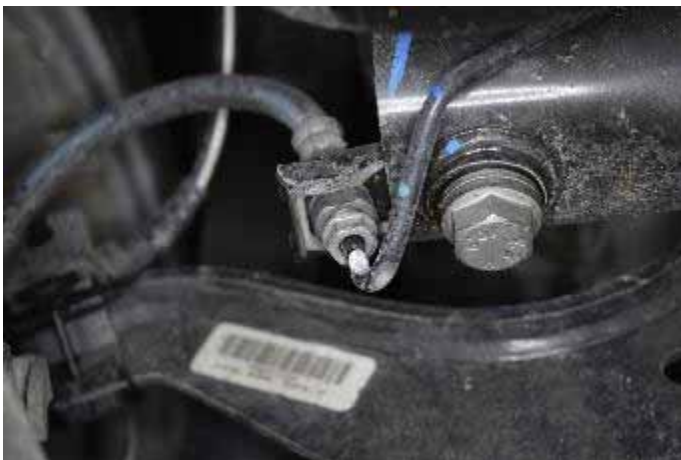
- Inspect all brake fittings at the ABS Pump and check for any leaks.
- Raise the vehicle slightly and inspect all underside brake fittings that were loosened during the procedure for leaks.
- Repair any leaking fittings as necessary.

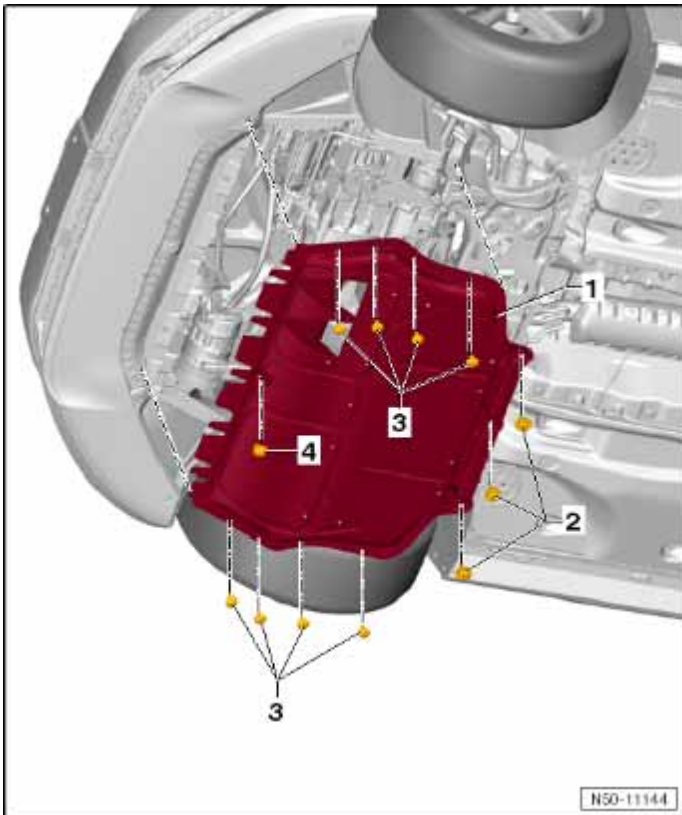
- Reinstall the noise insulation under panel <1> into the front bumper cover <4> toward the front.
- Reinstall the screws <2> and torque to 6 Nm. Reinstall screws <3> and torque to 2 Nm.
- Install all four wheels and torque lug bolts to 140 Nm.
