Volvo Car Customer Service QB Instruction VCC-501267-3					
Title	Inflatable curtain	Page	1 (19)		
Action	Bolt replacements	Operation number:	97184-2		
lesue Date	Reason

#### Affected vehicles

Model year	Model	
2017	V90 (17-)	
2017	V90 Cross Country

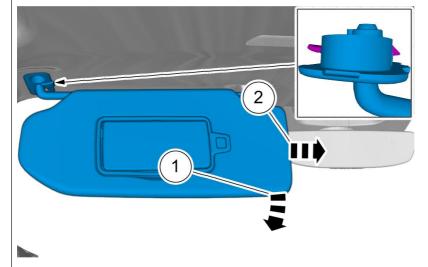
Remove the part carefully Fold marked part to one side. On both sides.

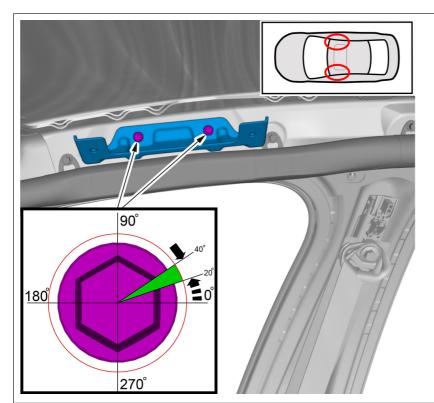
Warning! Loosen the screw between 20-40 degrees.

Warning! Do not re-tighten the screw after it has been loosened 20-40 degrees!

Note! Repeat the steps with the other marked screws.
