Action Required For Identifying the Recalled Bendix® SR-5™ Valve

Identifying SR-5 valves covered in this field action

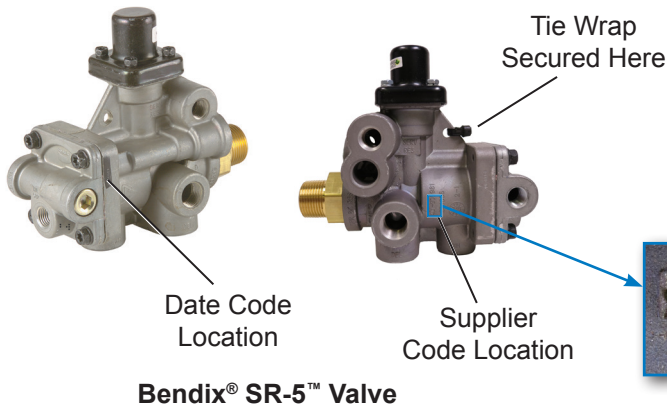
How do I know if the valve has been replaced on my vehicle?

To verify that the Bendix® SR-5™ valve has been repaired per the recall campaign, look for the presence of a black or green tie wrap secured to the valve body. **No further action is required.**

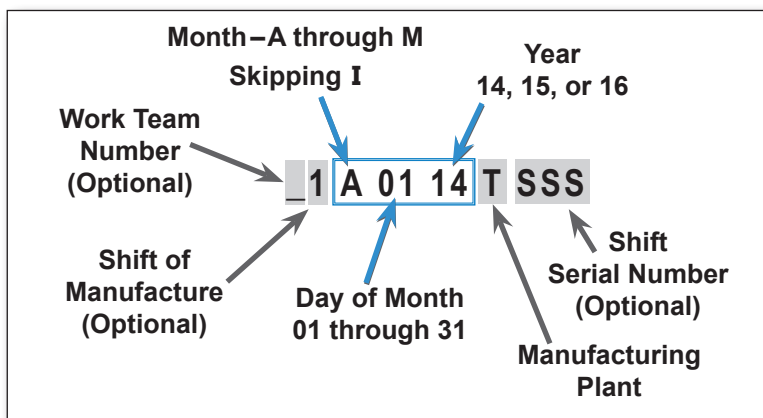
A date code is stamped (not cast) on the SR-5 valve body housing. *Locate the date code – removing the paint coating, if necessary – to read the code.* Disregard the Work Team Number, Shift of Manufacture, Manufacturing Plant and Shift Serial Number codes shown in gray below. The portion of the date code that determines the date of manufacture is highlighted and can be interpreted as follows:

- The first field is the month (A=January, B=February, etc. – excluding the letter I – so that J=September, and so on),
- The next two fields are the day of the month (e.g. 01 = 1st); and
- The next two fields are the year (e.g. 14=2014)

Valves included in this field action were manufactured during the period:
