# SAFETY RECALL BULLETIN

| SUBJECT:<br><b>OUTLANDER FMVSS LABEL REPLACEMENT -<br/>SAFETY RECALL CAMPAIGN</b> | | | No: <b>SR-18-006</b> |
| | | | MODEL: <b>2018-2019 Outlander</b> |

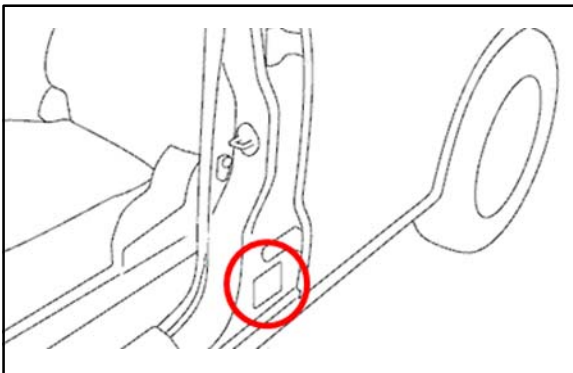
1. Open the driver's door and locate the certification label.

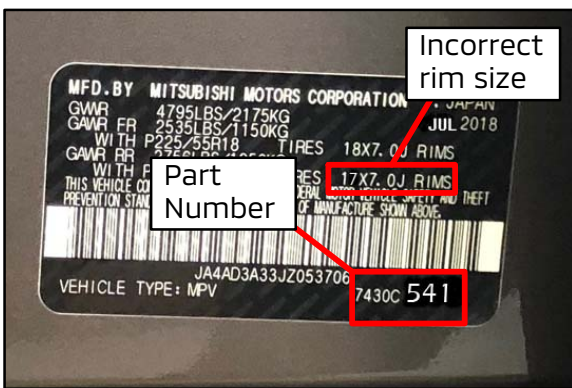
2. Confirm if the part number on the original label is "7430C**541**" and the rear wheel rim size is "17X7.0J."

If the label's part number is "7430C**541**" and the rear wheel rim size is "17X7.0J," proceed to the "Label Installation Procedure."

If the label's part number is **NOT** "7430C**541**" or the rear wheel rim size is "18X7.0J," this is not an affected vehicle. Do **NOT** proceed to the "Label Installation Procedure."

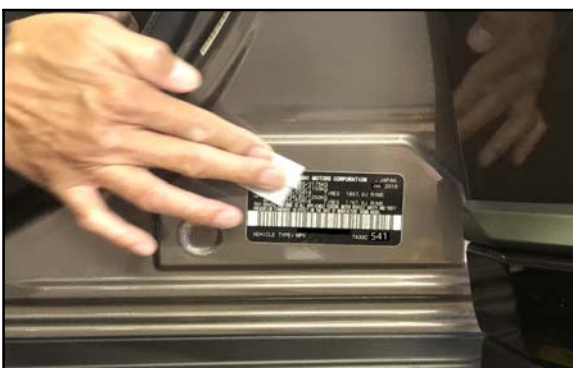
3. Gently clean and dry the surface of the original label with isopropyl alcohol and a clean cloth.

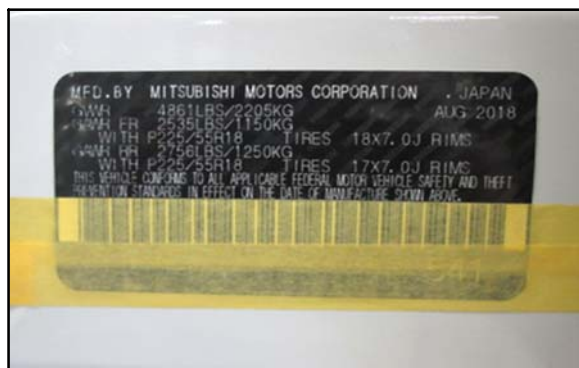
4. Place a piece of painter's tape (or equivalent) over the top of the bar code to use as a horizontal guide for positioning the overlay label.

**Note:** Another piece of painter's tape may be used along the left edge of the label as a vertical guide, if desired.

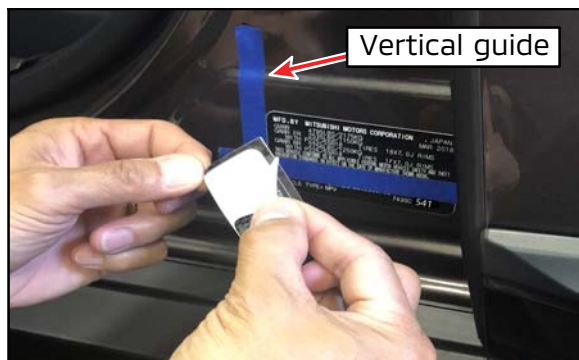
5. Carefully remove the backing of the overlay label.

Be careful **NOT** to touch the adhesive side of the label. The adhesive will lose effectiveness if it is touched.

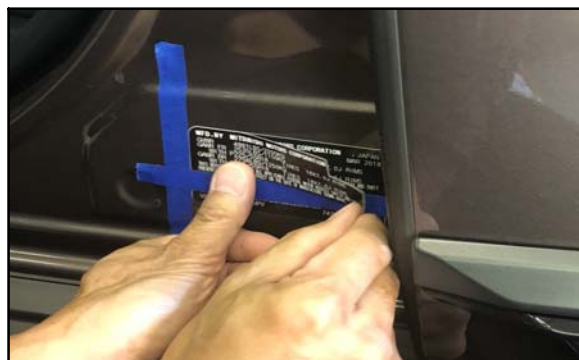
6. Apply the overlay label onto the original label.

**IMPORTANT:** Ensure the overlay label is properly positioned before allowing contact with the original label.

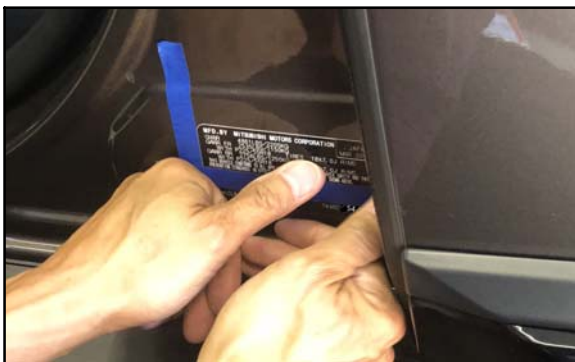
- a. Carefully align the overlay label with the vertical edge of the original label (or vertical painter's tape guide if used) and the top edge of the horizontal painter's tape guide, as shown.

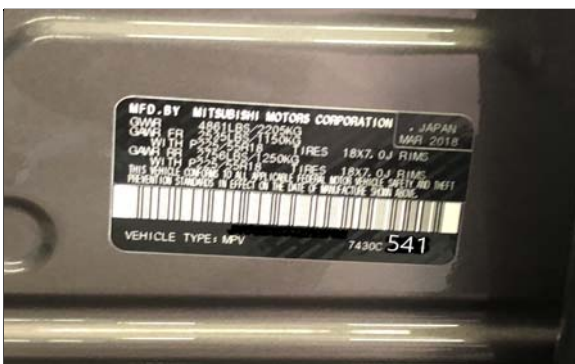
- b. Once the overlay label is properly positioned, use your thumb to work out any air-bubbles or creases, starting from the bottom edge to the top edge.
