Campaign No. 2021070026, July, 2022

SUBJECT: **Model 907 Sprinter, Model Year 2020
Software Update**

MBAG has determined that on certain Sprinter vehicles (platform 907), the Engine Control Unit (ECU) software and Transmission Control Unit (TCU) software does not correspond to current series production specifications.

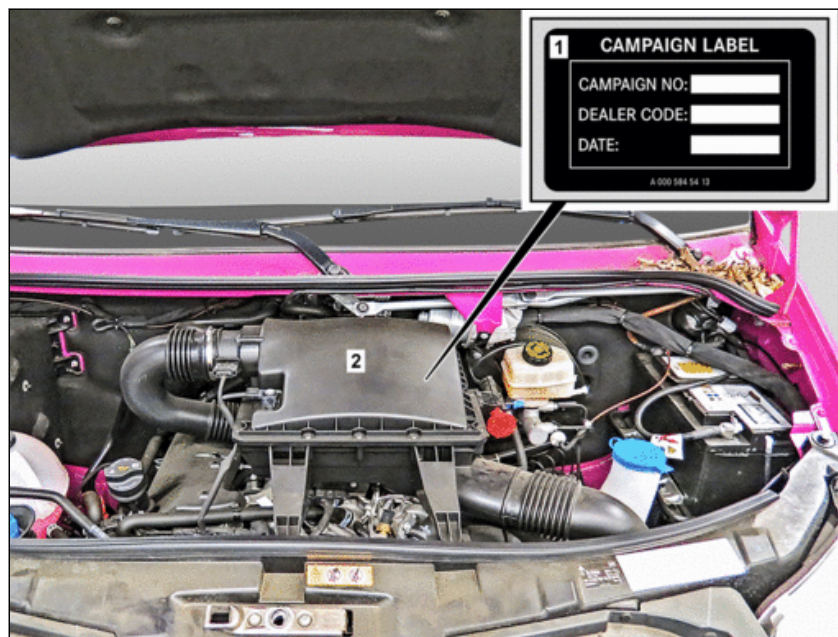
D54.21-A036-76

Shown on model 906 with engine 642

- 1 Campaign label
- 2 Air cleaner housing

Remove charger from vehicle.		AR54.10-D-1127TS
8	Fill out campaign label (1) and attach to air filter housing (2).	Only applies for vehicles in State of California.

Bonding surface must be absolutely free of dust and grease. Otherwise, a sufficient degree of adhesion cannot be assured.

To do so, enter 6-digit campaign number, dealer code and date. Cleaner	BR00.45-Z-1025-04A
9	Fill out certificate and hand over to customer.	Only applies for vehicles in State of California.

Apply number from campaign label (1).
