PRODUCT CAMPAIGN BULLETIN

APPLICABILITY: 2018MY Forester

NUMBER: WTS-78

SUBJECT: Subaru STOP SALE/FMVSS
Non-Compliance Recall-Incorrect
Certification Label Information

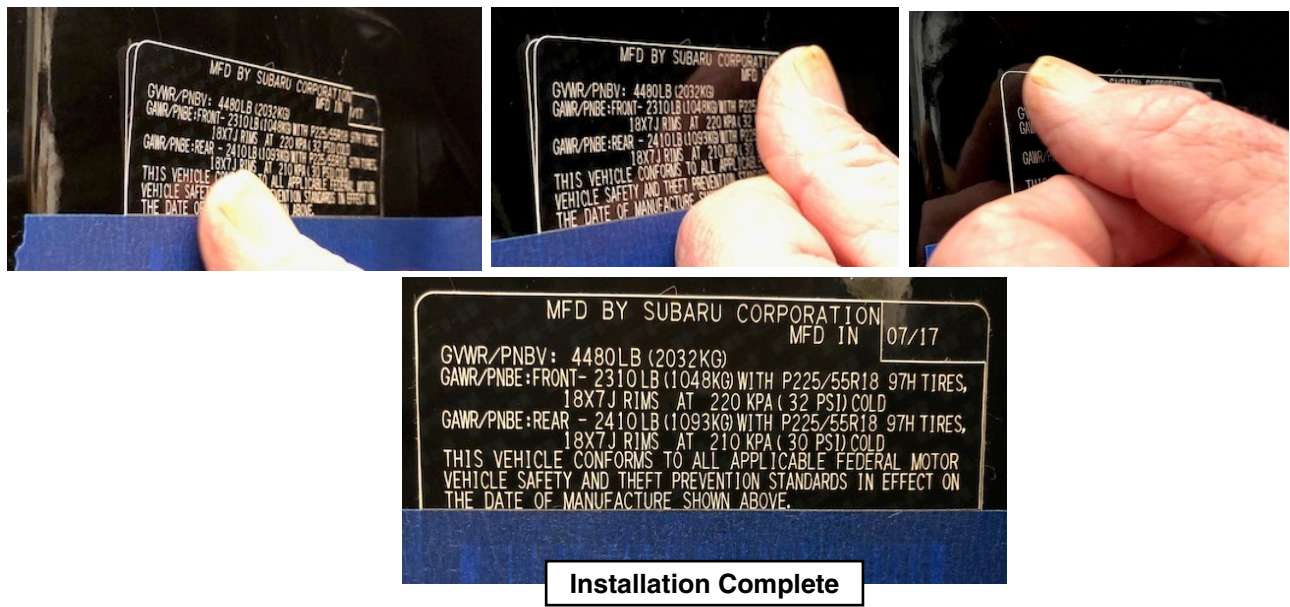
- Once the overlay is properly positioned, apply it fully using your thumb, starting at the bottom edge and working back and forth from the bottom upward to avoid trapping air.

- Remove the Painter's Tape to complete the procedure.
