PRODUCT CAMPAIGN BULLETIN

APPLICABILITY: 2018MY Forester **NUMBER:** WTS-78R
SUBJECT: Subaru STOP SALE/FMVSS **DATE:** 07/09/18
 Non-Compliance Recall-Incorrect **NHTSA ID:** 18V-455
 Certification Label Information **DATE:** 07/19/18

Subaru of America, Inc. (Subaru) is recalling certain 2018 model year Forester 2.5i Premium Black Edition vehicles, due to incorrect information listed on the certification label.

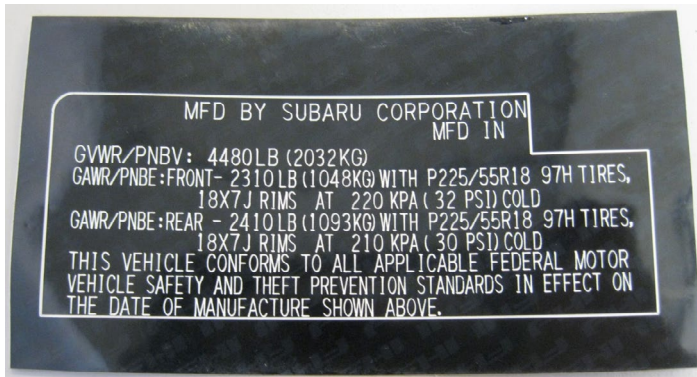
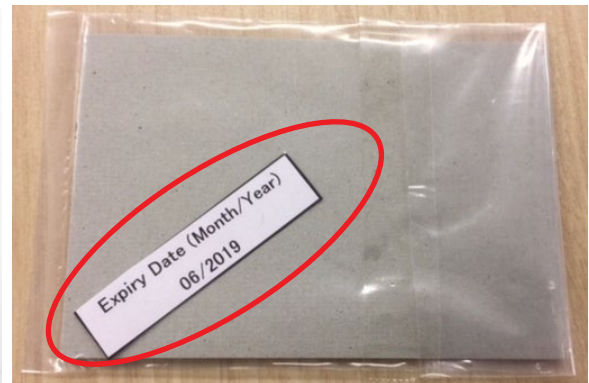
The part number for the replacement FMVSS label kit is **99095SG000**. These labels should be available at each RDC by July 13, 2018. Please order the labels for your affected vehicles accordingly.

IMPORTANT: The shelf-life of the remedy label is approximately one year. The label packaging will contain a sticker with an expiration date ('Expiry Date (Month/Year)'). If the repair date is beyond the expiration date of the label, that label should not be installed and a new one should be ordered.

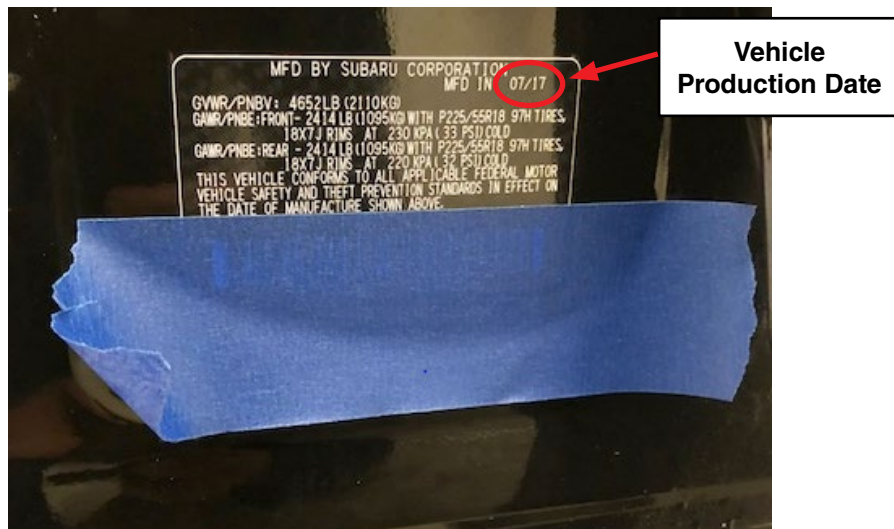
- Use a piece of Painter's Tape CAREFULLY placed along the top edge of the VIN as shown below. The tape will serve as a horizontal guide for application of the overlay. Do not cover any of the label text above the VIN.

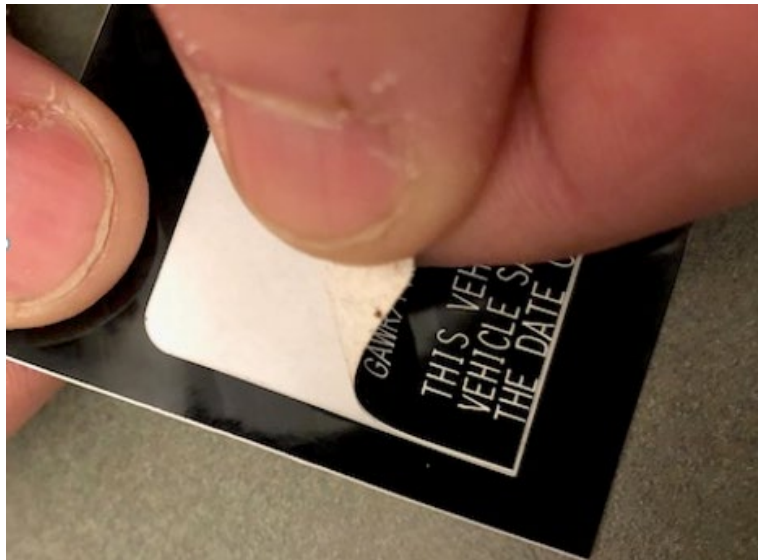
- Peel the backing of the overlay. **USE CARE as the overlay will tear easily.**

IMPORTANT NOTE: The adhesive on the overlay is **VERY** strong. Take the time to confirm the overlay is properly positioned before application as it **will** be destroyed if any attempt is made to remove it.

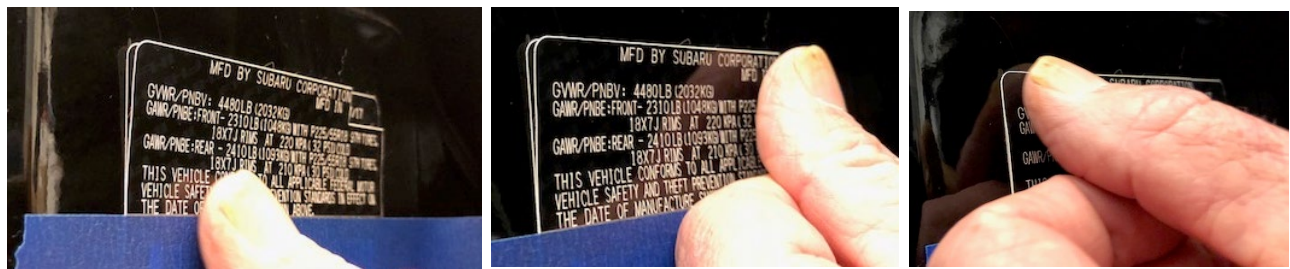
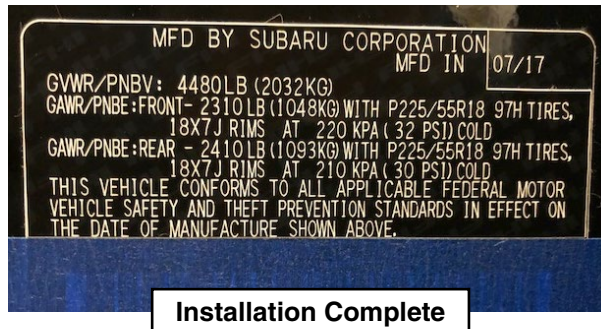
- Once the overlay is properly positioned, apply it fully using your thumb, starting at the bottom edge and working back and forth from the bottom upward to avoid trapping air.

- Remove the Painter's Tape to complete the procedure.

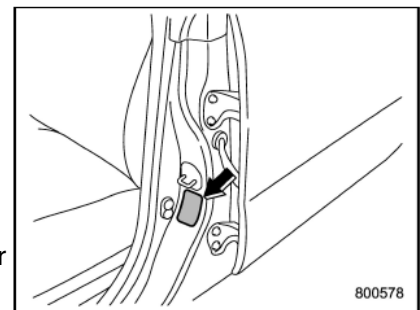
Until the corrected label is installed, when checking or adjusting the air pressure in your tires please refer to the tire inflation pressure label and/or your owner's manual which contains the correct information for your vehicle. The tire inflation pressure label is located on the inside of the driver's side door pillar below the door latch, as shown here.
