## Center Rear Seat Belt Buckle Installation Is OK

### AFFECTED VEHICLES

All 2014–**16** five-passenger models

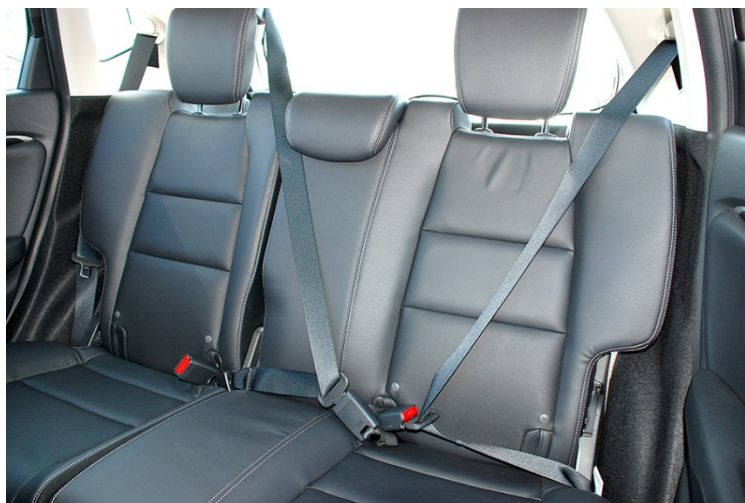
On some five-passenger models, at first glance, the center rear seat belt buckle may look like it isn't installed right (it looks crossed with the left outer buckle). Actually, it's OK. The outer buckles are intentionally mounted **inboard** of the center belt and buckle to give the passengers on either side more room to work their seat belts.

**Don't** unbolt the lower anchor plates to uncross the seat belts. Such a change in the belts' configuration, could affect their level of protection.
