May 13, 2015A15050B Version 1

Soft Set or Bad Connection at C505 Can Cause Various Electrical Problems

2005–15 Odyssey and 2009–15 Pilot

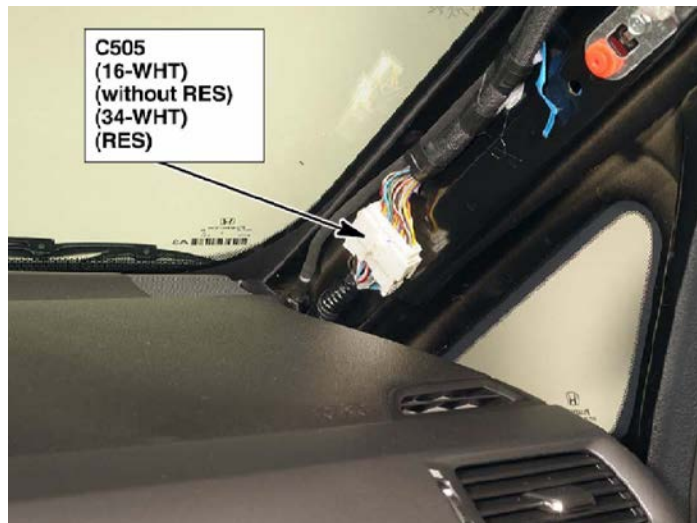
A soft set or bad connection at C505 in the right A-pillar can cause any or all of these symptoms:

To fix this problem, check the connector and reset it if needed. If the connection is good, continue with normal troubleshooting.
