Left Rear Door Molding End Is Loose?

Year	Model	Trim
2019	RDX	ALL

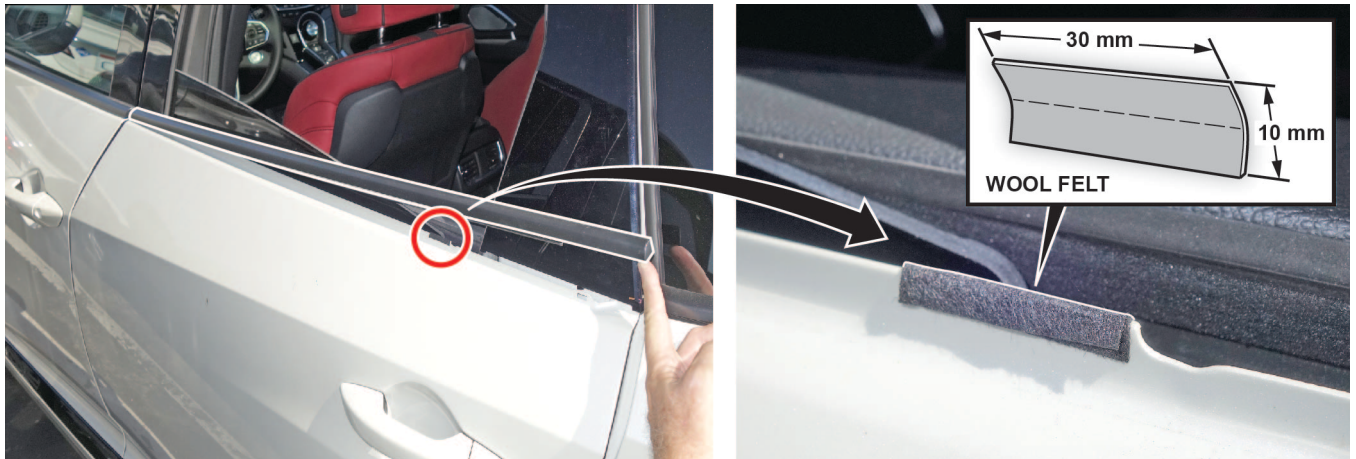
We're getting reports of the back end of the left rear door molding coming loose. From our investigation, we've found this may be caused by the molding clip coming loose due to a curvature in the door hem.

1. Remove the left rear door molding.
2. Cut a **10 x 30 mm** piece of adhesive-backed wool felt (must be **0.5 mm** thick), and wrap it around the door edge as shown. Make sure you've got a **5 mm** overhang on both sides.

3. Install the molding.
