**NUMBER:** 08-011-16

**GROUP:** Electrical

Install Intake Air Temperature Sensor Jumper Harness

2015 (VM) **\*\*RAM\*\*** ProMaster City

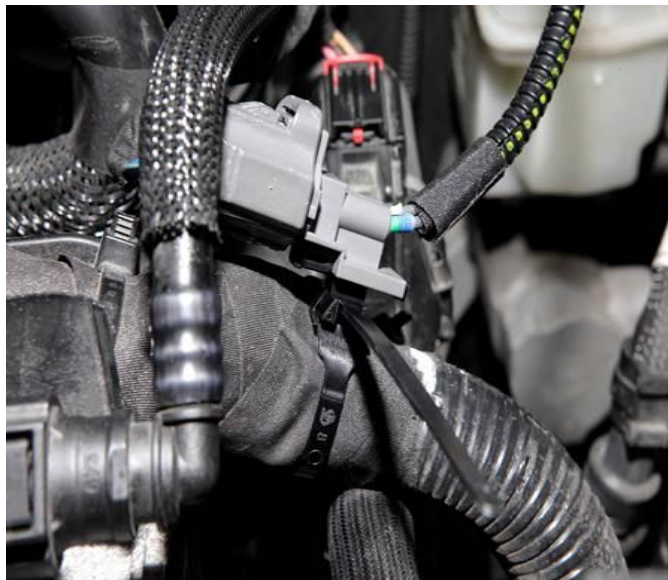
**Fig. 5 Location Where Jumper Is Fasten to Harness**

Fasten Jumper On Main Harness, In This Position

- 
8. Connect one end of the jumper harness to the old IAT connector and then the other end to the IAT sensor.
  9. Fasten the jumper harness to the main harness, as shown in (Fig. 5).
