NUMBER: 08-062-16 REV. A

GROUP: Electrical

Front Seat Bottom Cushion Hard Or Lumpy Spot

2015 (UF) Chrysler 200

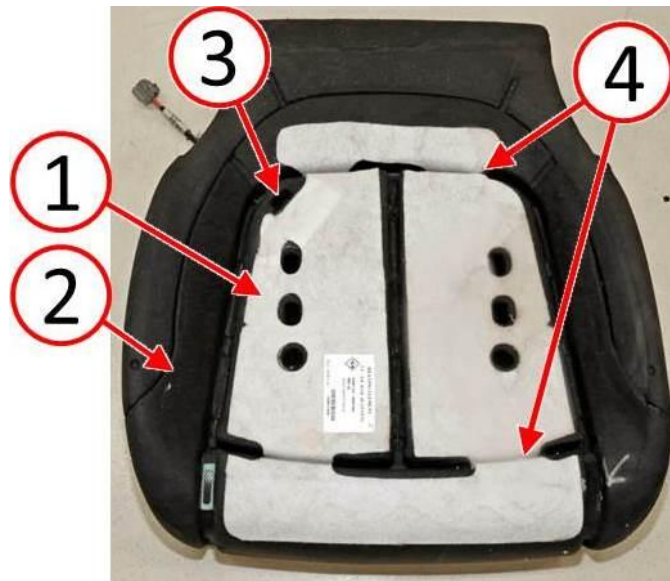
Fig. 2 Install New Heater Pad To Foam Cushion

- 1 - Heated Seat Pad
- 2 - Seat Foam Cushion
- 3 - Heating Pad Wiring Pass-Through
- 4 - Tuck Heater Pad Fully Into Cushion Channel

5. Assemble the **NEW** heated pads (1) to the **NEW** driver's seat cushion and passenger's seat foam cushion kit (2) (). Refer to the detailed service procedures available in DealerCONNECT> TechCONNECT under: Service Info> 08 - Electrical> 8G - Heated/Cooled Systems> Heated Seats> Pad, Heater> Installation.

NOTE: Ensure the heated seat pad wire harness lays flat and is guided into the pass-through (3) without kinking ([Fig. 2](#)).

NOTE: Ensure the heated seat pad (1) is tucked fully into the seat foam cushion channels (4) at front and back of the foam cushion and the heater pad lays flat on the foam cushion without wrinkles ([Fig. 2](#)).

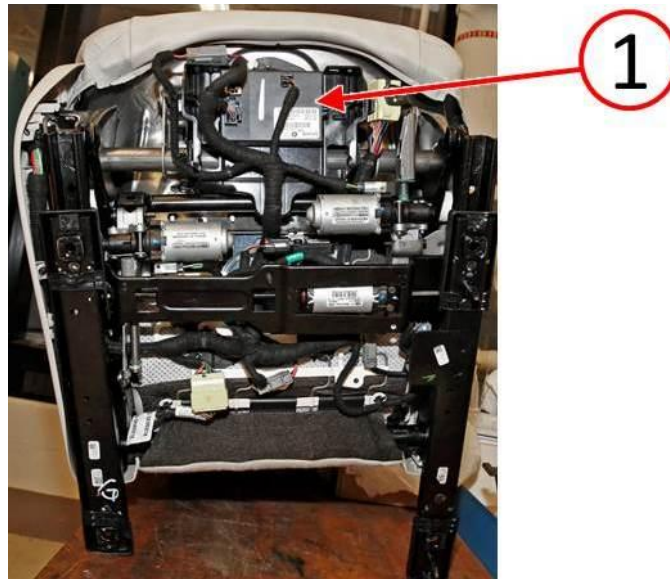
Fig. 4 CSWM Location Under Passenger Side Seat

1 - CSWM

8. Replace the OCM to the passenger seat structure. Refer to the detailed service procedures available in DealerCONNECT> TechCONNECT under: 08 - Electrical/8E - Electronic Control Modules/Module, Occupant Classification/Removal/Installation.
9. Assemble the seat cover to the bottom foam cushion using new hog rings, then install the seat bottom cushion with cover to the seat. Refer to the detailed service procedures available in DealerCONNECT> TechCONNECT under: Service Info> 23 - Body> Seats, Front> COVER, Seat Cushion> Installation.
10. Replace the CSWM (1) located under the passenger side seat (Fig. 4). Obtain the appropriate module from the Parts Required list. Refer to the detailed service procedures available in DealerCONNECT> TechCONNECT under: Service Info> 08 - Electrical> 8E - Electronic Control Modules> Module, Comfort Seat and Wheel> Removal/Installation.
