NUMBER: 08-064-15

Roof Clearance Lamp Has Moisture Inside

This bulletin involves inspecting the cab roof clearance lamps for moisture inside the lamp.

2015	(VF)	Ram Pro Master (NAFTA And Latin America)
------	------	---

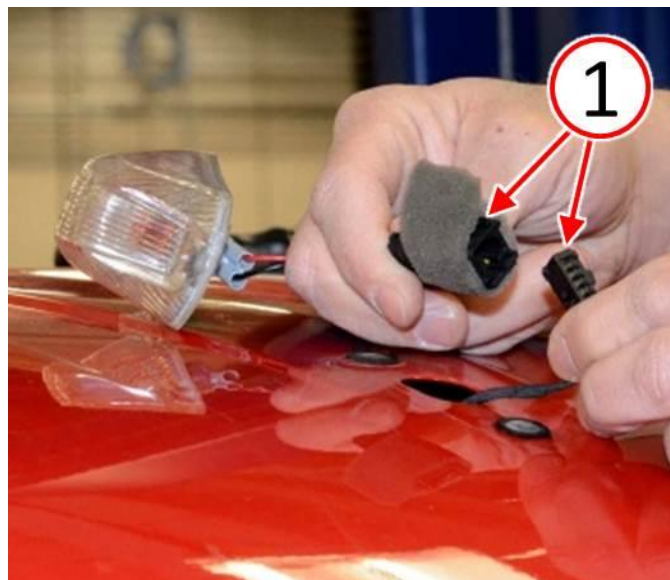
Fig. 5 Connect Roof Clearance Lamp

- 1 - Roof Clearance Lamp Electrical Harness

5. Connect the electrical harness (1) to the NEW roof clearance lamp ([Fig. 5](#)).

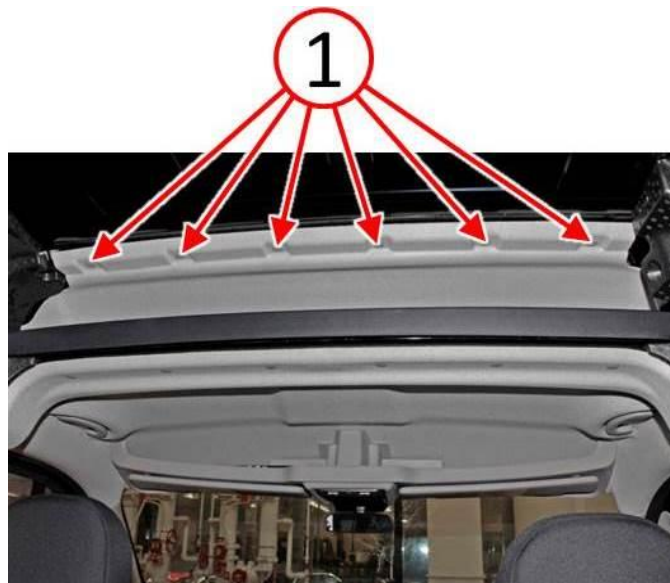
Fig. 11 Remove Push Pins From Upper Compartment Roof Liner

1 - Push Pins

-
3. Remove the push pins (1) from the upper compartment roof liner ([Fig. 11](#)).

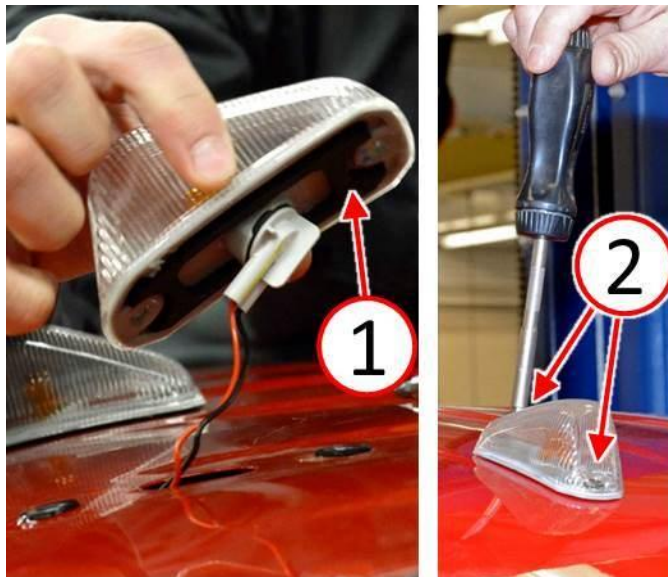
Fig. 15 Install Roof Clearance Lamp

1 - Roof Clearance Lamp

2 - Roof Clearance Lamp Screws

10. Install the NEW roof clearance lamp (1) to the vehicle ([Fig. 15](#)).

11. Install the roof clearance lamp screws (2) and tighten to 2 N·m (18 in. lbs.) ([Fig. 15](#)).

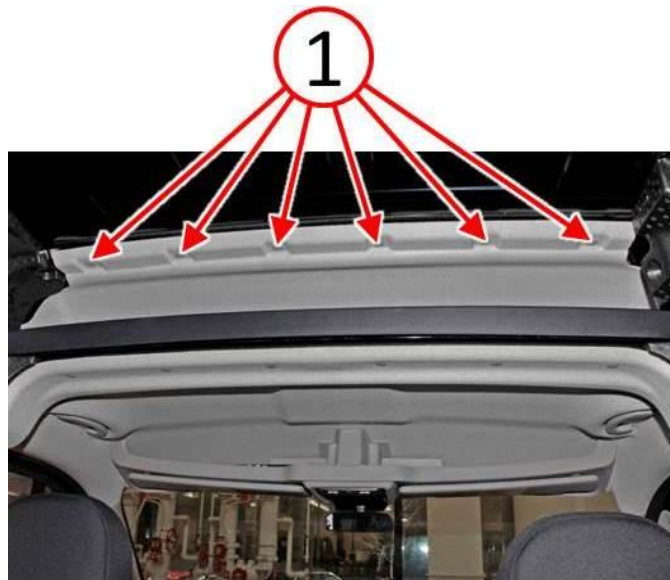
Fig. 18 Install Push Pins To Upper Compartment Roof Liner

- 1 - Push Pins

18. Install the push pins (1) to the upper compartment roof liner ([Fig. 18](#)).
