**NUMBER:** 08-107-15 REV. A

Cross Threaded Antenna Nut

This bulletin involves the replacement of the Radio Antenna Base/Cable Assembly and Radio Antenna Nut due to cross threading during assembly.

2016 (DS) Ram 1500 Pickup

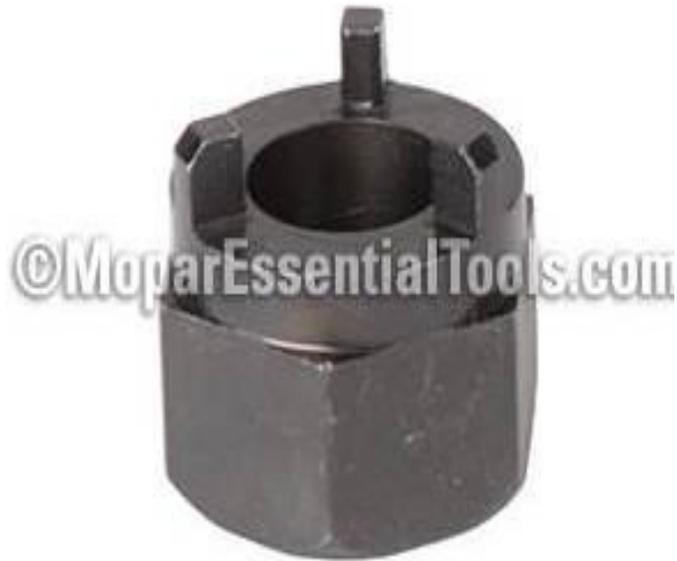
**Fig. 1 Antenna Socket**

C-4816	Socket, Antenna
--------	-----------------

9. Remove the antenna cap nut using the Antenna Socket C-4816(Fig. 6).

15. Install and tighten the antenna cap nut with the Antenna Socket C-4816.  
16. Verify that the antenna grommet is fully seated.

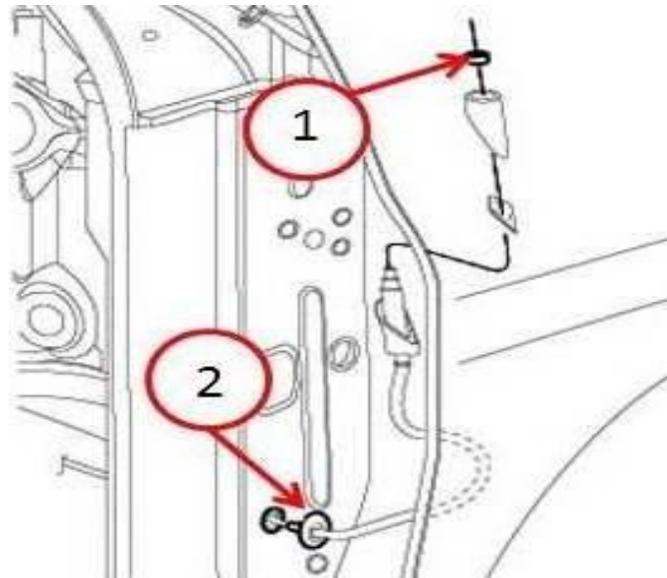
**Fig. 2 Antenna Base and Cable Assembly**

Upon inspection, the technician may find the radio antenna nut is cross threaded on the radio antenna base/cable assembly.

1. Inspect the antenna nut for cross threading on the antenna base and cable assembly([Fig. 2](#)).

- 1 - Antenna Nut
- 2 - Grommet

- 
2. Is the antenna nut cross threaded on the antenna base and cable assembly?
    - a. YES>>> Proceed to [Step #3](#).
    - b. NO>>>This bulletin has been completed, use Inspection Only LOP (08-60-05-97) to close the active RRT.
  3. Make note all radio presets; and the quality of radio reception for them before continuing with this repair.
  4. Disconnect and isolate the negative battery cable.

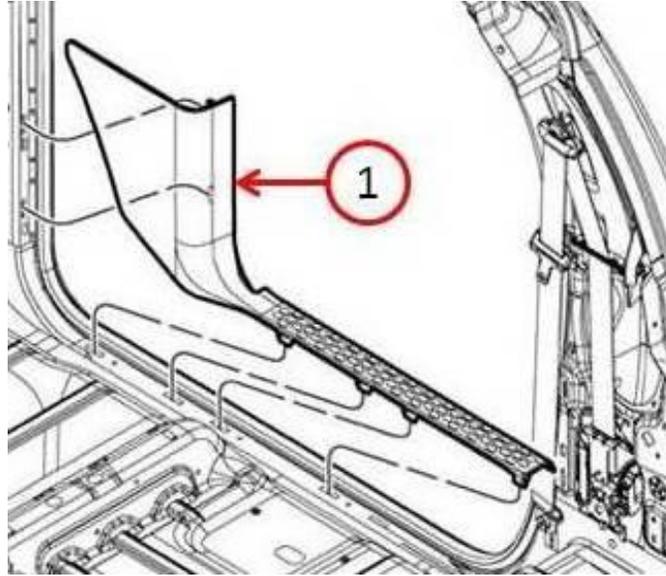
**Fig. 3 Passenger Lower Trim Panel**

1 - Passenger Lower Trim Panel

5. Remove the passenger side cowl trim panel ([Fig. 3](#)).

18. Install the passenger cowl trim panel.

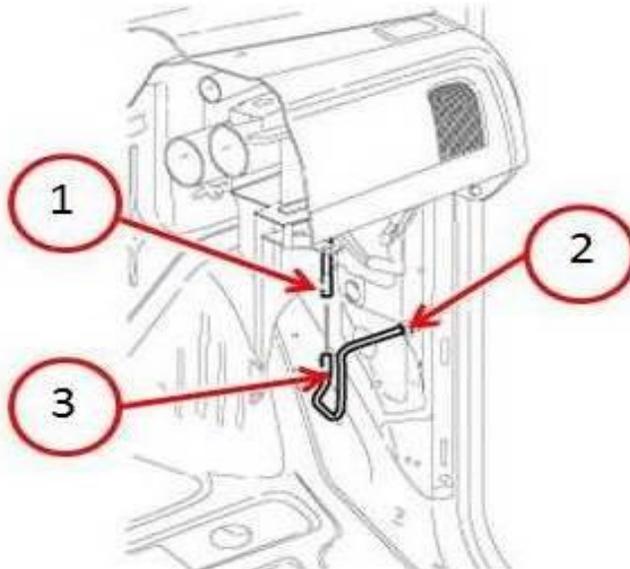
**Fig. 4 Antenna Mast Connection**

1 - Instrument Panel Antenna Connector  
2 - Antenna Cable  
3 - Antenna Cable Connector

6. Disconnect the antenna mast connector from the instrument panel antenna connector ([Fig. 4](#)).

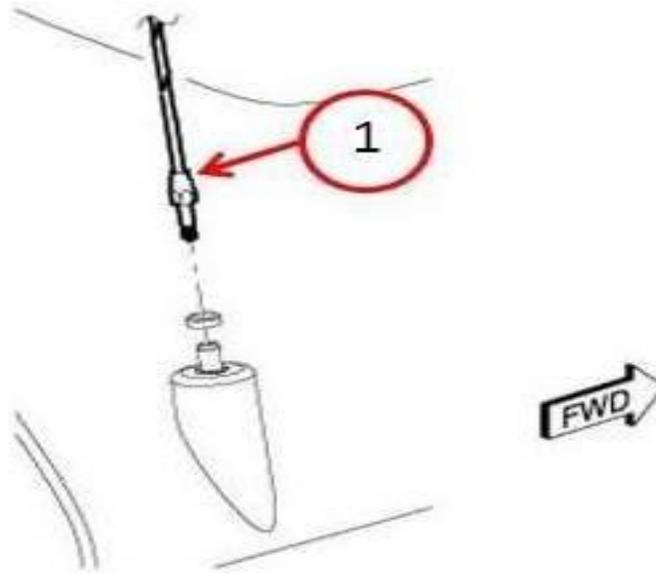
**Fig. 5 Antenna Mast**

1 - Antenna Mast

7. Securely tie a suitable length of cord or twine to the antenna half of the antenna cable connector. This cord will be used to pull the antenna cable back into position during installation.
8. Remove the antenna mast.

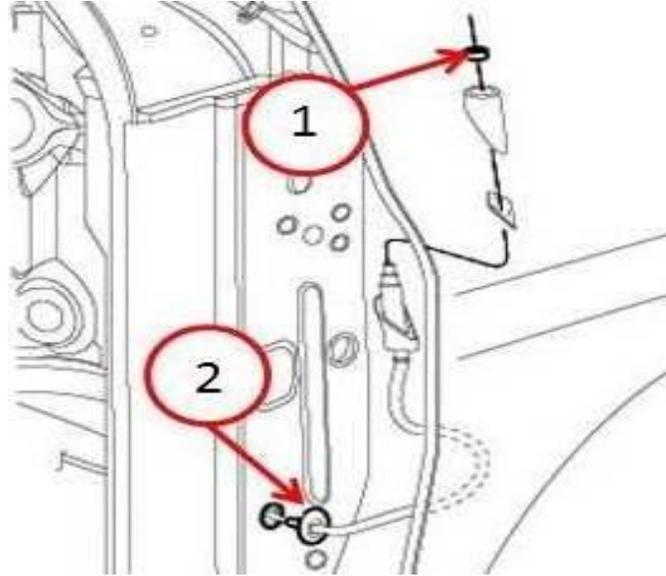
**Fig. 6 Antenna Base and Cable Assembly**

- 1 - Antenna Nut
- 2 - Grommet

- 
10. Remove the antenna adapter.
  11. With the passenger door open, pull the antenna body assembly out through the opening between the fender and body.
  12. Tie the cord that was used during the removal procedure to the cable being installed.
  13. Using the cord, pull the antenna cable through the hole in the door opening and seat grommet into place.

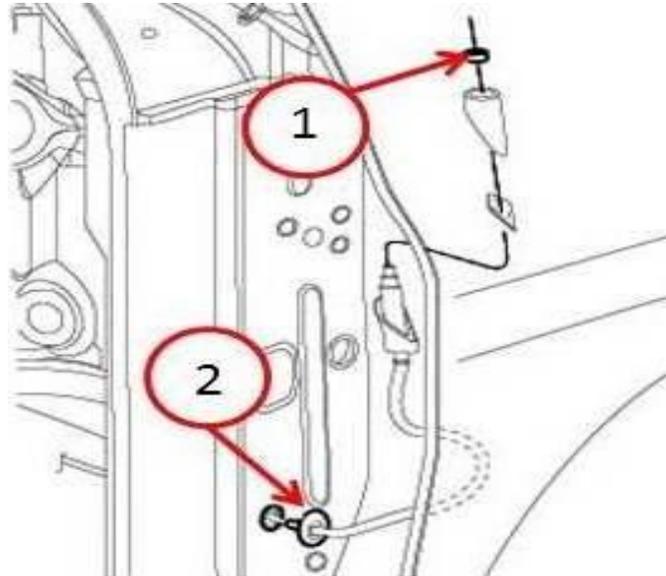
**Fig. 7 Antenna Base and Cable Assembly**

- 1 - Antenna Nut
- 2 - Grommet

14. Insert the antenna body through the hole in the fender and install adapter ([Fig. 7](#)).

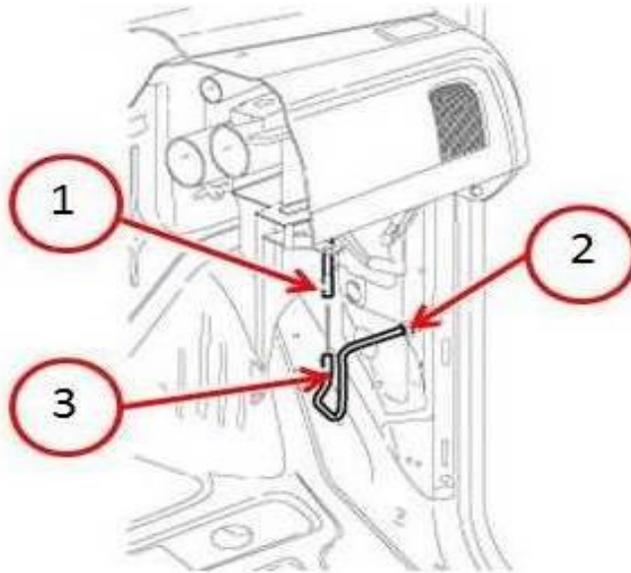
**Fig. 8 Antenna Mast Connection**

- 1 - Instrument Panel Antenna Connector
  - 2 - Antenna Cable
  - 3 - Antenna Cable Connector
-

17. Connect the antenna mast connector to the instrument panel antenna cable (Fig. 8).

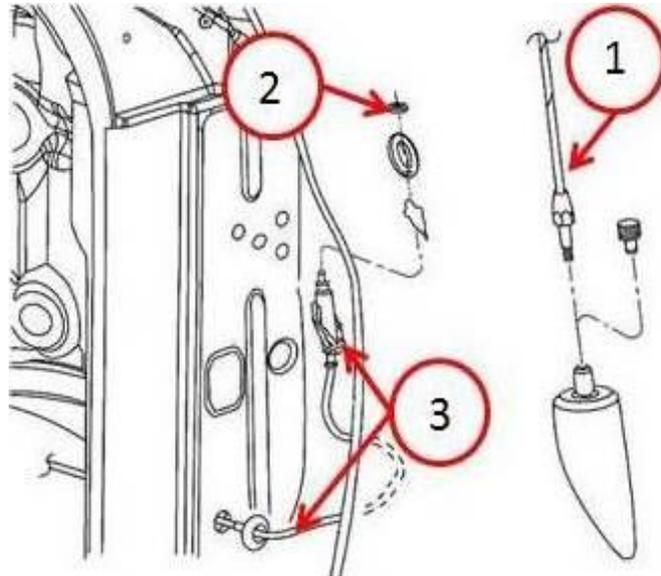
**Fig. 9 Antenna Mast Base and Cable Assembly**

- 1 - Antenna Mast
- 2 - Antenna Nut
- 3 - Antenna Base and Cable Assembly

19. Install the antenna mast (Fig. 9).

- 
- 20. Connect the battery negative cable.
  - 21. Verify the repair by checking the radio reception on the stations previously identified for presets.
  - 22. Set all customer presets to the previously noted positions.
