NUMBER: 14-001-12 REV. A

GROUP: Fuel System

Fuel Spit Back During Refueling Due To Inlet Check Valve X39 (Unlimited Time And Mileage Warranty Extension)

2006 - 2008	(HB)	Durango
2007 - 2008	(HG)	Aspen

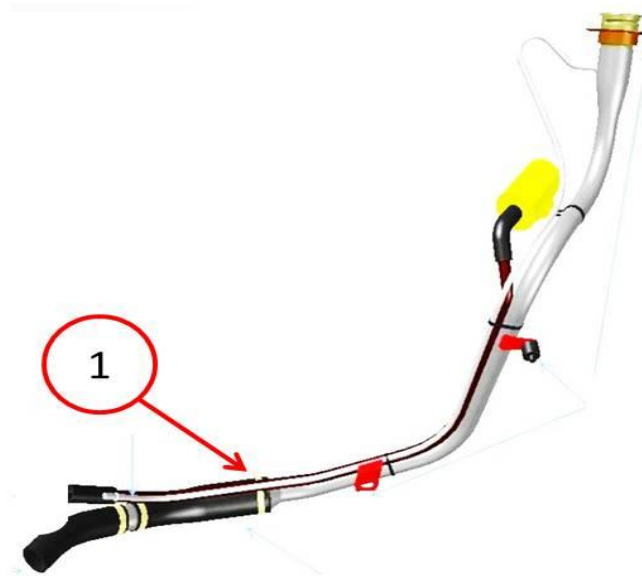
Fig. 1 Fuel Filler Tube

1. Hoist vehicle.
2. Remove Left rear wheel.
3. Remove the left quarter panel splash shield.
4. On new fuel filler tube verify and write down existing torque ([Fig. 1](#)).

NOTE: It may be necessary to loosen the worm gear hose clamp and rotate to allow the fuel filler neck to fit between the body and frame. If clamp is loosened then once installed re-torque to noted value.

1 - worm gear hose clamp

-
5. Replace the fuel filler tube, Following the detailed procedures found in DealerCONNECT>TechCONNECT Service Info > 14 - Fuel System> Fuel Delivery > Tube, Fuel Filler removal and installation procedures.
 6. Install the left quarter panel splash shield. There are 4 or 5 plastic retaining rivets.
 7. Install left rear wheel.
