2012-2014 Edge

2012-2014 MKX

Some 2012-2014 Edge and MKX vehicles may exhibit a sagging headliner by the roof opening panel.

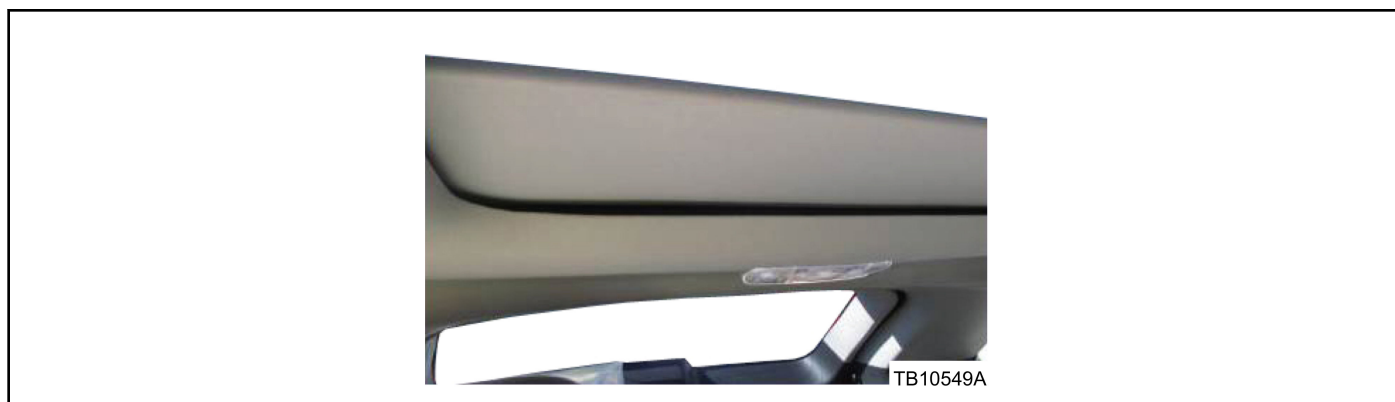
Figure 1 - Article 14-0088

1. Inspect the headliner for sagging at the roof opening panel near the overhead lamp. Is the headliner sagging? (Figure 1)

- a. No - this article does not apply.
  - b. Yes - proceed to Step 2.
2. Apply upward pressure to the headliner for 45 seconds to eliminate the sag condition. Allow the vehicle to sit for 30 minutes. (Figure 2)
