To All Lamborghini Dealers and Licensed Service Point  
From Customer Service Department  
Subject Service campaign – Fixing of Gallardo Shock Absorbers Covers  
Group 140.4.11.00.05 (front) and 140.5.12.00.05 (rear)  
Date 18.07.2005  
Pages 7

Fixing of the Gallardo shock absorbers protection covers.

All Gallardo models until VIN ZHWG\_11\_\_5LA02579

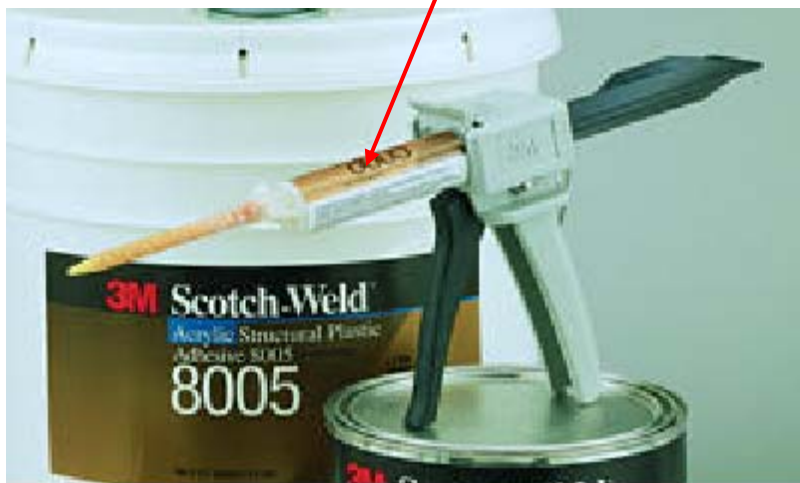
3M™ Scotch-Weld™ Structural Plastic Adhesive DP8005 Translucent Duo-Pak, 38ml (please contact the local 3M dealer – [www.3m.com](http://www.3m.com) for more information).

- Gun 568 applicator – manual – EPX
- Nozzle MMS 40035 for 8005 – DP 4000 – 10:1
- Plunger MMS 4000 for 8005 – EPX - 10:1
- Glue MMS 8005 – DP Scotch Weld – MC 38

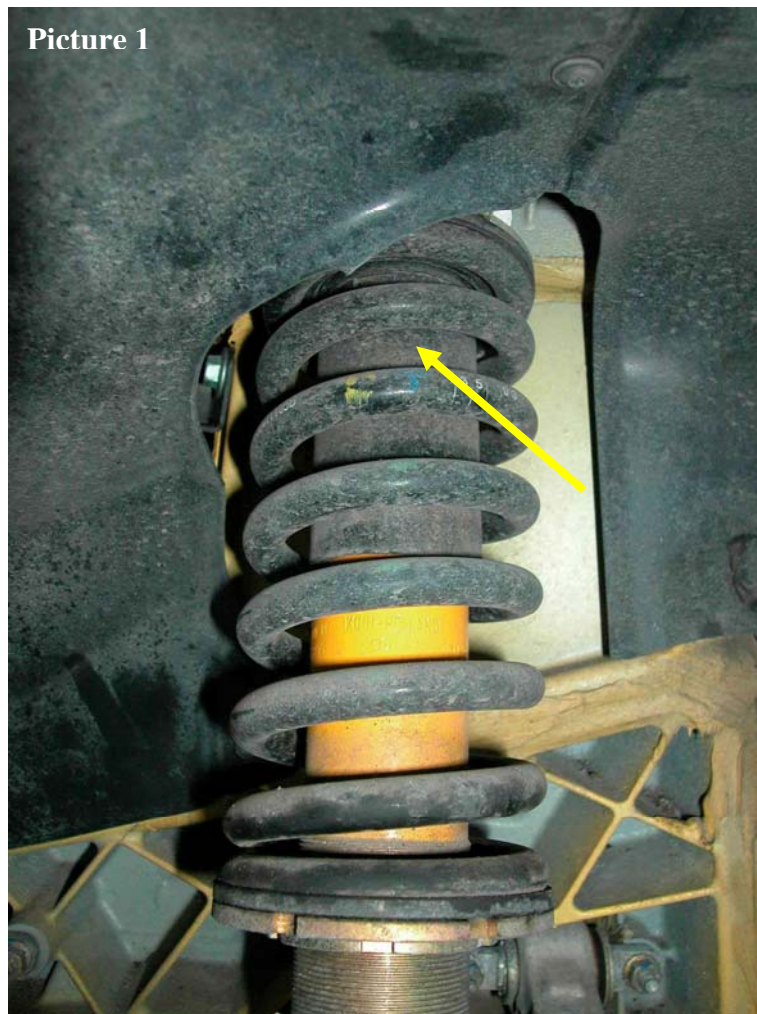
1.4 Identify the black protection cover (pictures 1, 2) and check the protection cover position.

Correct position:

**1.5** If the cover is in the correct position (pic.1), remove it from its upper fixing point, using a screw driver (pic. 3), in order to carry out the rework and go to operation 1.6.

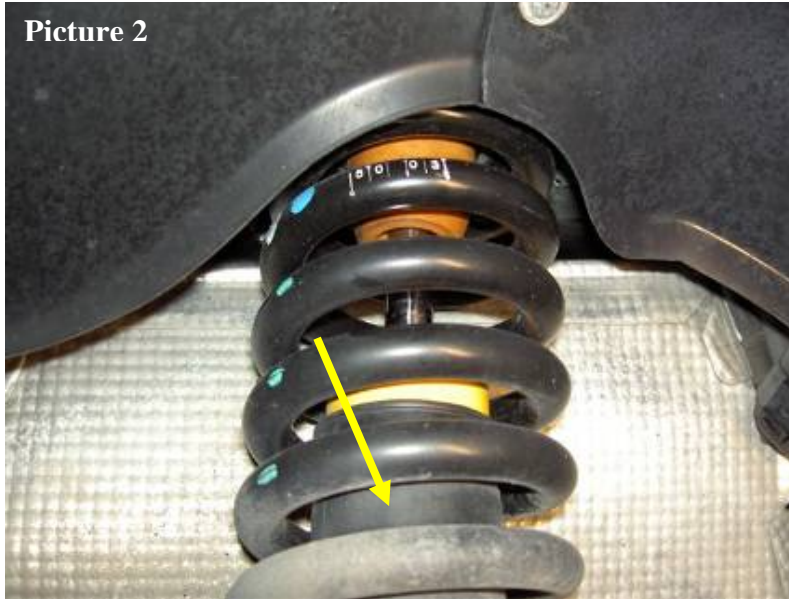
Picture 2

Not correct position:

If the cover is in a not correct position (pic.2) go to operation 1.6.

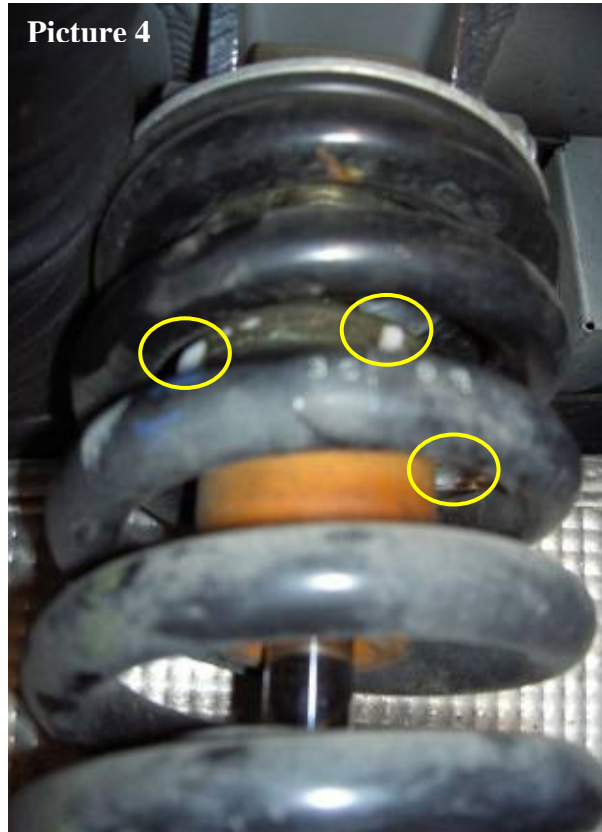
**1.6** Using the glue gun, apply the glue in four points to block the protection (use the gloves when operating the glue). (picture 4)

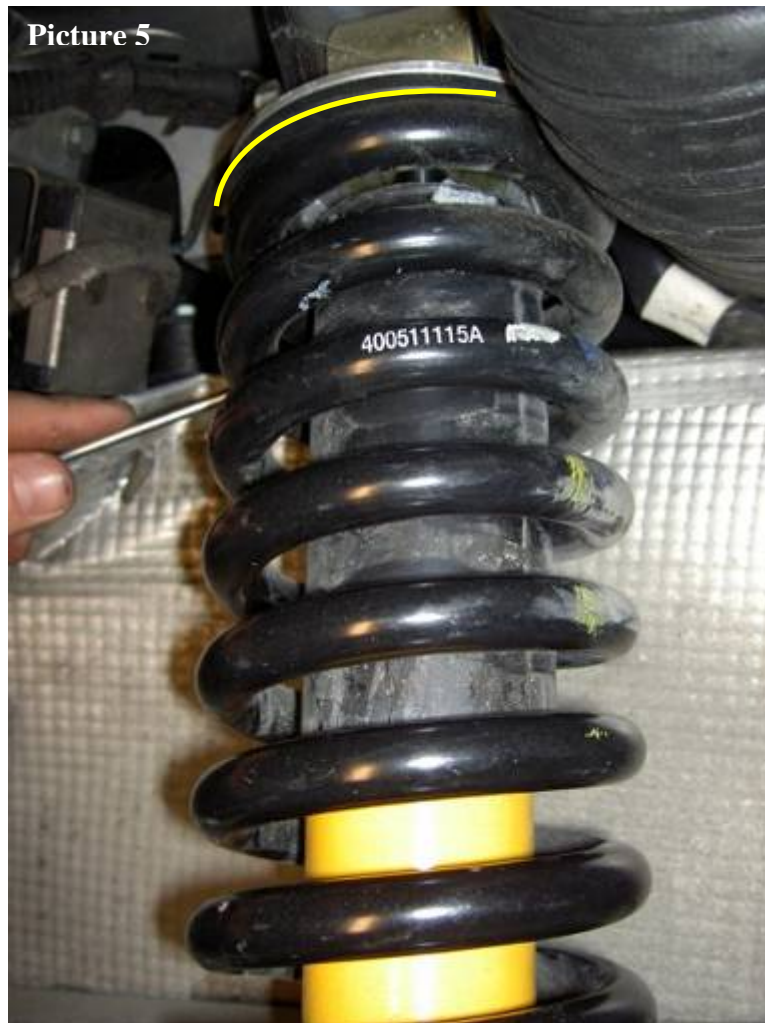
**1.8** After fitting in the protection, apply other 4 points of glue between the protection and the fixing point. (Picture 5 indicated with yellow).

**1.9** Then use the screw driver to spread the glue. (Picture 5)

**1.10** Please consider that the glue needs about 7/8 hours to fix the parts.
