To all Lamborghini Dealers and Authorised Service Points
From After Sales Service
Pages 1+2
Object Technical Bulletin ref.:CT.03.04
Service 2500 km (Coupon A) or 12000 km-
Lamborghini Gallardo L140
Group 140.00.00.00.04.AditionalCheck.GB
Date 31.05.2004

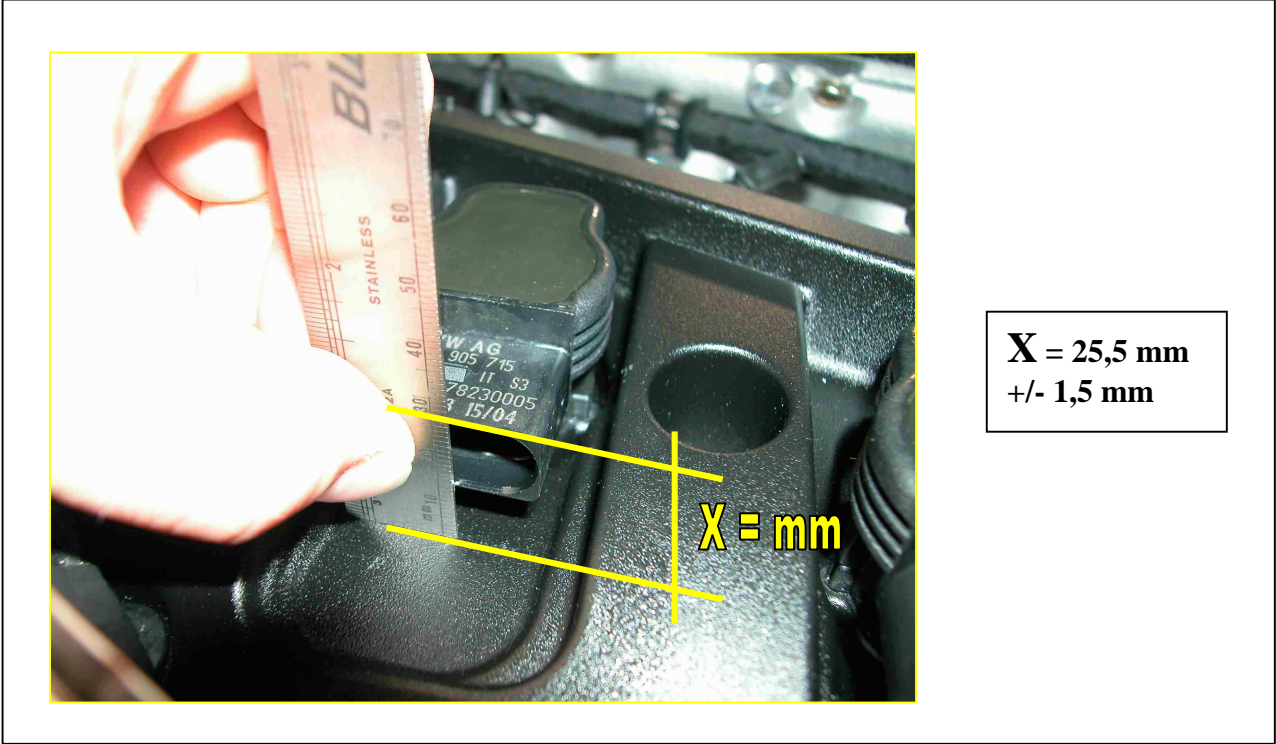
Picture (d)

X = 25,5 mm
+/- 1,5 mm

ATTENTION: The correct ignition coil fitting can be verified by checking the measure as shown in picture d.
