To All Lamborghini Dealers and Licensed Service Point
From Customer Service Department
Subject Secondary air pump disconnection
Group 140.1.31
Date 06.02.2007
Pages 6

Subject
Secondary air pump disconnection

Model / VIN-Range
All MY06 / 07 Gallardo Coupè & Spyder until VIN G74995.

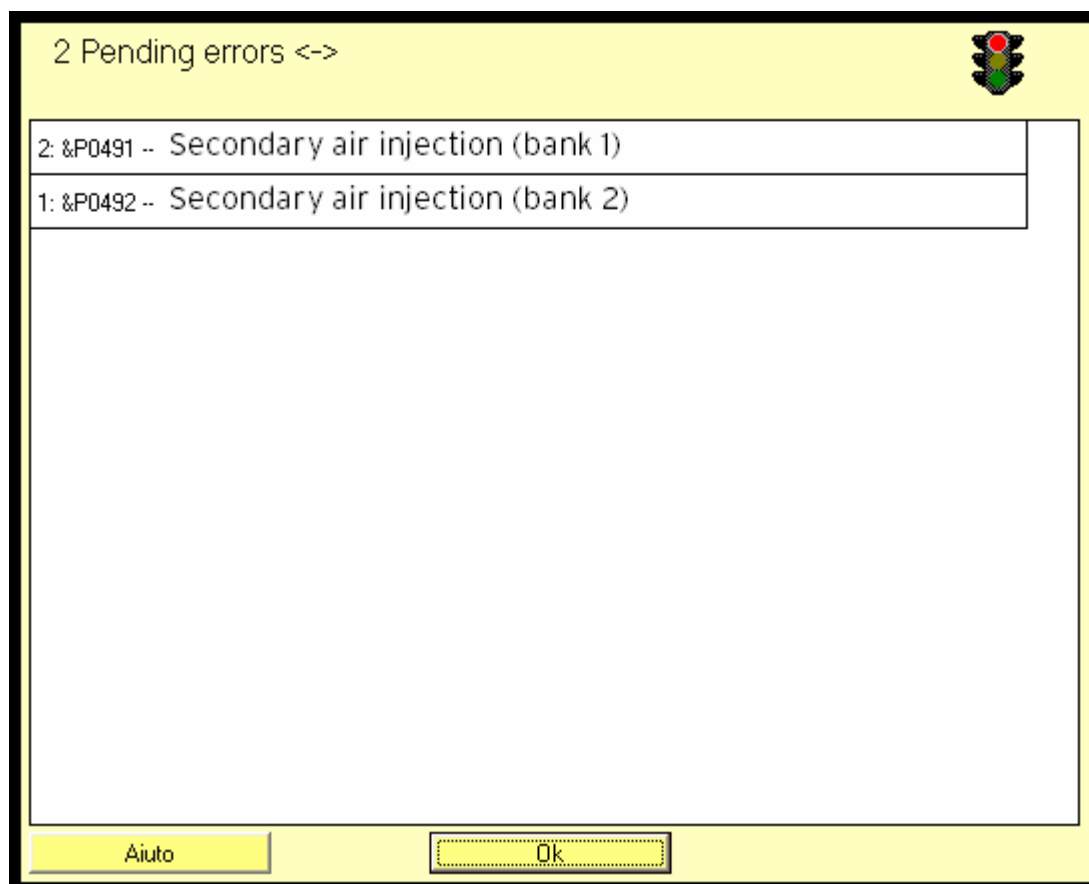
Pict. 1

1.2 If an error regarding the secondary air pump is displayed during an LDAS check, as in picture 1, please check the connection from the pipe to the pump in the airbox.

P0491: Secondary air injection
P0492: Secondary air injection

- 1.5** If the pump is not connected to the tube the system will not work correctly, (the air will not flow sufficient), and in the diagnosis software LDAS the pending errors for the secondary air pump will be displayed as in picture 1.

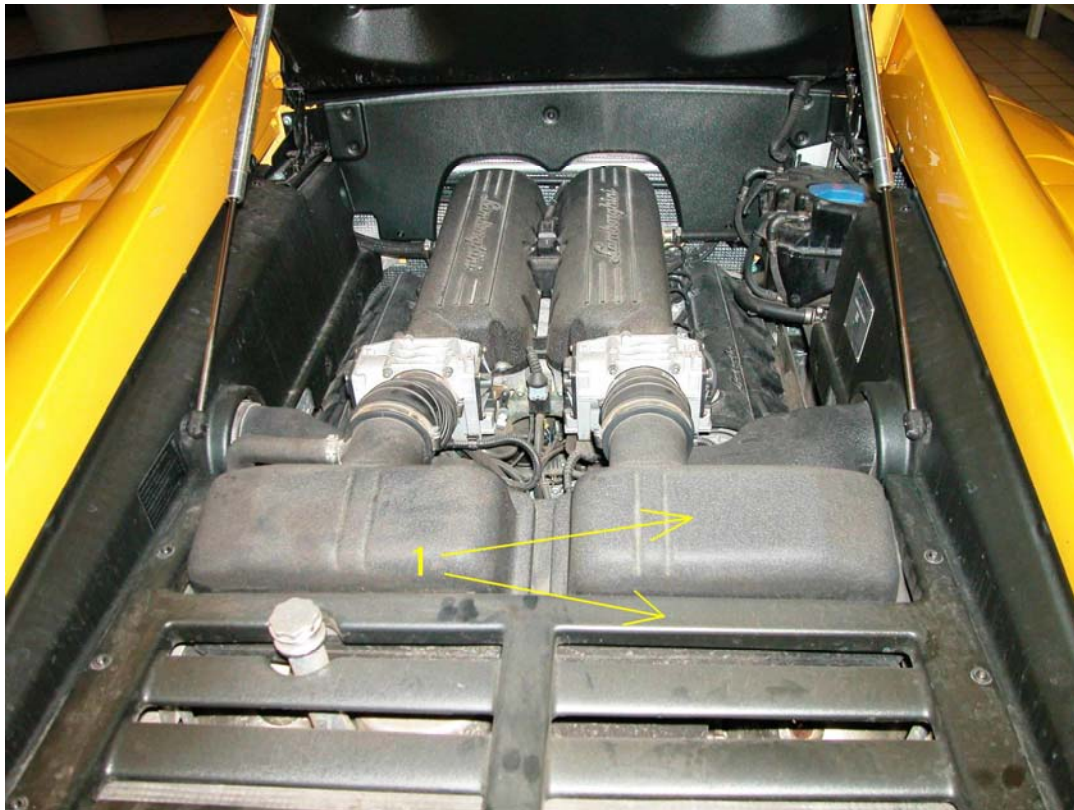
Pict. 2

1.3 To check the connection you must disassemble the engine bay panel and the right airbox cap as shown in picture 2.

To check the connection; it will be necessary to disassemble the right cap of the airbox and to look for the pipe as shown in the following pictures.

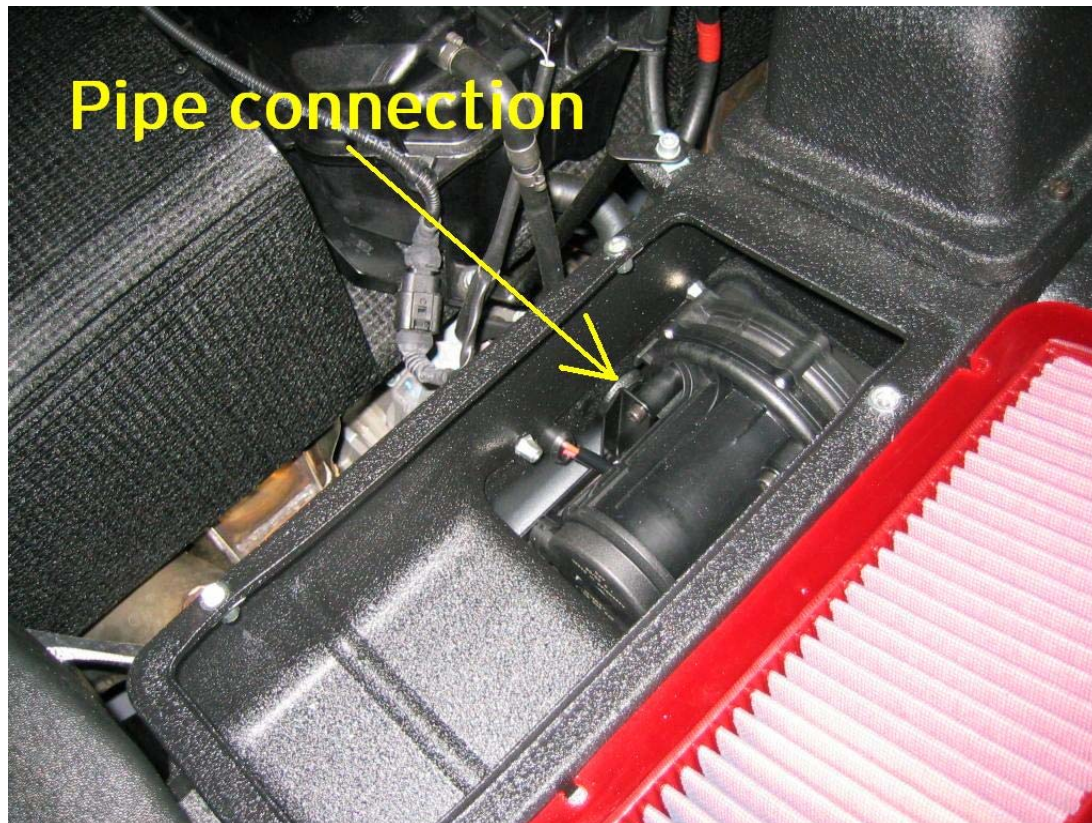
Pict. 3

- 1.4** Then it is necessary to open the airbox removing the air filter and to locate the pipe connection to the pump as shown in picture 3.

- 1.6** Connect the the pipe to the air pump.

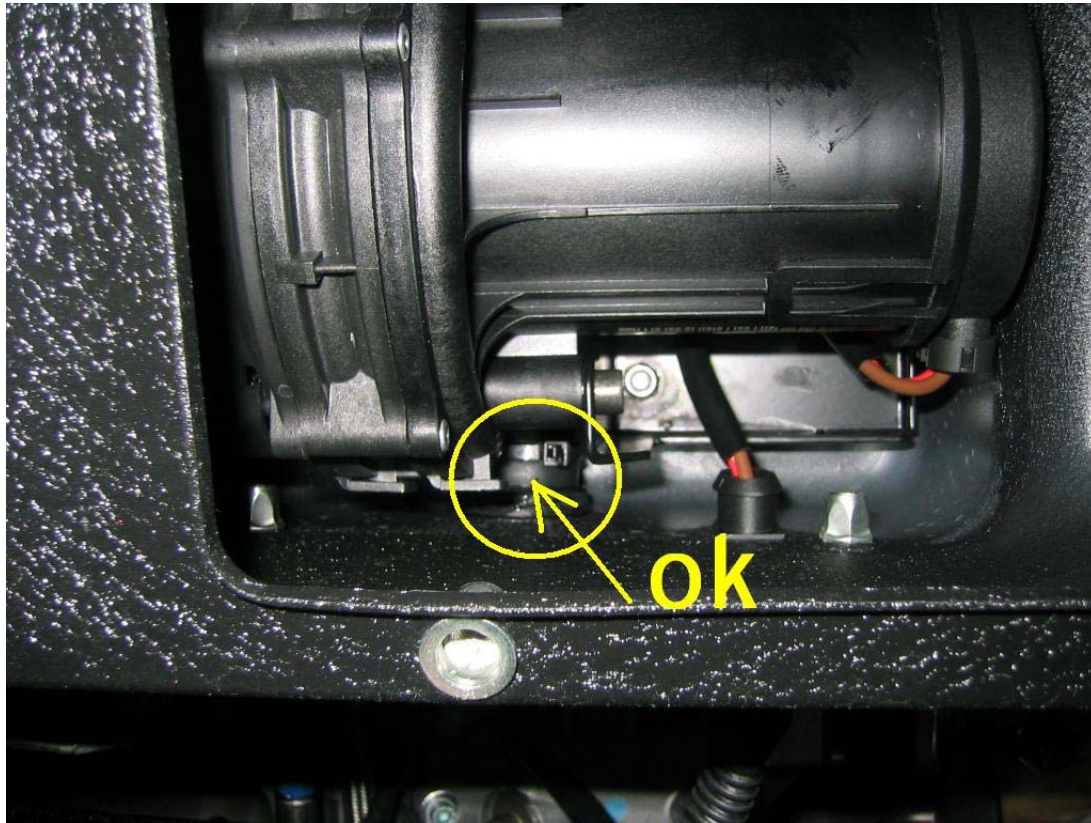
Pict. 4

1.7 The correct pipe position is shown in picture 4.

Note: on MY06 Gallardo the pipe connection with the pump is on the engine side of the airbox not on the exhaust side as on MY07.
