To All Lamborghini Dealers and Licensed Service Point  
From Customer Service Department  
Subject New third tail light Murciélago  
Group 147.08.17  
Attachments -  
Date 29.11.05  
Pages 9

New third tail light Murciélago.

All Murciélago coupè (L147) MY 02-03-04-05-06 until VIN 1900 .

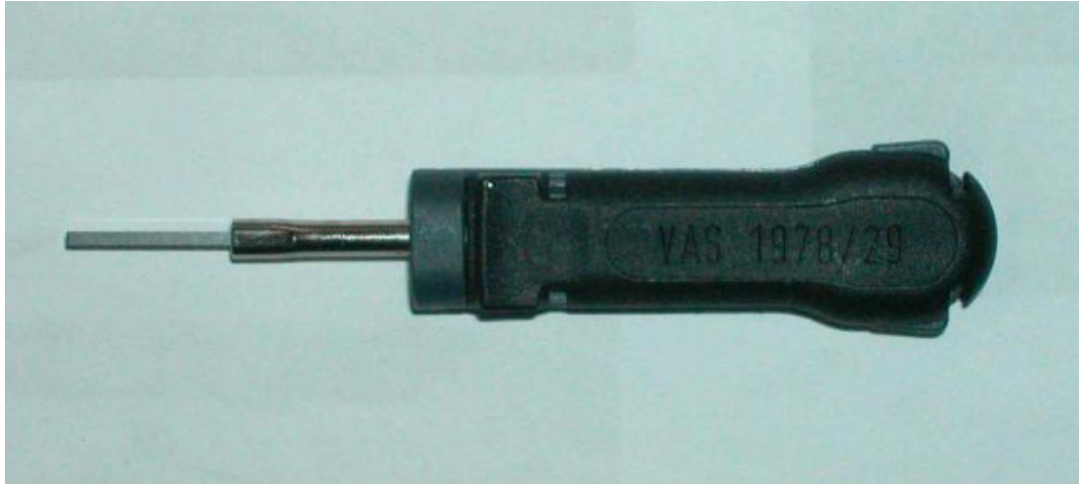
Pic. 1

- Kit p.n. 0R1470010 (third tail light + rubber protection cap) available at Lamborghini Spare Parts
- adhesive tape for automotive wirings
- Tool VAS 1978/29 (included in your Lamborghini tool kit)

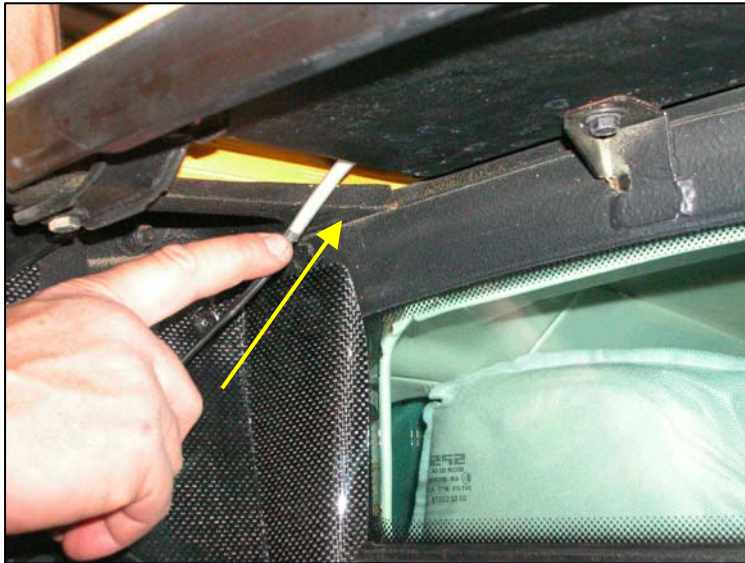
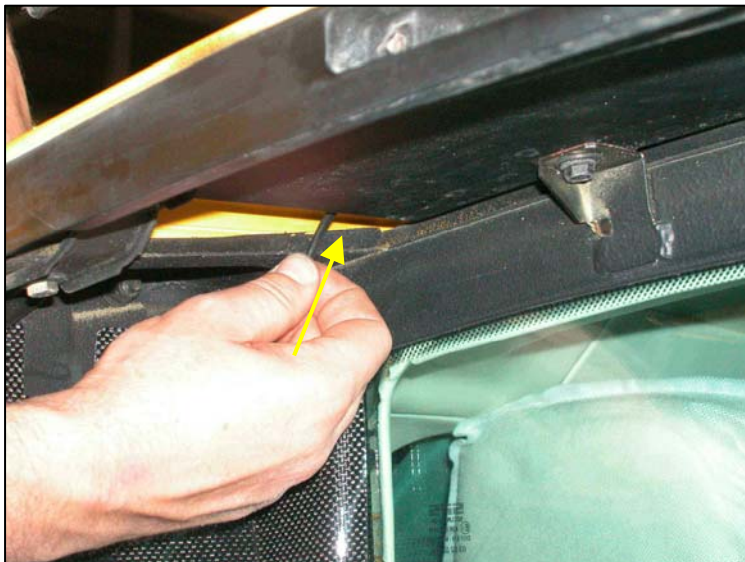
Pic. 2

- 1.1 Adopt all precautions to prevent car damages and to work safe.
- 1.2 Remove the damaged tail light
- 1.3 In order to have a sufficient wiring length extending from the pavilion spoiler, please move the wiring under the spoiler (see pictures).

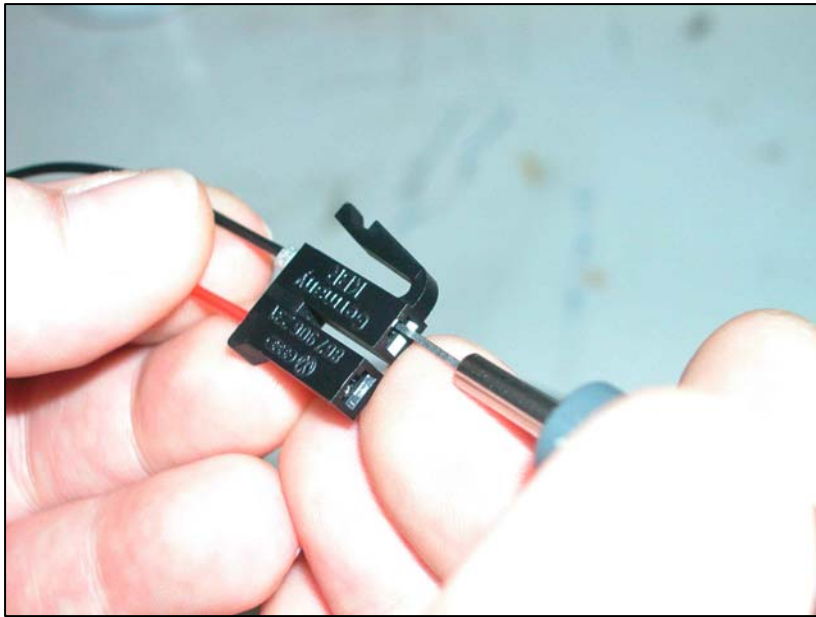
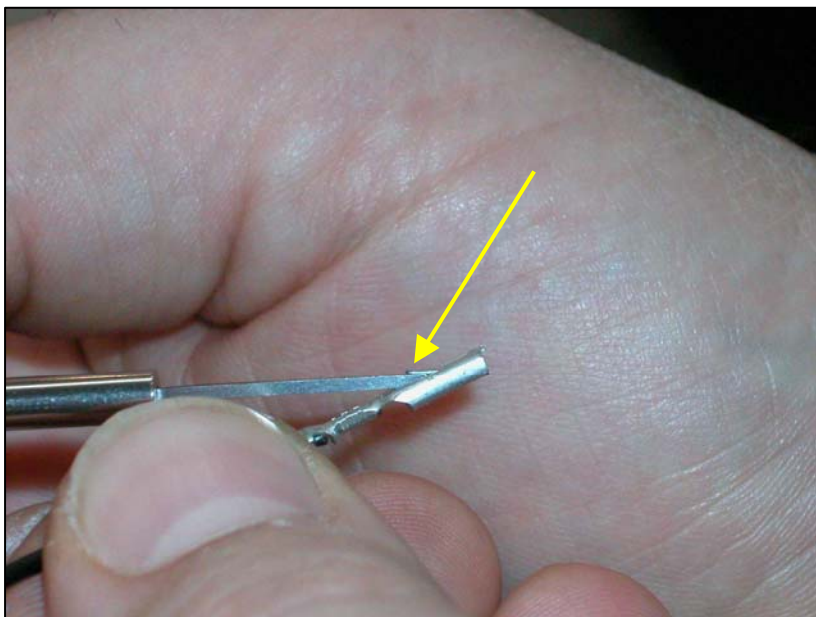
Pic. 4

**1.4** Disconnect the pins from the connector using the VAS 1978/29 tool, be careful to avoid damaging the connector. To disconnect the pins you have to lower the pins' tangs.

After disconnecting the pins relift the pins' tangs to allow the following reassembly.

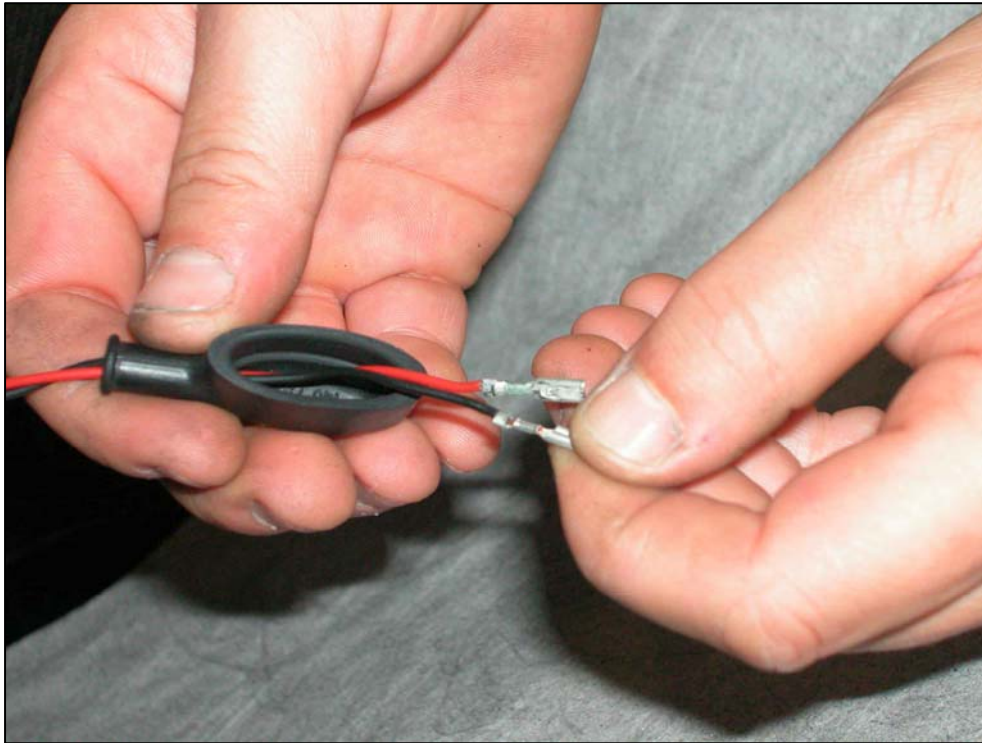
Pic. 6

**1.6** Insert the rubber protection cap on the wirings (pic.6) and reconnect the wirers with the connector (pic.7).

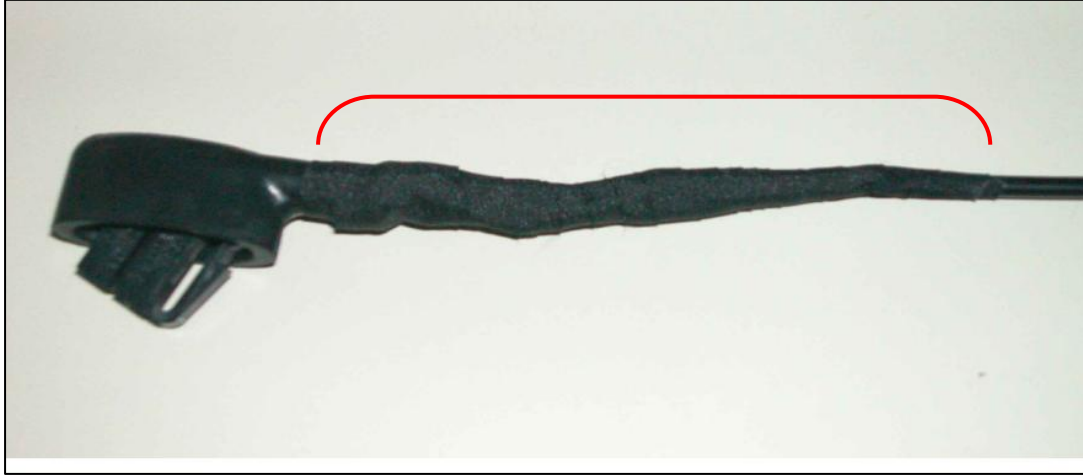
Pic. 8

**1.7** Carefully cover the wiring (from the end of the sheath) and part of the rubber cap with automotive adhesive tape to avoid water infiltrations.

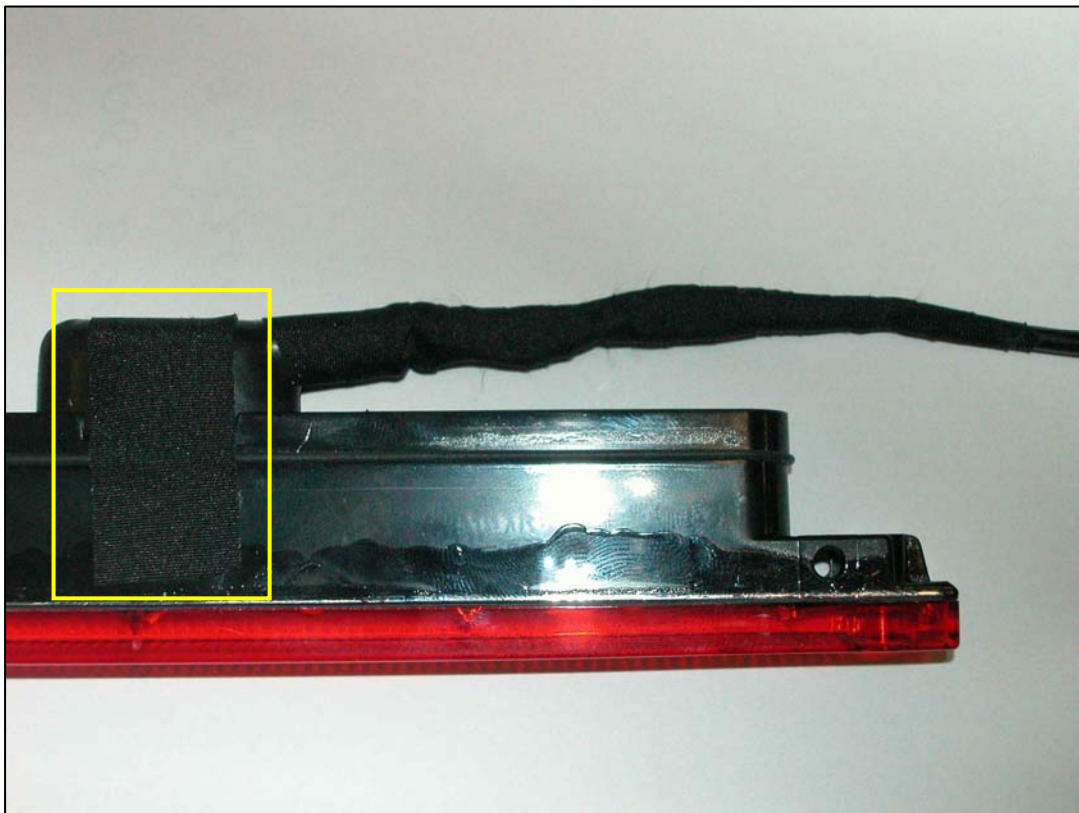
Pic. 9

**1.8** Connect the wiring to the lamp, then use adhesive tape to secure the cap to avoid disconnection (like shown in the picture below).

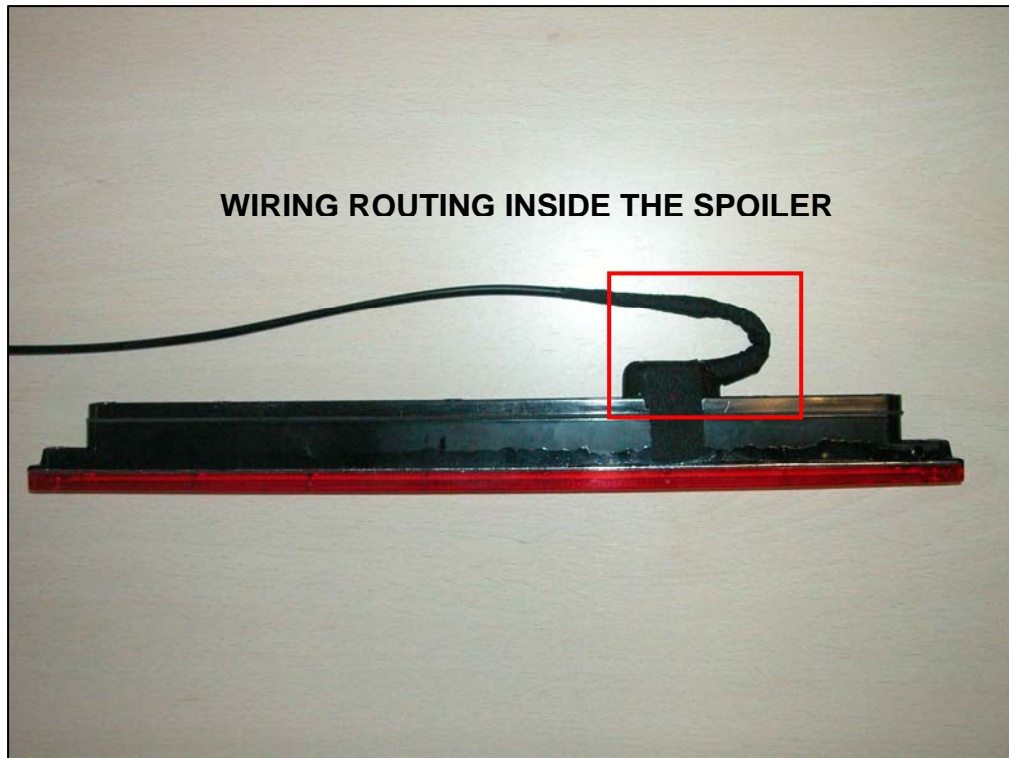
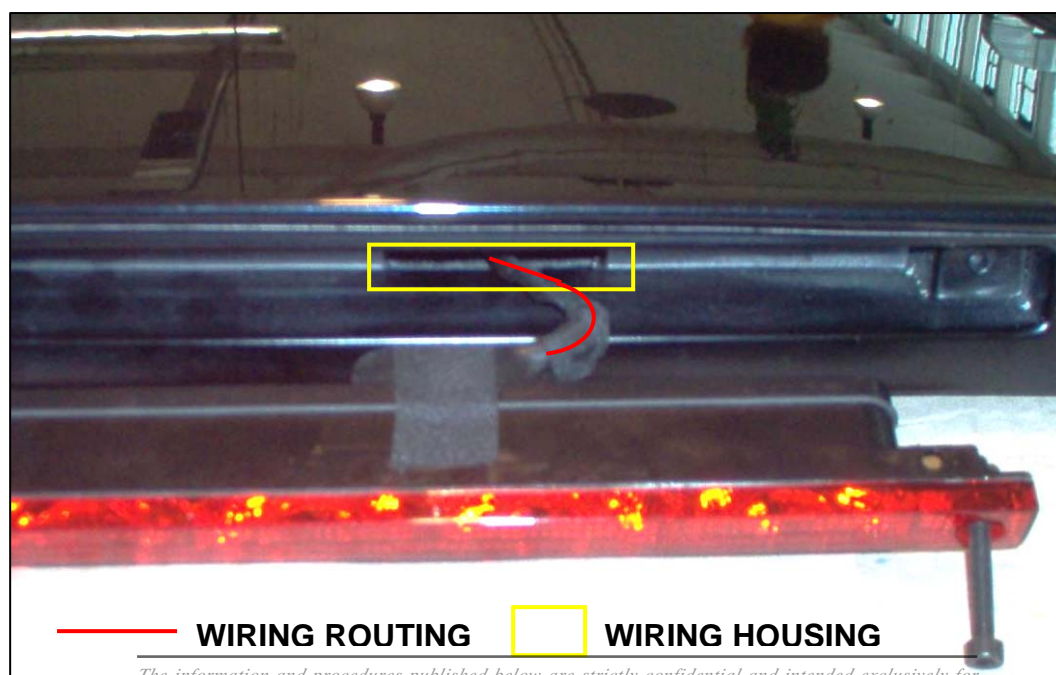
Pic. 10

**1.9** Insert the lamp back in the spoiler taking care to keep the wiring routing shown in the pictures below. Secure the lamp in the spoiler, following the instructions and assemble order (shown in pic.12).

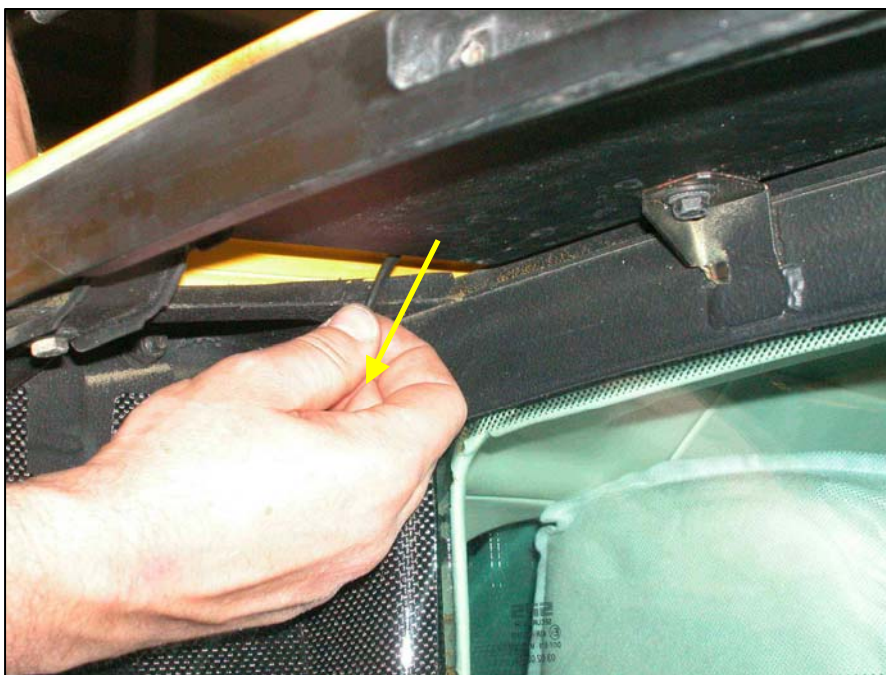
Pic. 13

Fix the lamp in the spoiler while pulling the wires (like shown in pic.13) to avoid the excess wiring inside the housing pulls out the lamp.

**1.10** Before tightening the lamp securing screws check if the wiring pulls out the lamp, in this case adjust the wiring length like shown in pic.13 .
