To All Lamborghini Dealers and Licensed Service Point
From Customer Service Department
Subject Technical communication - Protection cover for Murciélago door actuator
Group 147.8.37.00.05.DoorActuatorCover.GB
Attachments -
Date 17.11.2005
Pages 7

Protection cover for Murciélago door actuator.

Murciélago models until VIN 1649.

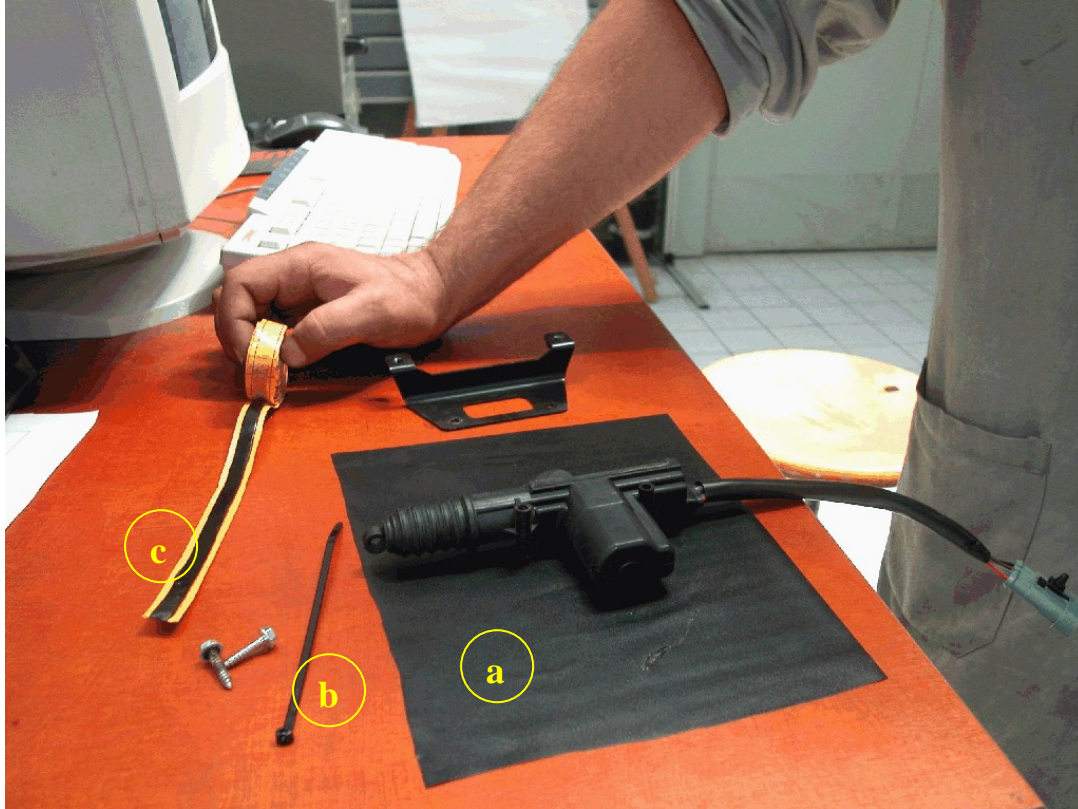
Necessary material

a - 1 Waterproof cloth - p/n 410837909

b - 1 clamp - p/n 893971850C

c - 1 piece of 3M Scotch Extruded Sealer EC-5313, 2mm thickness, 7mm breadth,
(please contact the local 3M dealer – www.3m.com for more information)

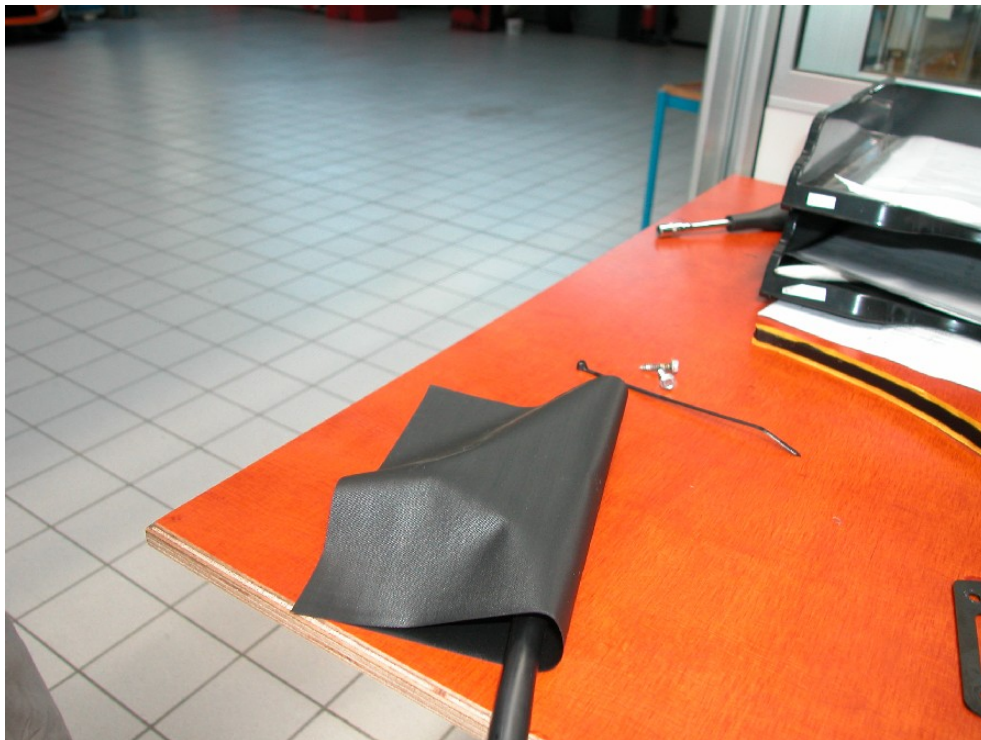
Picture 2

1.4 Fold the actuator with the cloth and fix it with the adhesive applied before (picture 2).

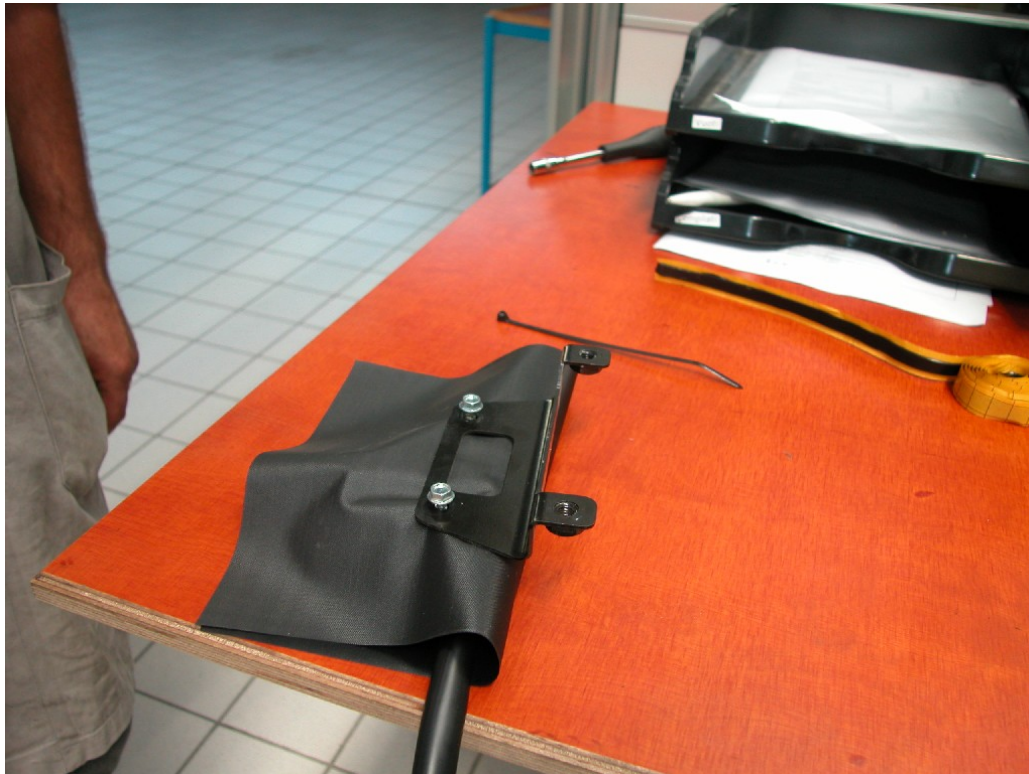
Picture 3

1.5 Assemble the bracket on the actuator, fixing the cloth (picture 3).

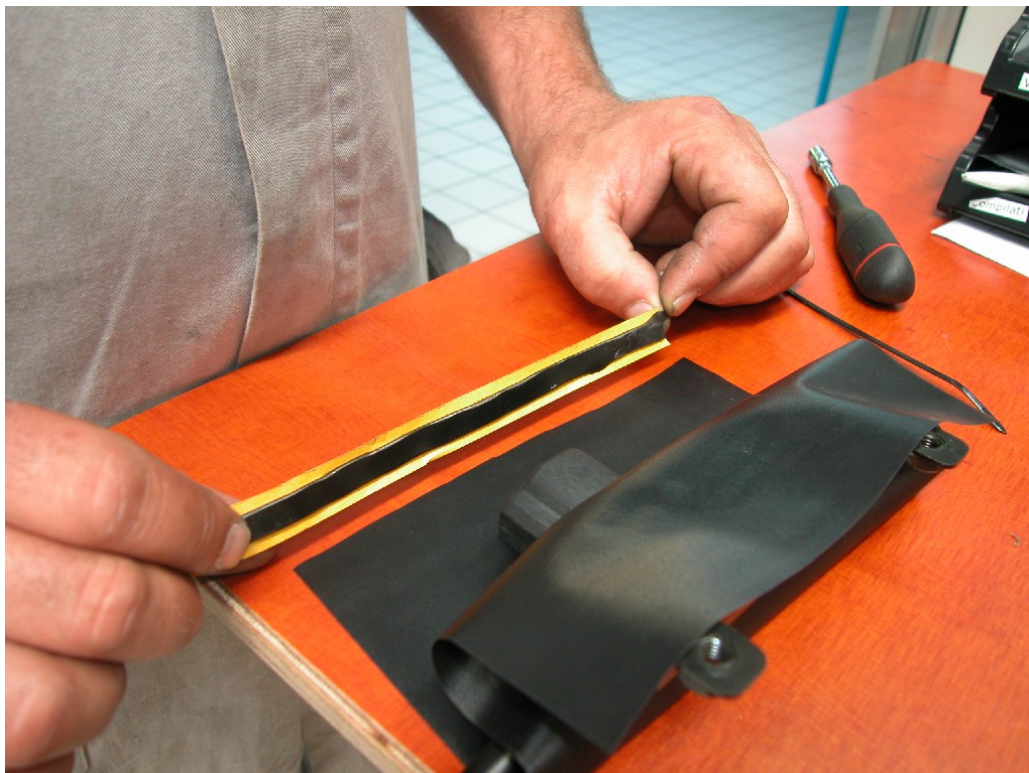
Picture 4a

1.6 Apply the adhesive film on the lower edge of the cloth (pic. 4a, 4b).

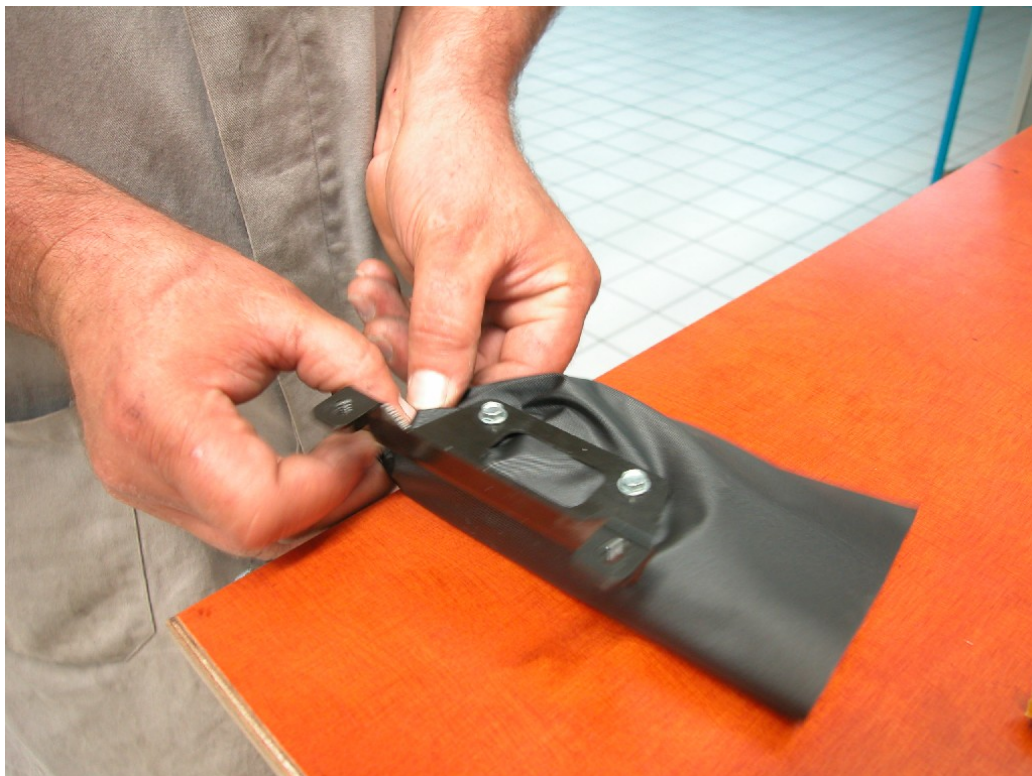
Picture 5

1.7 Close the lower edge of the cloth (pic. 5).

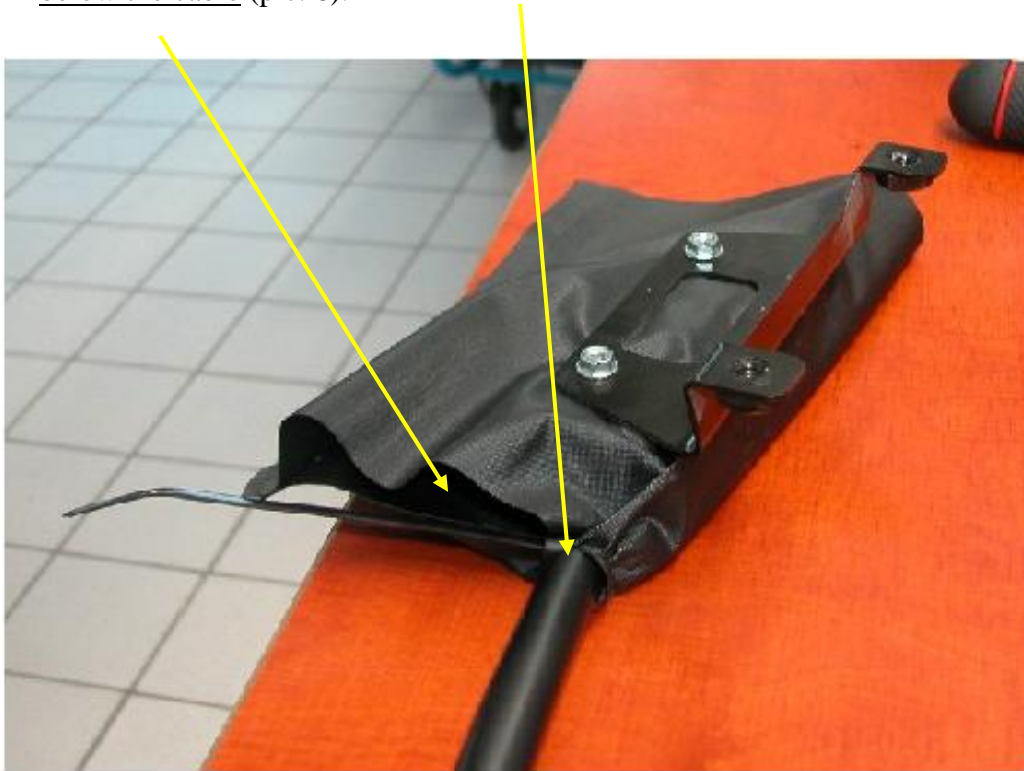
Picture 6

1.8 Close the cloth around the cable using the clamp and leaving the cloth open below the cable (pic. 6).
