To All Lamborghini Dealers and Licensed Service Point
From Customer Service Department
Subject Correct positioning of wirings in contact with engine bay
heat protection grid
Group 147.09.00
Attachments -
Date 16.01.2006
Pages 2

Correct positioning of the wiring in contact with engine bay heat protection grid.

Murciélago coupè (L147) models until VIN 1781

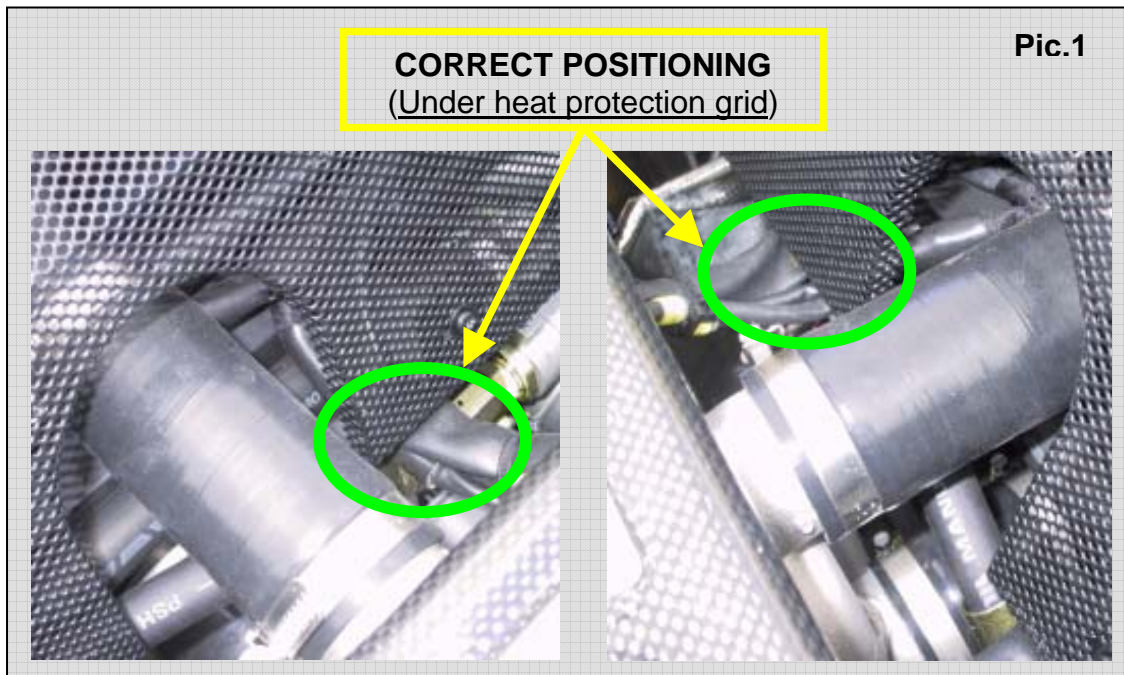
The pictures below show the possible position you may find.

- 1.3 If the wiring is not correctly positioned (Pic.2), re-position the wiring under the heat protection grid similar to shown in Pic.1.
