**FORD:**

2013 F-650, F-750

2015 F-650, F-750

This article supersedes TSB **14-0035** to update the vehicle model years and the Service Procedure.

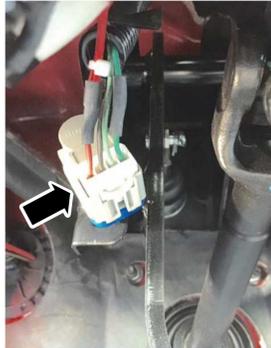
Figure 1 - Article 15-0110

1. Retrieve DTCs using the Cummins InSite software program. Is DTC 4526 present in the Cummins engine control module (ECM)?
  - a. Yes - proceed to Step 2.
  - b. No - this article does not apply. Refer to normal Cummins ECM diagnostics.
2. Inspect the orientation of the brake pedal position (BPP) switch. When installed correctly the BPP switch will be oriented approximately 45 degrees from vertical. Is the BPP switch oriented correctly? (Figure 1)

- 3. Does the BPP switch plunger move freely in/out with tension and are both black cams present and unbroken? (Figure 2)
  - a. Yes - carefully reinstall the original BPP switch, place the BPP switch body flush against the bracket at a vertical and rotate it counterclockwise to seat. Proceed to Step 4. (Figure 1)

- b. No - replace the BPP switch. Carefully install the new BPP switch by placing the BPP switch body flush against the bracket at a vertical and rotate it counterclockwise to seat. Repair is complete. (Figure 1)

- a. Yes - proceed to Step 6.
  - b. No - replace the BPP switch. Carefully install the BPP switch by placing the BPP switch body flush against the bracket at a vertical and rotate it counterclockwise to seat. Repair is complete. (Figure 1)

- a. Yes - refer to Cummins ECM diagnosis and repair publications.
  - b. No - replace the BPP switch. Carefully install the new BPP switch by placing the BPP switch body flush against the bracket at a vertical and rotate it counterclockwise to seat. Repair is complete. (Figure 1)

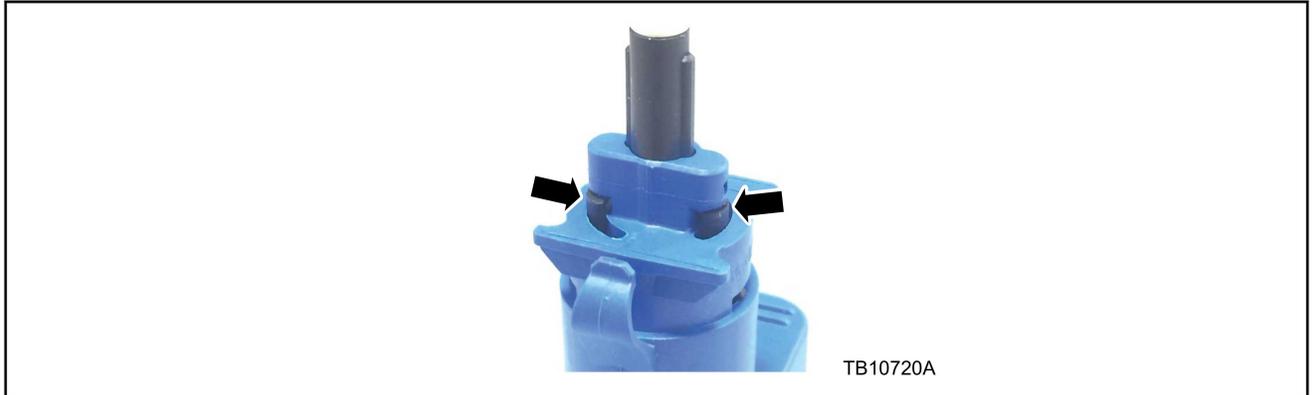
Figure 2 - Article 15-0110

- b. No - remove the BPP switch by rotating it clockwise, and proceed to Step 3.
  - (1) When removing or installing the BPP switch, use only fingertip force to rotate the switch body. Excessive force could damage the black switch cams. Make sure the brake pedal is at its rest position and is not moved during BPP switch installation. (Figure 2)
