**FRONT DRIVER OR PASSENGER SEAT CUSHION COVER CRACKED
ON OUTBOARD BOLSTER OR SIDE FACING PANEL**

TSB 15-0129

2013-2015 C-MAX

2013-2016 Escape

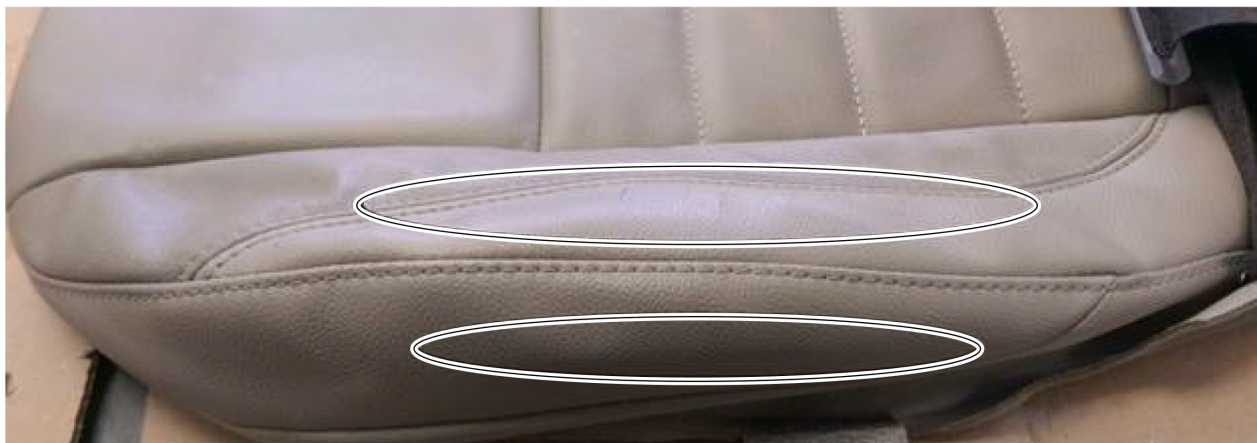
Figure 1 - Article 15-0129

Some 2013-2016 Escape and 2013-2015 C-MAX vehicles with leather seating may exhibit cracks in the front driver or passenger seat cushion cover outboard bolster or side facing panel.

Inspect the seat cushion cover for cracks in the specific areas circled. If cracks are present, replace the seat cushion cover. Refer to Workshop Manual (WSM), Section 501-10. (Figure 1)

Follow the Service Procedure steps to correct the condition.
