SERVICE BULLETIN

APPLICABILITY: 2015-16MY XV Crosstrek Models with Accessory Rear Splash Guard Kit J101CFJ270

NUMBER: 15-191-15

SUBJECT: Corrosion of Attachment Hardware

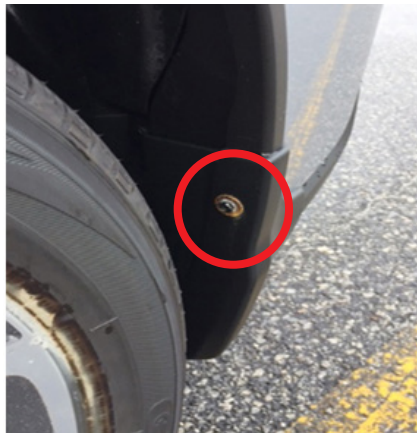
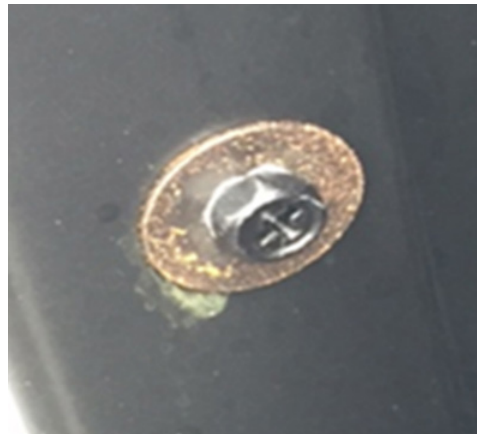
This bulletin announces availability of a replacement attachment hardware kit for the rear splash guards to address customer concerns of poor appearance due to corrosion and / or rusting. Examples of the condition are shown in the photos below.

The part number for the replacement hardware kit (2 screws and 2 washers) is: **SOA008W001**. The new screw and washer will have a glossy black finish as opposed to the original parts which have a more flat or “matte” appearing finish. In the rare case where a replacement “J-Nut” is required, hardware kit, P.N. J101CFJ258 must be ordered.

- Remove the affected screw and washer “set” (one per splash guard).
- Remove any residual rust staining from the splash guard with a mild solvent or all-purpose cleaner on a clean shop cloth.
- Install the new kit parts. Assure the splash guard remains in place and tight to the vehicle by holding it upward with a slight inward pressure to avoid any gapping. The splash guard installation photos below show a proper fit and for comparison, an improper fit with excessive gapping.
