Technical Bulletin

Model(s)	Year	Eng. Code	Trans. Code	VIN Range From	VIN Range To
Jetta A5 New Beetle, New Beetle Convertible	2005 – 2007 2006	2.5 L BGP, BGQ, BPR, BPS	All	All	All

17 07 04 Mar. 2, 2007 2010384 supersedes Technical Bulletin Group 17 number 05-06 dated Oct. 18, 2005 due to inclusion in ElsaWeb and additional models.

Cap, Oil Filler, Comes Apart When Removing Engine Cover

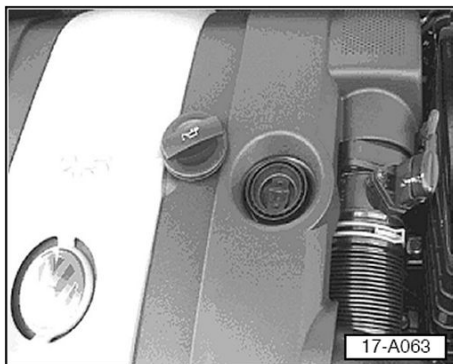
Oil filler cap separates when engine cover is improperly removed.

If oil filler cap has separated:

Oil filler cap can be repaired. Do not replace oil filler cap!

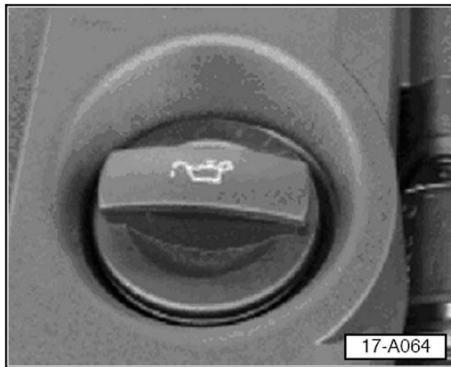
Make sure that the symbol on oil filler cap is facing in the correct direction.

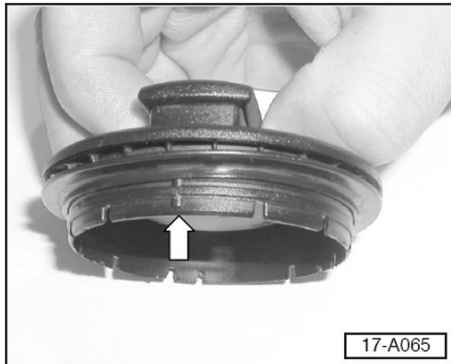
- Locate the upper cap portion index mark.

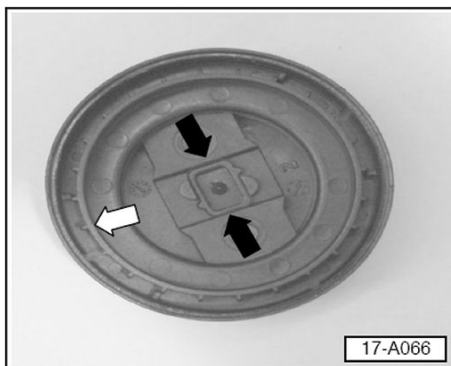
- Position the lower cap so that the molded parallel lines (black arrows) align with the handle of the top portion, and the top piece index mark rests between the parallel lines.

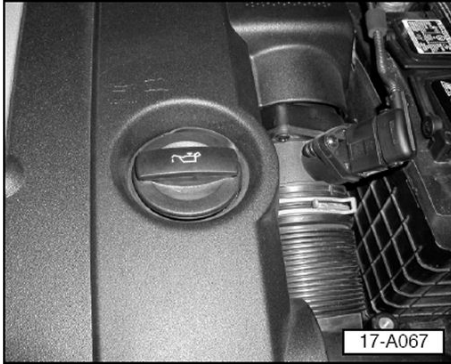
- Align the upper portion of the cap over the lower portion and press firmly together.

The oil filler cap will not be damaged during this action and will operate as designed.
