NUMBER
043 [Rev 2] 02/25/2013

TECHNICAL SERVICE BULLETIN

SUBJECT: 6-SPEED AUTOMATIC TRANSAXLE OIL TEMPERATURE
SENSOR DTC P0711, P0712 & P0713

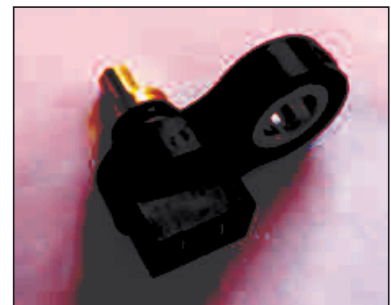
Transaxle oil temperature sensor

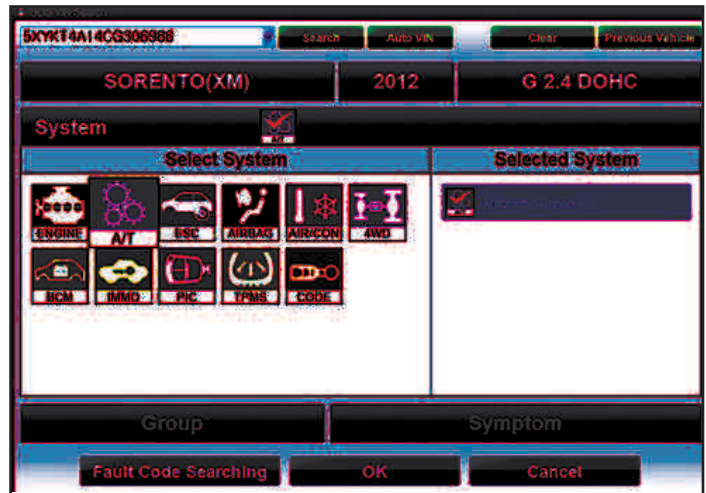
1. Connect the GDS to the vehicle. Turn the ignition on with engine OFF. Navigate to the A/T menu and check for DTCs. **Record any DTC and freeze frame data if available on back of RO.** Delete the DTC.

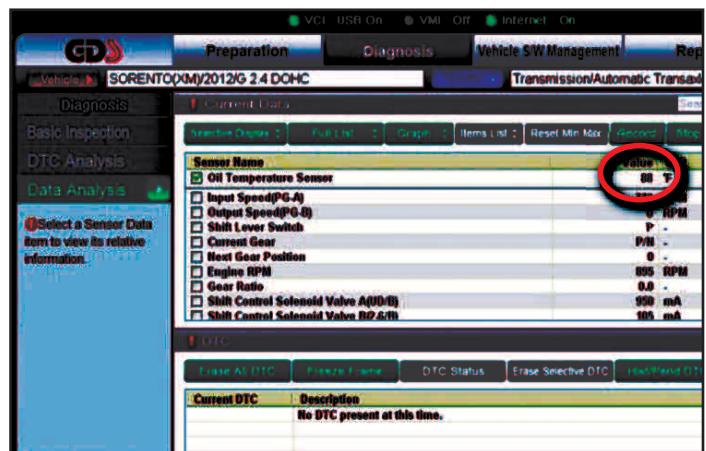
2. From the GDS, select:
 - Data Analysis
 - Oil Temperature Sensor

Drive the vehicle and monitor the oil temperature sensor. Record observations on the RO.

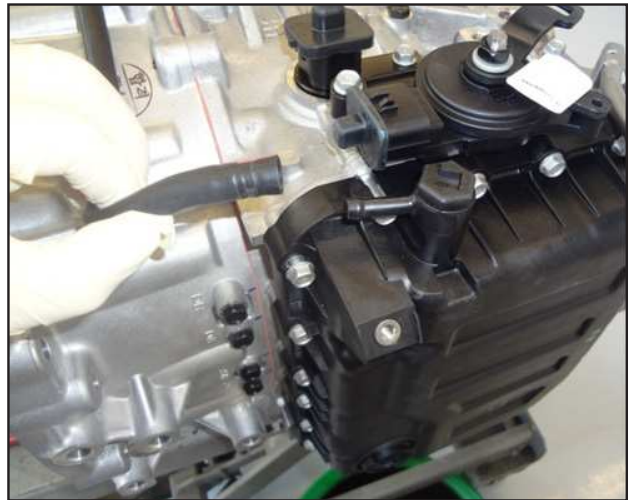
7. Disconnect the breather tube from the valve body cover. Remove the hose clamp and disconnect the breather tube from the nipple.

For plastic cover: Use caution not to damage the nipple during hose removal. A damaged nipple will require valve body cover replacement.

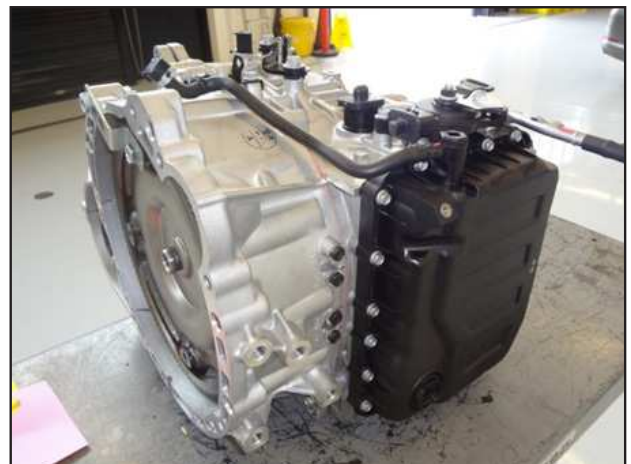
8. Remove the valve body cover. Detailed removal/installation steps vary depending on model. The valve body cover can be removed from all models listed in this TSB without removing the transaxle from the vehicle.

**Tightening torque:
7.2 ~ 8.7 ft-lbs (9.8 ~ 11.8 Nm)**

For plastic cover, do not lose the rubber gasket: Reuse rubber gaskets on plastic valve body covers.

Metal cover uses liquid sealant: UM010 CH046 or equivalent: Clean mating surfaces on cover/transaxle. Apply liquid gasket at application points at the valve body cover with a 2.5 mm (0.0984 in.) bead.

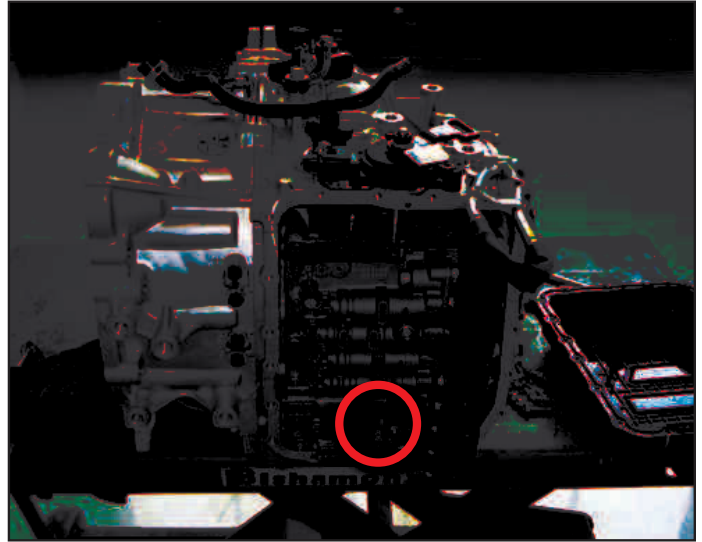
9. Locate the transaxle temperature sensor.

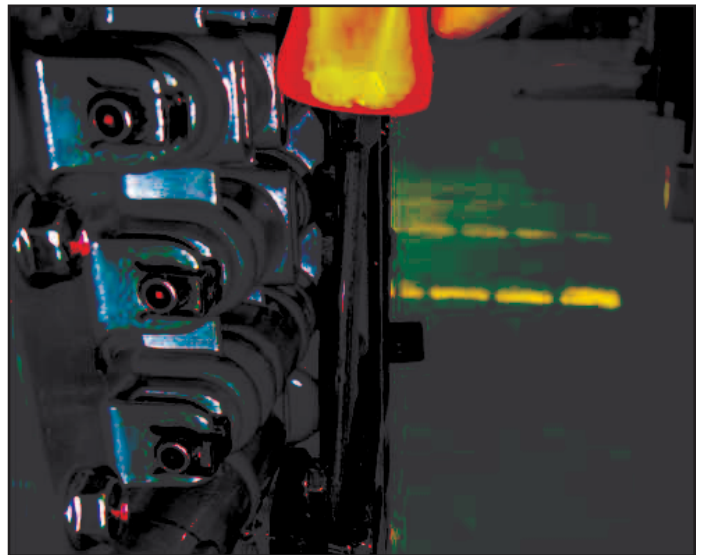
10. Use a flat-head screwdriver to disconnect the wire harness from the transaxle temperature sensor.

Use caution not to damage the wire harness. Damage to the wire harness will require replacement and transaxle removal to replace the ribbon cable.

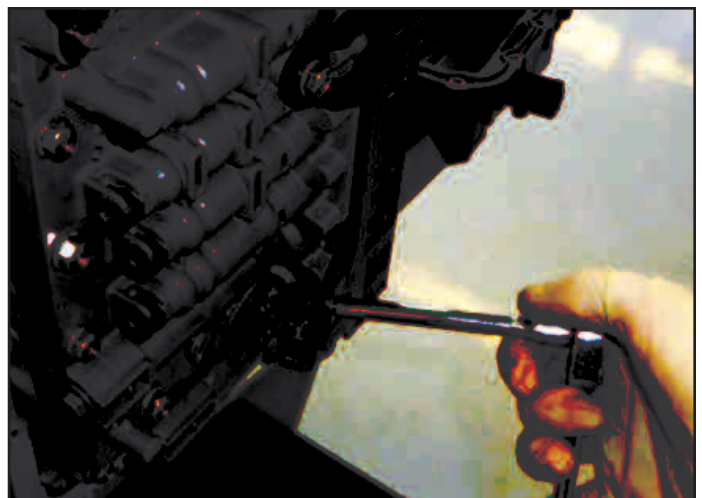
11. Remove the transaxle temperature sensor after removing the bolt. Replace with a new sensor and re-connect the harness to the sensor.

7.2 ~ 8.7 ft-lbs (9.8 ~ 11.8 Nm)
