GROUP Body	MODEL 2013MY Rio (UB)
NUMBER 087	DATE November 2012

TECHNICAL SERVICE BULLETIN

SERVICE ACTION: LUGGAGE TRAY ASSEMBLY KIT INSTALLATION (SA130)

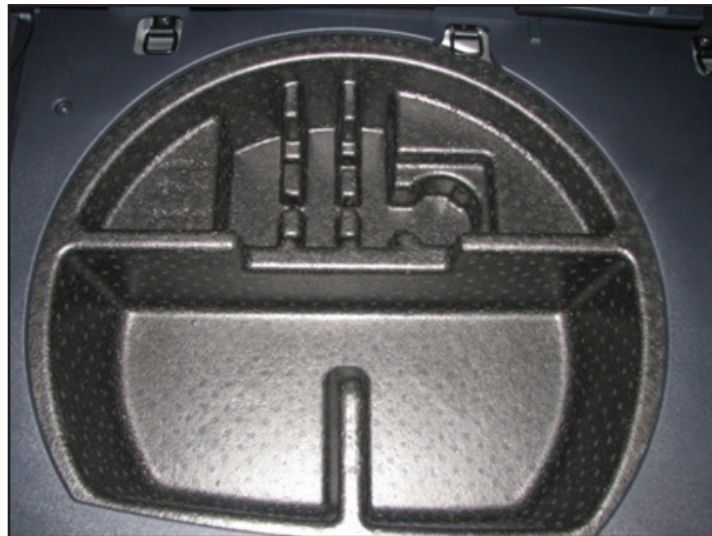
This bulletin provides information relating to the missing luggage tray assembly in some 2013MY Rio vehicles produced from June 11, 2012 to September 6, 2012. To correct this issue, installation of the Luggage Tray Assembly Kit will be required for all affected units. Kia is requesting the completion of this Service Action on all affected Rio vehicles in dealer stock prior to delivery. Before conducting the procedure, verify that the vehicle is included in the list of affected VINs.

New Luggage Tray Assembly
