NUMBER: 23-016-15

Front Passenger Fold Flat Seat Back Inoperative

This bulletin involves adjusting the passenger fold flat seat back cable.

Jeep Cherokee

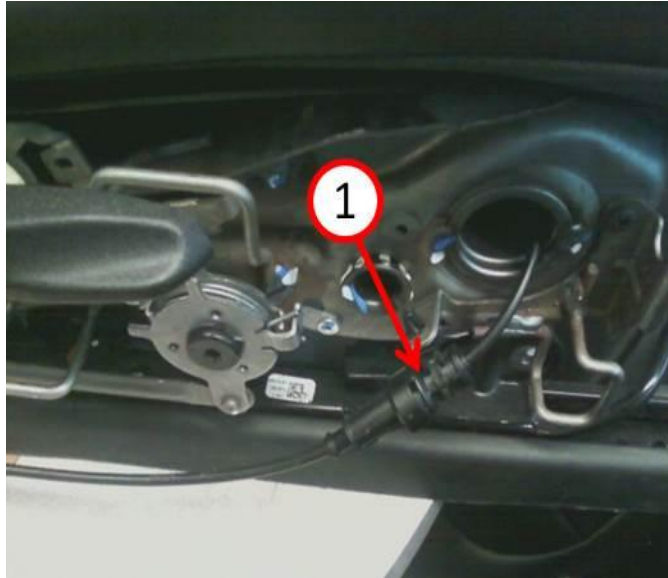
Fig. 1 Locate the Cable

1. Remove the passenger seat from the vehicle. Refer to 23 - Body/Seats, Front/SEAT/Removal.
2. Remove the inboard and outboard side shields from the seat. Refer to 23 - Body/Seats, Front/SIDE SHIELDS, Seat Cushion, Front/Removal.
3. Locate the cable adjuster (1) on the outboard side of the seat ([Fig. 1](#)).

1 - Seat Back Adjuster Cable

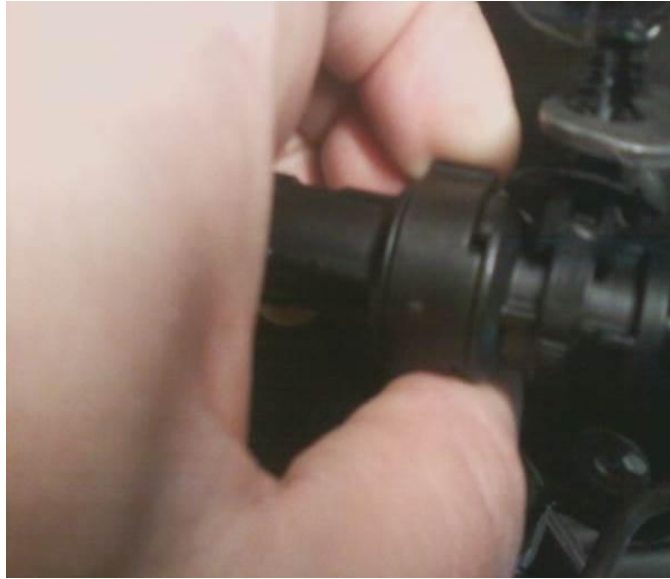
Fig. 2 U-Shaped Lock On Cable

4. Use your fingers to spread the two tabs (Fig. 2) on the U shaped lock and slide it out about 5mm. The adjuster should now be able to move.

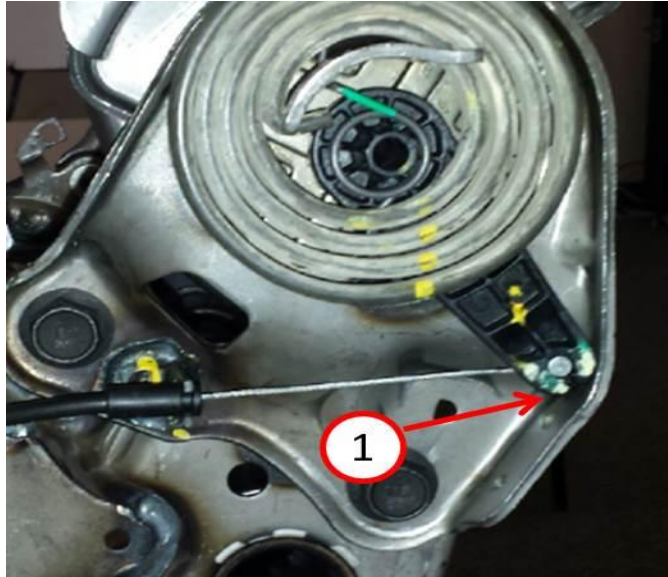
Fig. 3 Cable Into Lever

5. If the end of the cable has come out of the lever place the end of the cable back into the lever (1) on the recliner ([Fig. 3](#)).
6. Push the top of the seat back rearward to ensure that the recliners are fully locked

1 - Lever

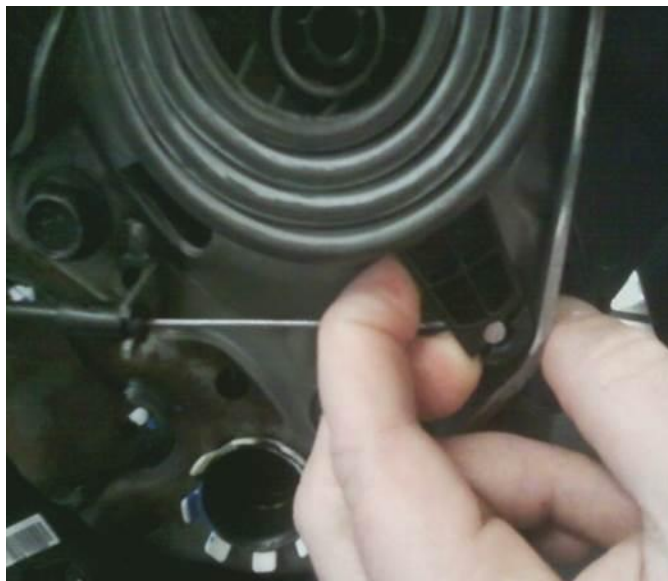
Fig. 4 Hold Cable into Place

7. Use two fingers to hold the inboard side recliner lever closed. Ensure that this does not move as you are moving the adjuster ([Fig. 4](#)).

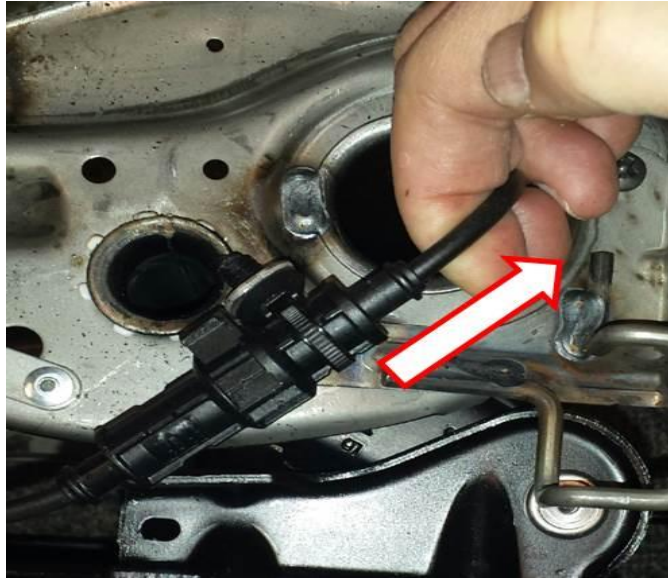
Fig. 5 Remove Slack From Adjuster

8. While holding the recliner closed with one hand use the other hand to pull the movable end of the conduit out of the adjuster as far as possible to remove all slack ([Fig. 5](#)).

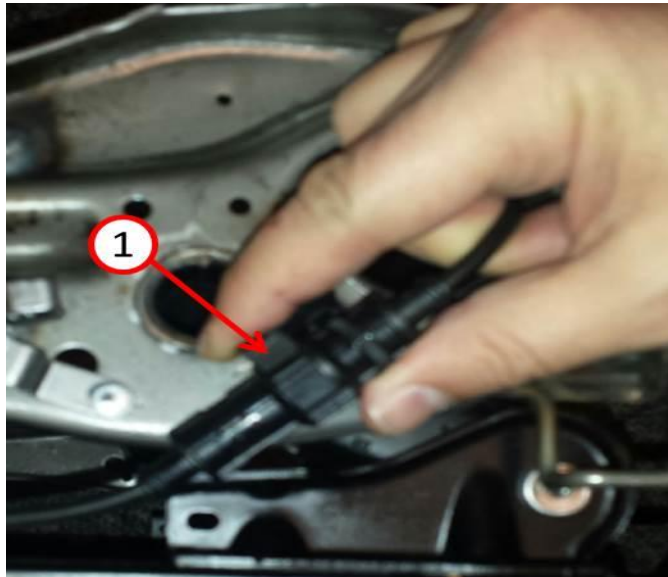
Fig. 6 Lock Adjuster

9. While pulling the conduit use the same hand to lock the adjuster (1) in place ([Fig. 6](#))

1 - Adjuster Lock

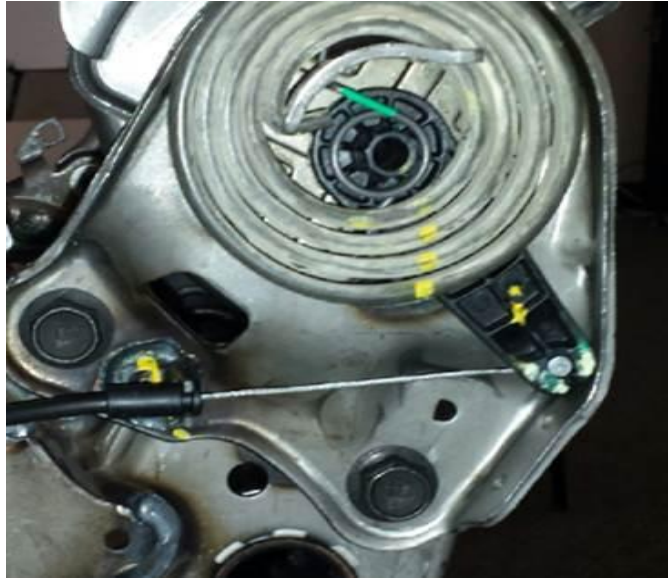
Fig. 7 No Slack In Cable

10. Verify that there is no slack in the cable (Fig. 7).

11. Adjust the passenger seat back to the downward and full upward positions. Was the seat back able to move?
 - a. NO>>> Repeat [Step #4](#).
 - b. YES>>> Repair is completed.
 - c. Reinstall inboard and outboard side shields to the seat. Refer to 23 - Body/Seats, Front/SIDE SHIELDS, Seat Cushion, Front/Installation.
 - d. Reinstall passenger seat to the vehicle, with the use of a scan tool, configure the occupant classification module. Refer to 23 - Body/Seats, Front/SEAT/Installation.
