NUMBER: 23-021-15

Squeak Noise Coming From The Rear Seat

This bulletin involves applying tape to the rear seat track J-rail.

2014 - 2015 (KL) Jeep Cherokee

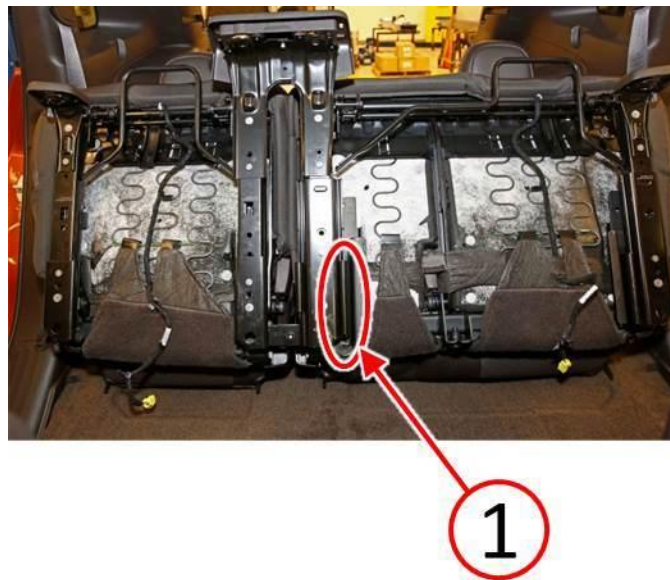
Fig. 1 Rear Seat Unbolted And Repositioned In Vehicle

1 - Area Of Concern On 60 Percent Side

5. Disconnect and isolate the negative battery cable. If equipped with an Intelligent Battery Sensor (IBS), disconnect the IBS connector first before disconnecting the negative battery cable.
6. Disconnect the rear seat electrical connectors and remove the fasteners attaching the rear seat to the vehicle. **DO NOT REMOVE THE SEAT FROM THE VEHICLE.** Refer to the detailed service procedures available in DealerCONNECT> TechCONNECT under: Service Info> 23 - Body> Seats, Rear> SEAT, Rear> Removal.
7. With the seat back folded down and seat track in the full rearward position, lift the seat off the rear studs and flip 90 degrees so that the bottom of the seat is exposed ([Fig. 1](#)).

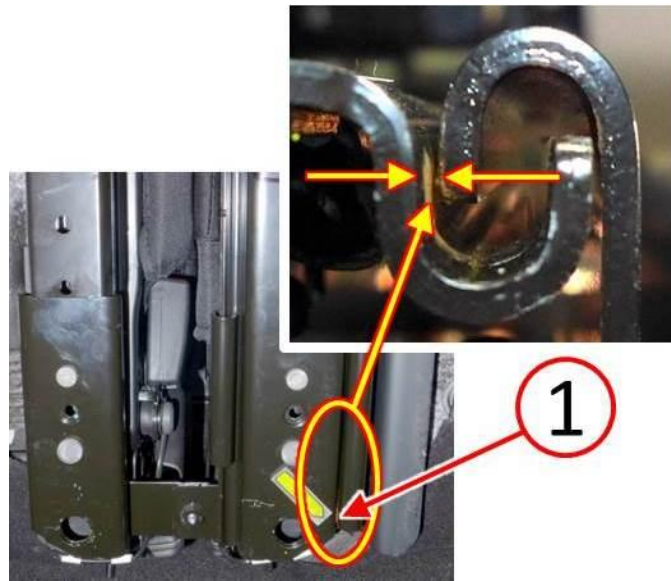
-
8. Examine the rearward portion of the 60 percent side inner seat track for a “V” shaped gap with a touch condition at the rear lower edge of the seat track ([Fig. 2](#)).

Fig. 2 Inspect Gap At The 60 Percent Inboard Side

1 - Touch Condition At Rear Lower Edge

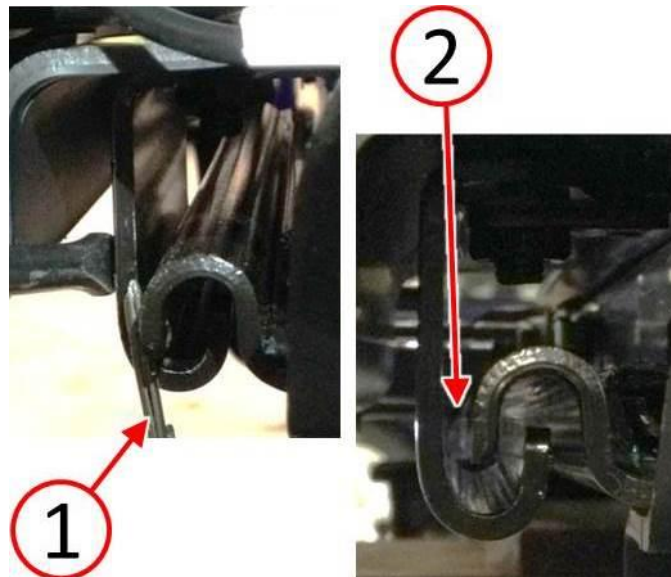
Fig. 3 Adjust 60 Percent J-Rail For Clearance

1 - Suitable Tool
2 - J-Rail Clearance

9. If the seat track J-rail rear lower edge is touching, use a suitable tool (1) to reposition the seat track so that a 1.5 mm (0.06 in.) gap (2) is present between the J-rails (Fig. 3).

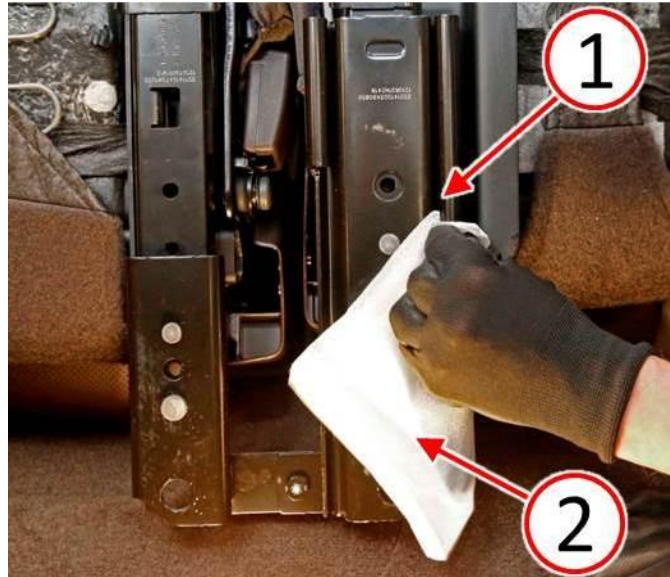
Fig. 4 Clean J-Rail

- 1 - Seat Track J-Rail
- 2 - Clean With Isopropyl Alcohol

10. Move the seat track position so that the rear portion of the J-rail is visible.
11. Clean the J-rail (1) with isopropyl alcohol or equivalent (2), to remove any oil or grease residue from the area of the seat track to which the tape will be applied (Fig. 4).

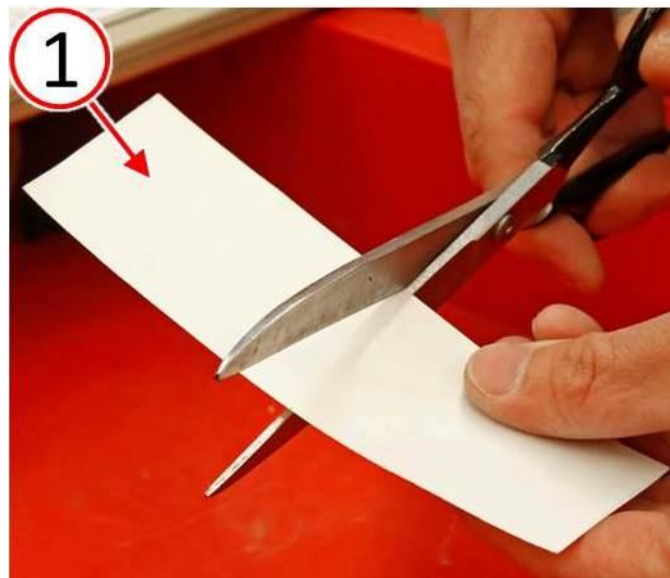
Fig. 5 Cut Tape In Half

- 1 - Tape
-

-
12. Cut the tape (1) in half (Fig. 5).

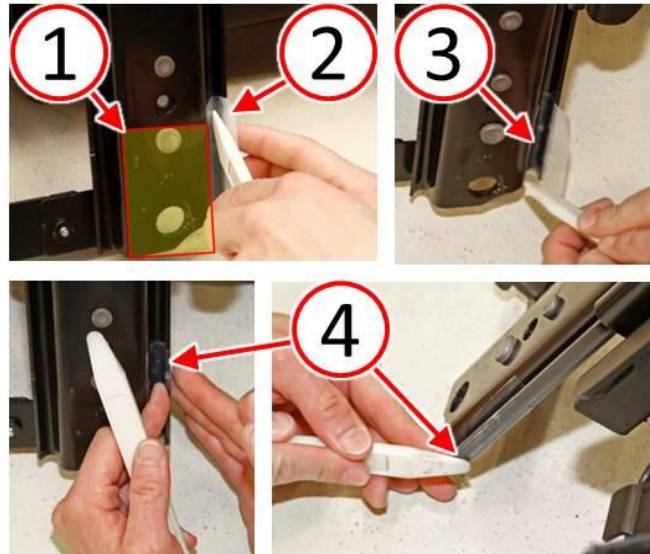
Fig. 6 Apply Tape To Inner J-Rail Rear Edge

- 1 - No Tape Zone On Underside Of Seat Track
- 2 - Apply Tape To Rear Edge Of Inner J-Rail
- 3 - Ensure Tape Is Fully Adhered In J-Rail Channel
- 4 - Wrap Tape over J-Rail And Adhere To J-Rail Side

13. Apply the tape (2) to the lower inner J-rail, taking care not to apply the tape to the underside of the seat track area (1) where it will contact the body mount (Fig. 6).
14. Using fingers and a trim stick or equivalent, firmly press on the tape to ensure complete contact of tape to J-rail surface (3) without air gaps (Fig. 6).
15. Wrap the tape (4) over the J-rail and ensure the tape is fully adhered to the outer surface of the J-rail without air gaps (Fig. 6).

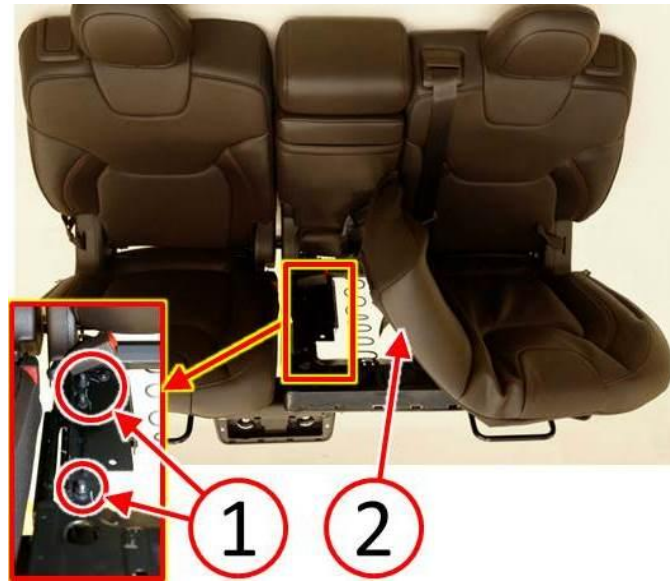
Fig. 7 Access Seat Track Fasteners Under Seat Cushion

1 - Seat Track Fasteners

2 - 60 Percent Side Lower Seat Cushion

-
16. Cycle the seat track a few times to ensure that the J-rail does not peel the tape away.
 17. Did the tape peel away?
 - a. YES>>> Further adjustment of the seat track is necessary. Continue with [Step #18](#).
 - b. NO>>> Seat may be reinstalled. Proceed to [Step #25](#).
 18. If further adjustment of the seat track is necessary, remove the rear seat from the vehicle.
 19. Remove the 60 percent side lower seat cushion (2) enough to expose the inboard side seat track fasteners (1) (Fig. 7). Refer to the detailed service procedures available in DealerCONNECT> TechCONNECT under: Service Info> 23 - Body> Seats, Rear> COVER, Seat Cushion> Removal.

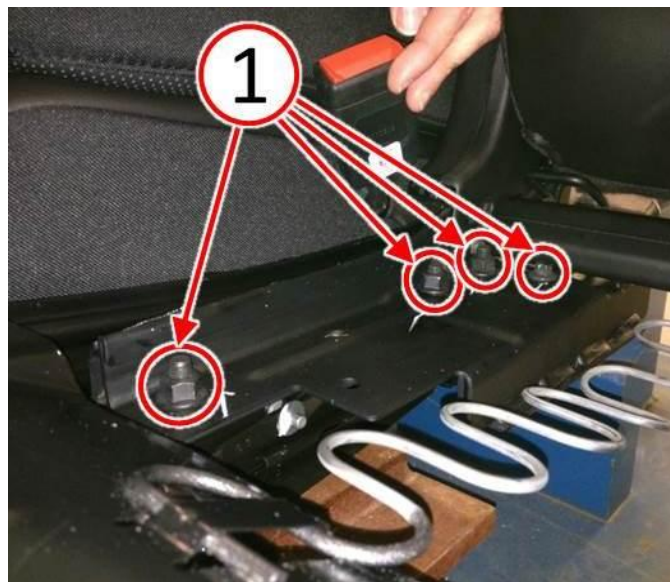
Fig. 8 Remove Seat Cushion To Access Seat Rail Fasteners

1 - Seat Track Fasteners

20. Loosen the 60 percent side inboard seat track fasteners (1) (Fig. 8).

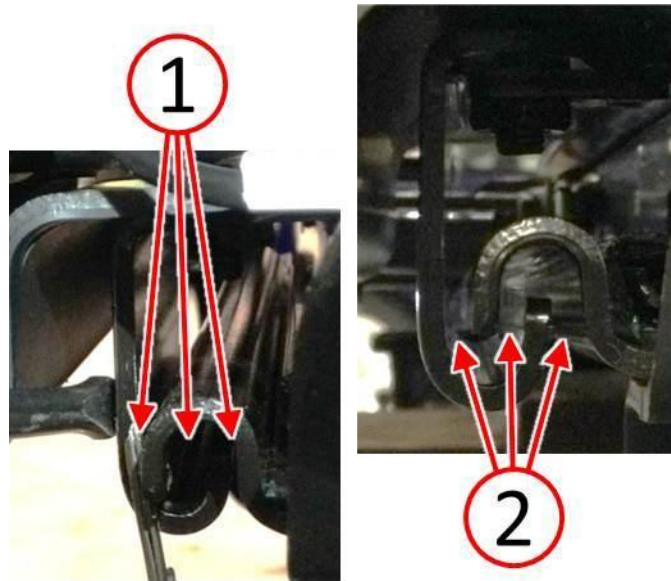
Fig. 9 Position 60 Percent Rail To Achieve Even Spacing

- 1 - J-Rail Gap Uneven
- 2 - J-Rail Gap Even

21. Adjust the seat track alignment (1) to ensure a minimum of 1.5 mm (0.06 in.) gap between the J-rails (2) at the rear of the seat track (Fig. 9).

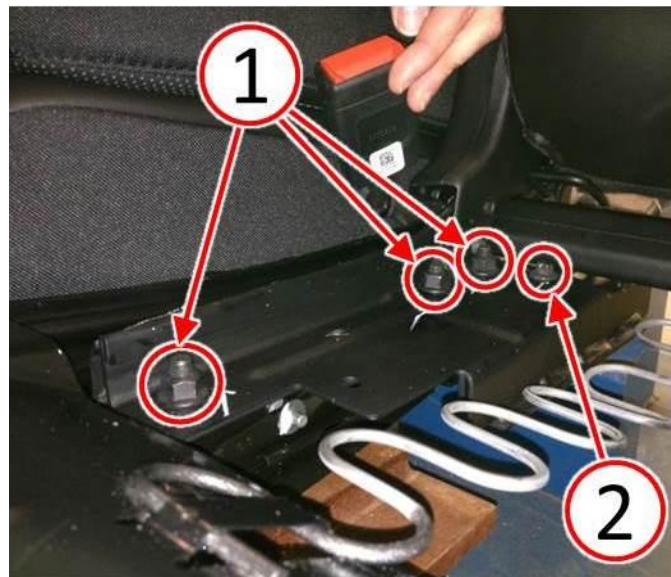
Fig. 10 Tighten Seat Rail Fasteners

- 1 - M10 Nuts
 - 2 - M8 Bolt
-

22. Tighten the three M10 nuts (1) to 50 N-m (37 ft. lbs.) and the one M8 bolt (2) to 25 N-m (18 ft. lbs.) (Fig. 10).
