NUMBER: 23-025-15

Rear Door Glass Stain

This bulletin involves removing stains from the rear door glass.

Jeep Renegade (Brazil Only)

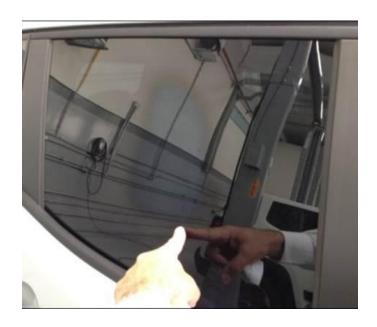
Some customers may describe stains on the rear door glass as shown in (Fig. 1). This bulletin contains the procedure for removing stains from the glass.

Fig. 1 Glass Stain
