NUMBER: 23-025-16

Discolored Door Hinge Nuts

This bulletin involves replacing all the lower nuts on the side upper and lower door hinges.

2015 - (JK) Jeep Wrangler
****2016****

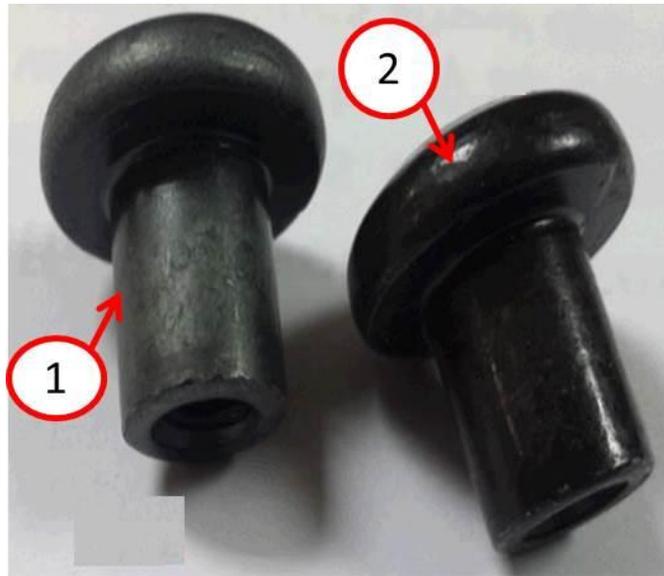
Fig. 1 Door Hinge Nuts

The customer may describe discoloring or rust from the lower nut securing the doors to the hinges.

Some lower nuts for the side door hinges may have been installed without the plating (1) process to the nut. **New plated nuts (2) will have a slight shine or low gloss (Fig. 1).**

1 - Non Plated Nut

2 - Plated Nut
