NUMBER: 23-038-15

Cracked Vinyl Soft Top Window

This bulletin provides soft top vinyl window precautions during cold weather.

2007 - 2015 (JK) Jeep Wrangler

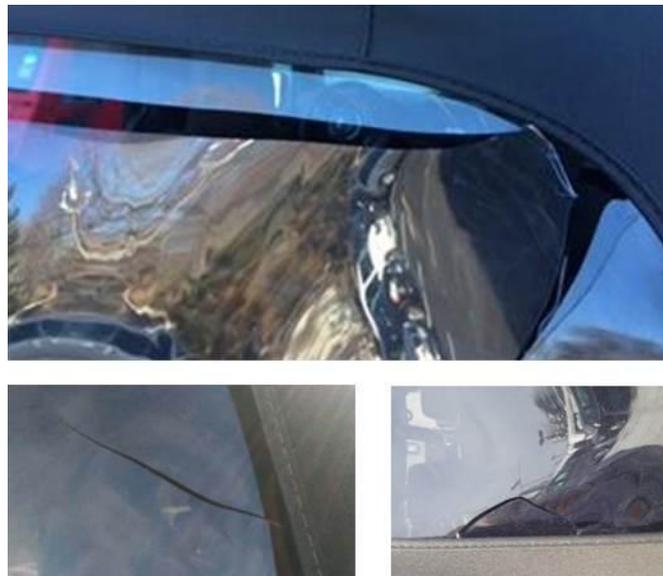
Vinyl windows are susceptible to cracking when handled in cold temperature below 41°F (5°C). The condition shown in (Fig. 1) is not warrantable.

Fig. 1 Examples Of Cracked Vinyl Window - Non Warrantable Condition

In cold weather conditions below 41°F (5°C) the soft top vinyl windows may be more susceptible to cracking while being stretched or folded.

If the temperature is 41°F (5°C) or below, do not attempt to put the vinyl top up/down or roll/unroll the rear or side curtains. Place the vehicle in a warm area and allow the vinyl to reach an ambient temperature above 41°F (5°C) before attempting to put the top up/down or roll/unroll the rear or side curtains. Once the vinyl is warm, pull steadily on the top fabric. The vinyl will stretch back to its original size and the top can then be installed.
