NUMBER: 23-040-15

Right Sliding Door Will Not Open From Exterior

This bulletin involves replacing the right sliding door exterior handle and rerouting door cable.

2014 - 2015 (VF) Ram Pro Master

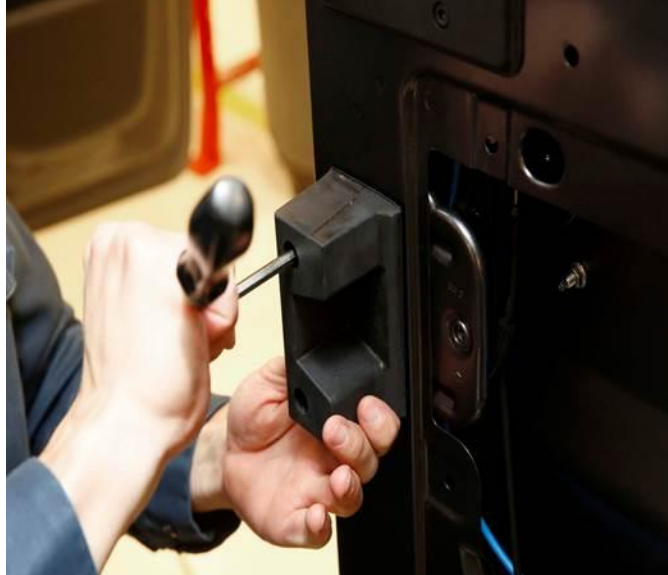
1. Open right sliding door.
2. Remove the trim panel. Refer to 23 - Body/Doors - Sliding/PANEL, Door Trim/Removal.
3. Remove rubber bump stop ([Fig. 1](#)).

Fig. 1 Bump stop

21. Install the handle to the vehicle and engage cable at interior handle (Fig. 6).
22. Install the four mounting nuts (1) to outer handle (Fig. 3). Tighten to 9 N·m (80 in.lbs).
23. Install the interior door handle. (Refer to 23 - Body/Doors - Sliding/HANDLE, Interior/Installation) (Fig. 2).
24. Install rubber bump stop (Fig. 1). Tighten to 25 N·m (221 in.lbs).
25. Install the trim panel. (Refer to 23 - Body/Doors - Sliding/PANEL, Door Trim/Installation).

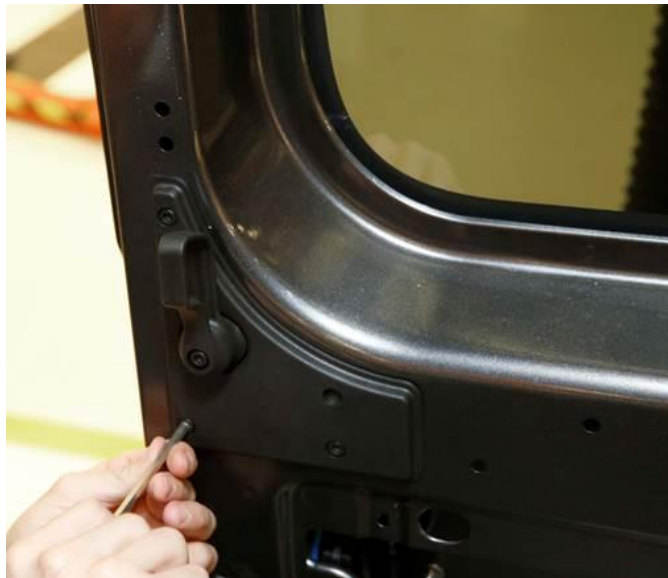
4. Remove the interior door handle. (Refer to 23 - Body/Doors - Sliding/HANDLE, Interior/Removal) ([Fig. 2](#)).

Fig. 2 Interior handle

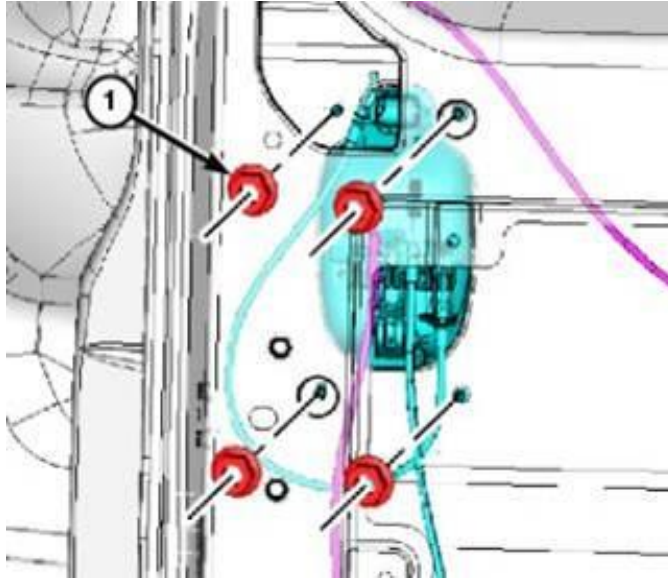
5. Remove four mounting nuts (1) to outer handle ([Fig. 3](#)).

Fig. 3 Door handle nuts

1 - Nuts

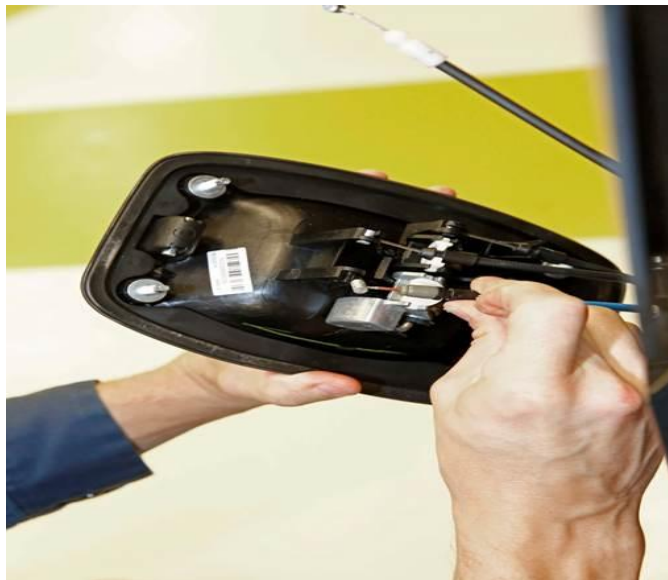
6. Remove handle from vehicle and disconnect cable at exterior handle ([Fig. 4](#)).

Fig. 4 Cable connections

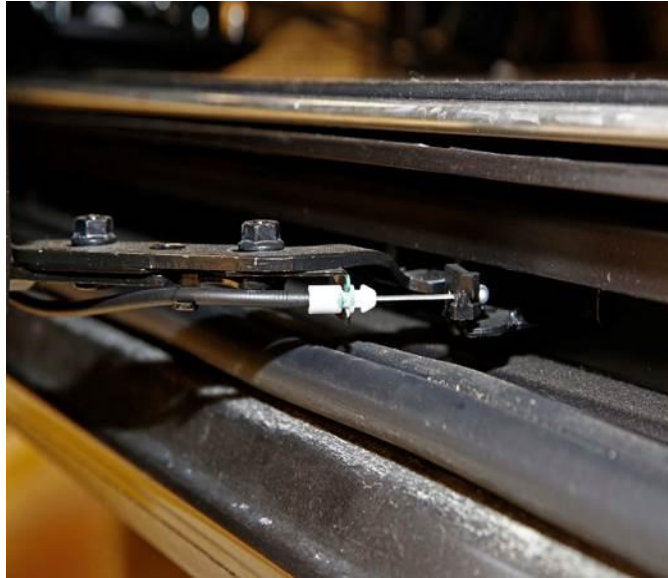
7. Remove the cable at the hold open latch from the lower area of the side door ([Fig. 5](#)).

Fig. 5 Hold open latch cable

20. Route (Fig. 19) and connect the cable at the lower part from the side door (Fig. 5).

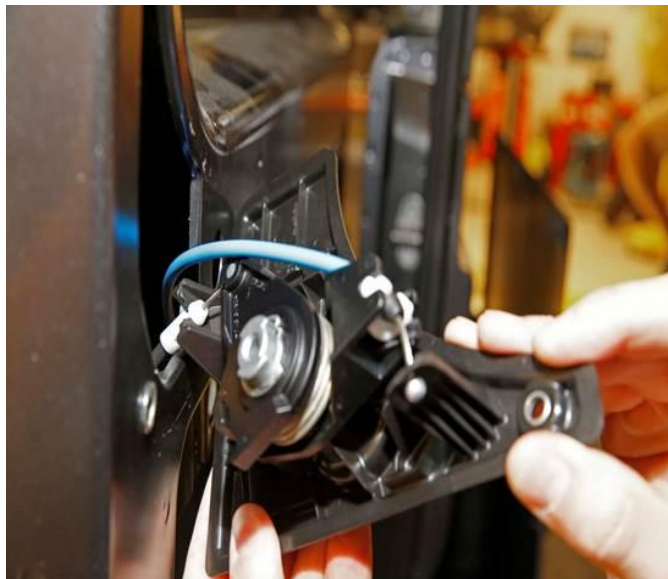
8. Disconnect interior door handle cable from the handle assembly ([Fig. 6](#)).

Fig. 6 Inside door handle cables

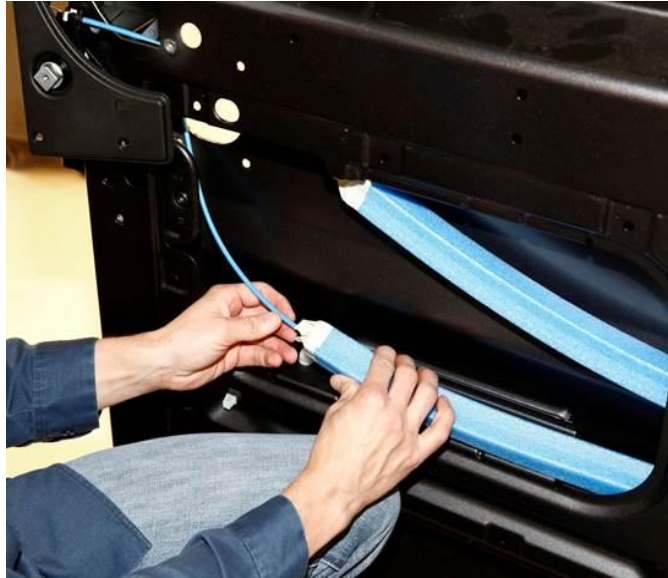
9. If tape is on the end of the cable remove tape from cable ([Fig. 7](#)).

Fig. 7 Remove tape from foam

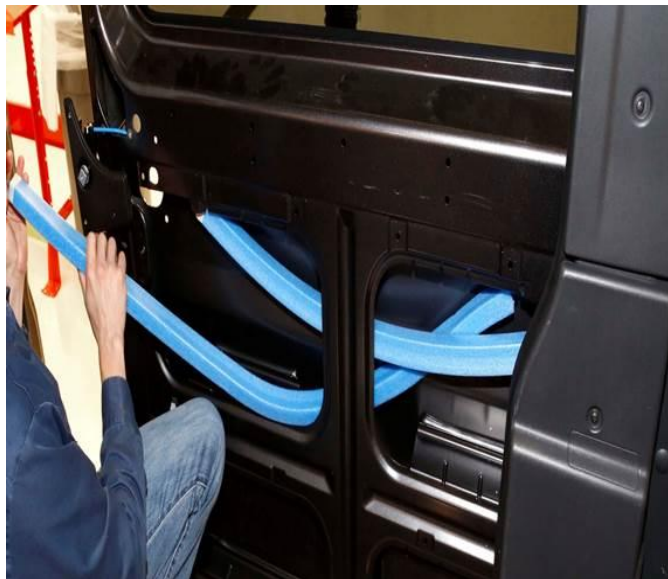
10. Remove foam from cable ([Fig. 8](#)).

Fig. 8 Remove foam from cable

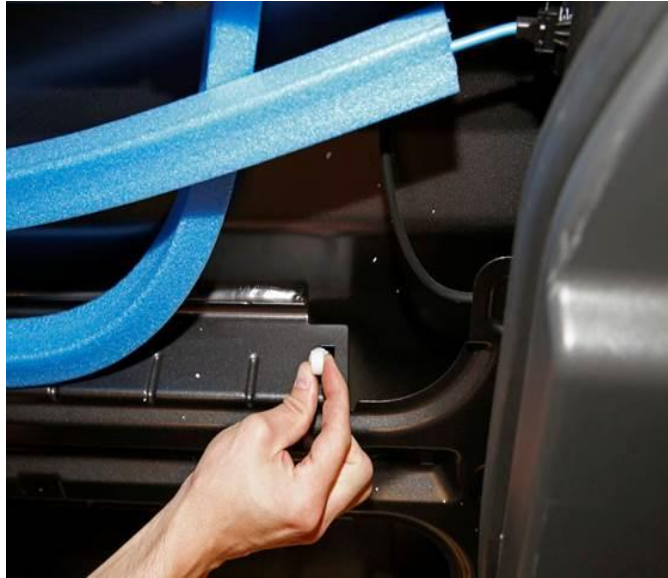
11. Install additional clip to inside door ([Fig. 9](#)).

Fig. 9 Install additional clip

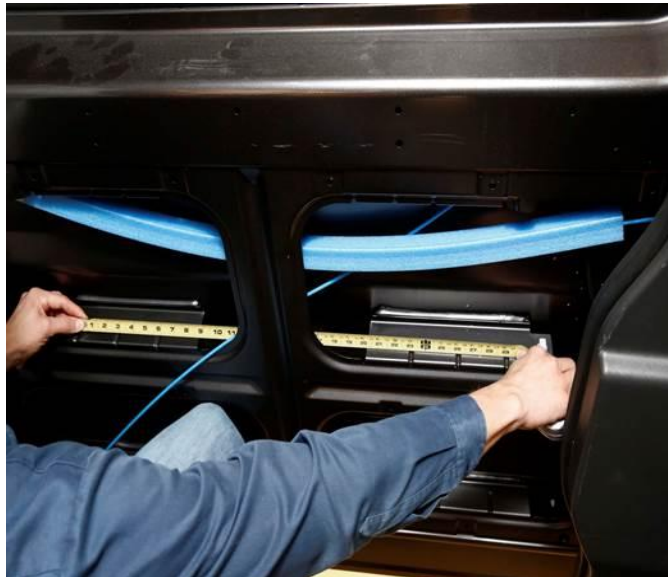
12. Measure the distance from clip to clip and then subtract 102 mm (4.0 in) from the total measurement ([Fig. 10](#)).

Fig. 10 Measure distance from clip to clip

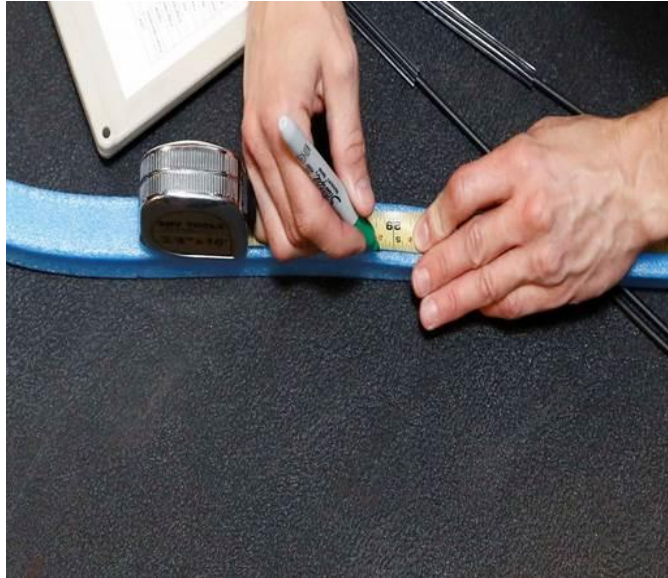
13. Measure and mark the long foam that was removed to measurement ([Fig. 11](#)).

Fig. 11 Measure foam to cut

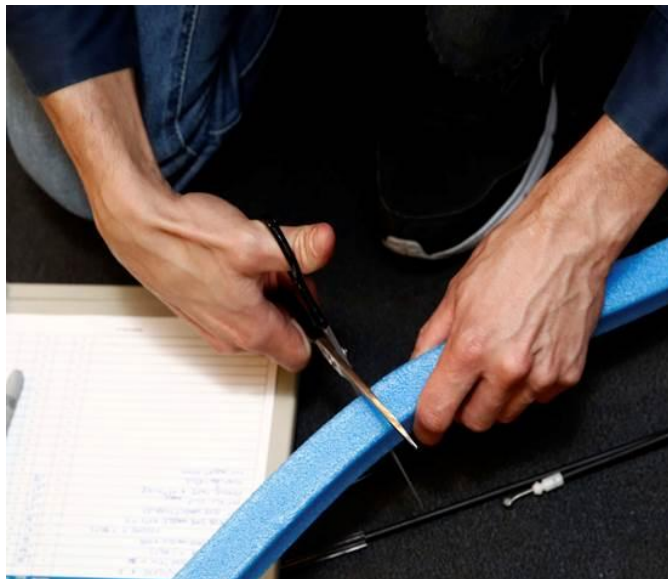
14. Cut the foam at mark. ([Fig. 12](#))

Fig. 12 Cut foam

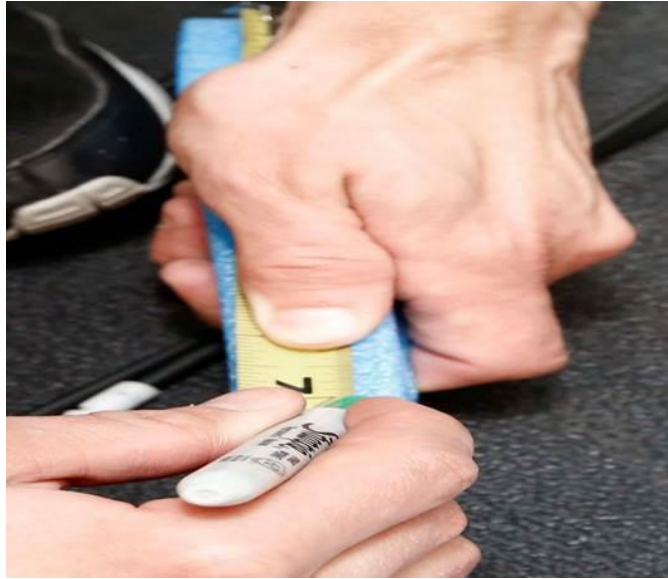
15. Measure (Fig. 13) the remaining smaller length of foam and cut 185 mm (7.25 in) from the foam (Fig. 14). Then discard the excess cut piece of foam.

Fig. 13 Measure smaller foam

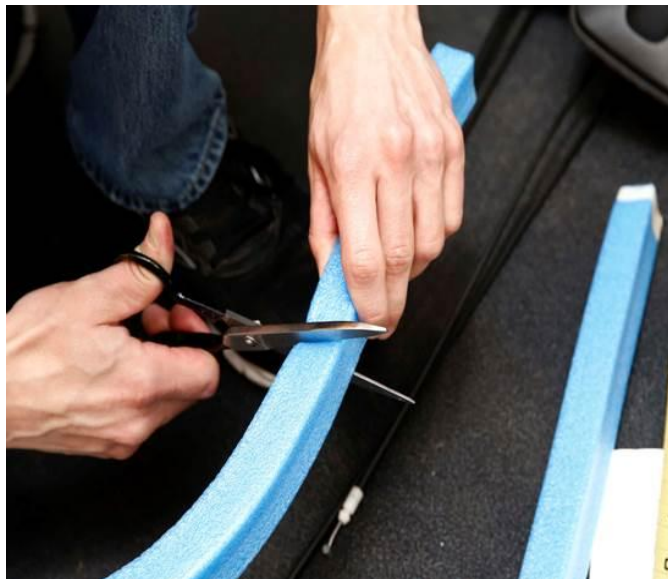
Fig. 14 Cut smaller foam

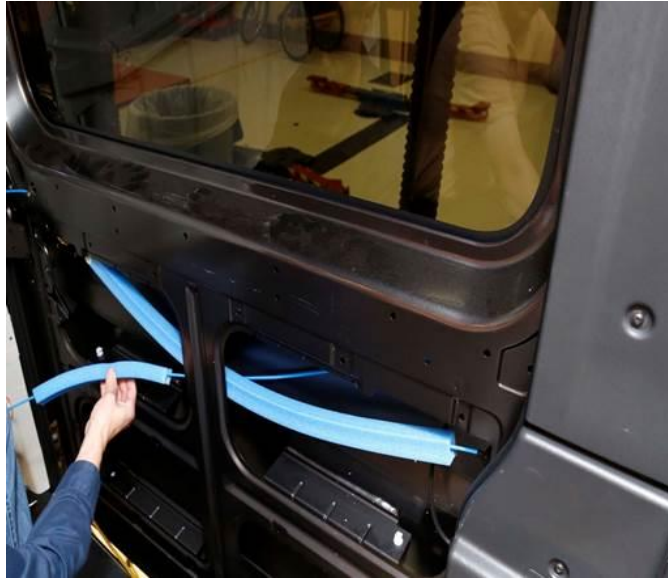
16. Slide the 185 mm (7.25 in) piece of foam over the cable to the latch side ([Fig. 15](#)).

Fig. 15 Install small foam

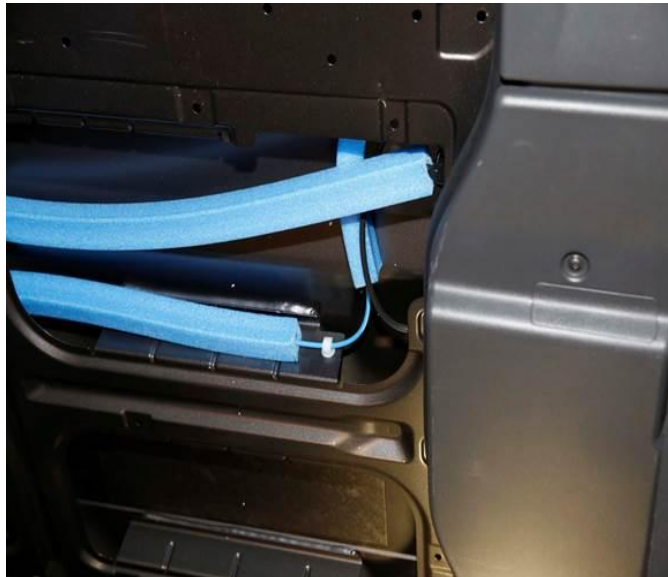
17. Slide the larger piece of foam over the cable and connect cable to the clip toward the rear of the door ([Fig. 16](#)).

Fig. 16 Cable in clip

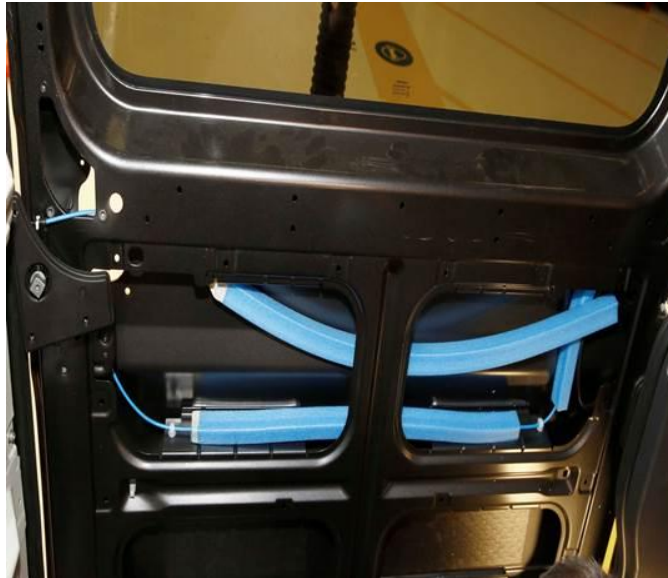
18. Connect cable to the clip toward the front of the door and leave 51 mm (2.0 in) on each side from clips ([Fig. 17](#)).

NOTE: On earlier built vehicle the foam may be split; in this case tape the end of the foam to secure foam in place.

Fig. 17 Cable properly routed and secured

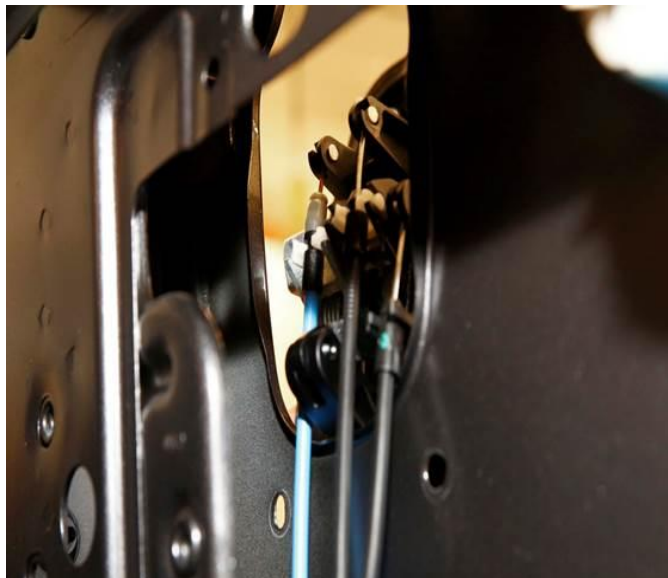
19. Connect the blue cable to the handle assembly ([Fig. 18](#)).

Fig. 18 Door handle cables attached

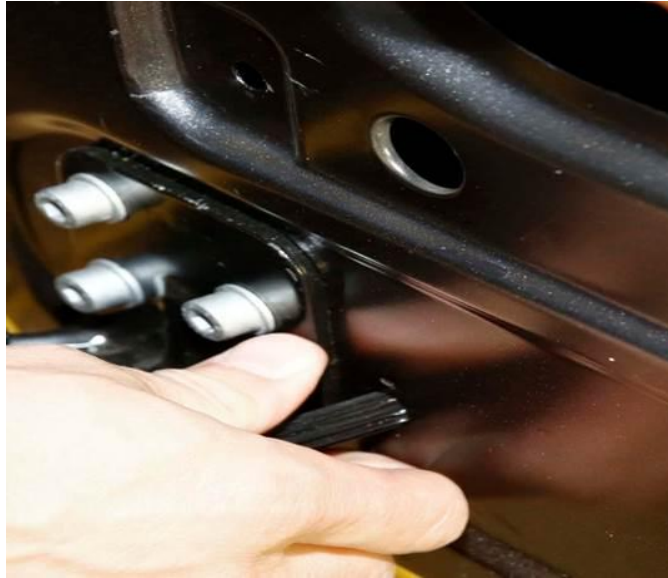
Fig. 19 Routing open latch cable through door
