NUMBER: 23-051-15

Liftgate Open Indicator Illuminated And Liftgate Will Not Latch Fully

This bulletin involves replacing the liftgate bumpers, liftgate weatherstrip, and adjusting the liftgate latch.

2016 (FB) Fiat 500X

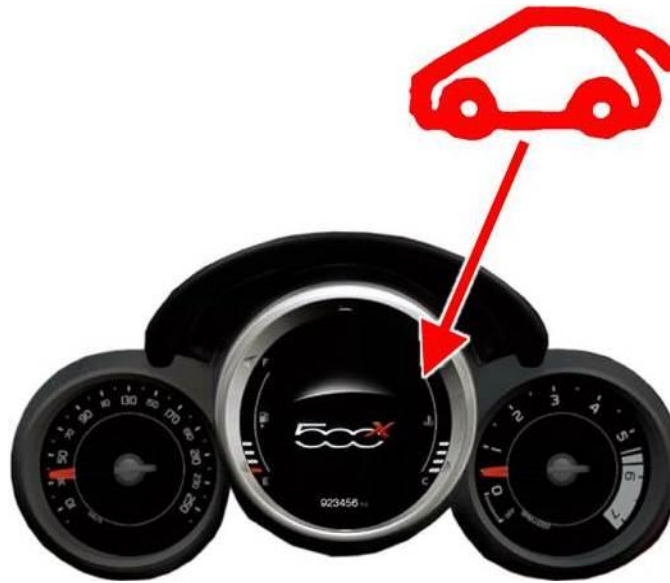
Fig. 1 Liftgate Open Indicator

The customer may describe the liftgate open indicator is illuminated in the instrument cluster information center ([Fig. 1](#)) and/or the liftgate does not close fully.

When the liftgate is shut, the liftgate latch engages the striker with the first latch position but does not achieve the second latch position.

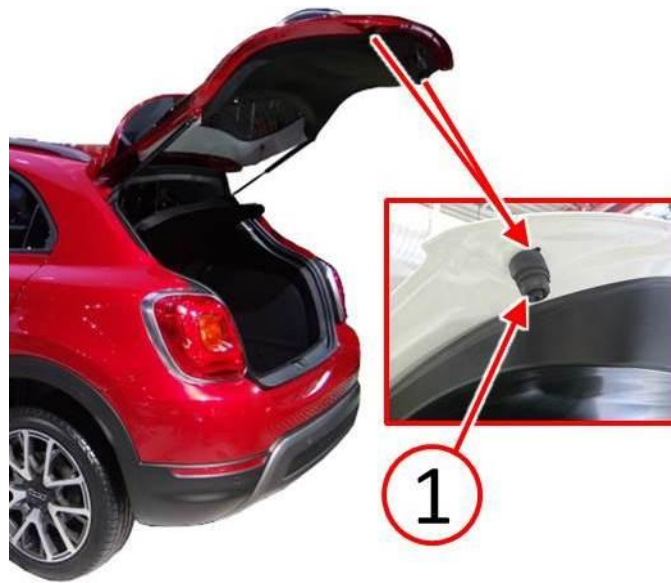
Fig. 2 Liftgate Bumpers

1 - Liftgate Bumpers

1. Remove and discard the two liftgate bumpers (1) (Fig. 2).
2. Install two NEW liftgate bumpers (1) listed in the Parts Required section of this bulletin (Fig. 2).

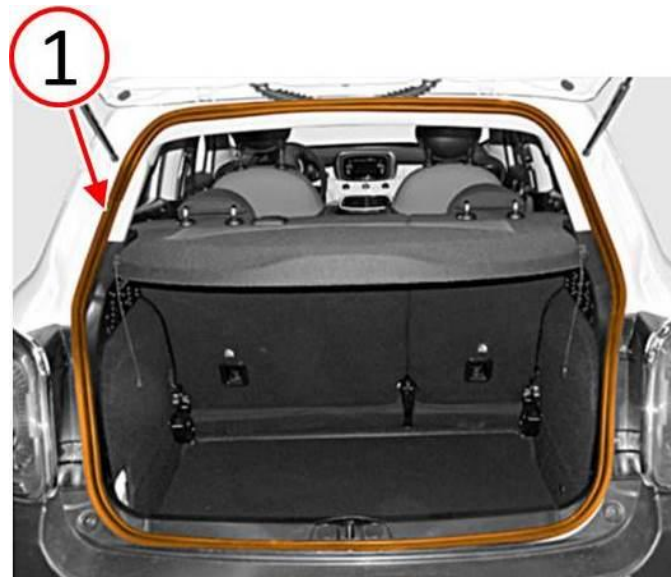
Fig. 3 Liftgate Weatherstrip

1 - Liftgate Weatherstrip

3. Remove and discard the liftgate weatherstrip (1) (Fig. 3).
4. Install the NEW liftgate weatherstrip (1) listed in the Parts Required section of this bulletin (Fig. 3).

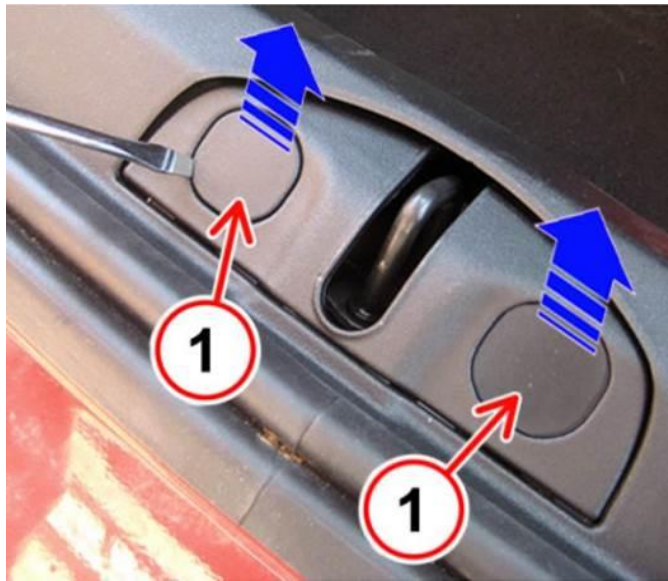
Fig. 4 Liftgate Striker Cover

1 - Covers

6. Is the liftgate open indicator illuminated and/or does the liftgate not close fully?
 - a. YES>>> Continue with the Repair Procedure [Step #7](#).
 - b. NO>>> This bulletin has been completed.
7. Remove the liftgate striker fastener covers (1) ([Fig. 4](#)).

- 11. Verify proper liftgate latch operation.
- 12. Install the liftgate striker fastener covers (1) (Fig. 4).

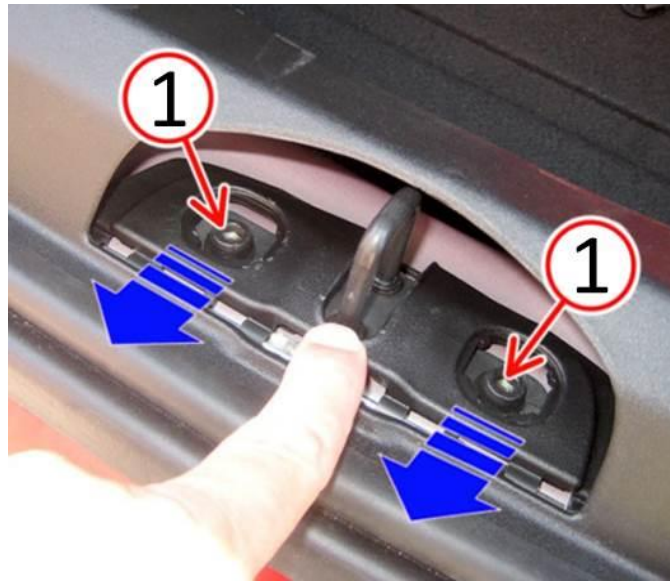
Fig. 5 Liftgate Striker Adjustment

1 - Striker Fasteners

8. Loosen the liftgate striker fasteners (1) ([Fig. 5](#)).
9. Move the striker approximately 1 mm (0.04 in.) toward the rear of the vehicle ([Fig. 5](#)).
10. Tighten the striker fasteners (1) to 25 N·m (18 Ft. Lbs.) ([Fig. 5](#)).
