Applies To: **2007–11 CR-V – ALL****July 10, 2012****Exhaust System Squeaks****(Supersedes 08-049, dated August 15, 2008, to revise the information marked by the black bars)****REVISION SUMMARY**

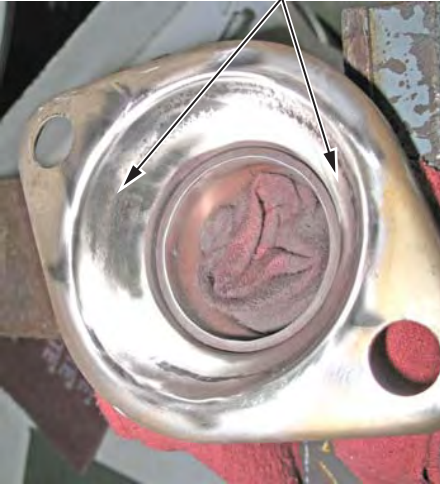
6. Stuff a shop towel into the exhaust pipe to keep debris out. Use a 90-degree angle grinder with a Scotch-Brite Roloc surface conditioning disc to remove all old gasket material.

Clean the surface of the flange.

7. Install the TWC with new gaskets and new nuts. Torque the nuts to **33 N·m (25 lb-ft)** and the bolts to **22 N·m (16 lb-ft)**.

NOTE: It may be necessary to walk the new exhaust gasket onto the primary catalyst, and then lightly tap the gasket into place.
