Applies To: **2007–08 Fit – ALL**

A/C Switch or Rear Window Defogger Switch Does Not Work; Fuse 22 Is Blown

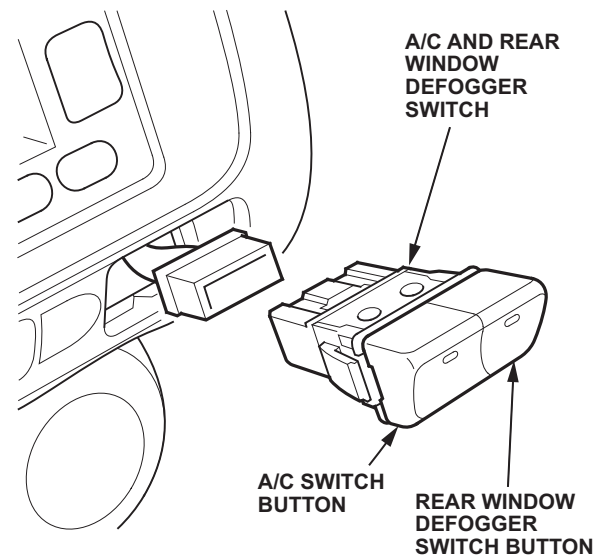
- Be careful not to scratch the dashboard or any other parts.
 - Do not use tools to remove the center panel.
4. Remove the A/C and rear window defogger switch from the center panel by pushing it out from the back of the panel.

5. Install a new A/C and rear window defogger switch into the center panel by pressing it in from the front of the panel.
