**Introduction** On some ECHO, Scion xA, and Scion xB vehicles, a condition may exist that allows the evaporator drain hose to become detached, causing the passenger foot well to become wet. This bulletin provides a procedure to correct this condition.

- Applicable Vehicles**
- **2003 - 2005** model year **ECHO** vehicles produced **BEFORE** the Production Change Effective VIN shown below.
  - **2004 - 2006** model year **Scion xA** and **xB** vehicles produced **BEFORE** the Production Change Effective VINs shown below.

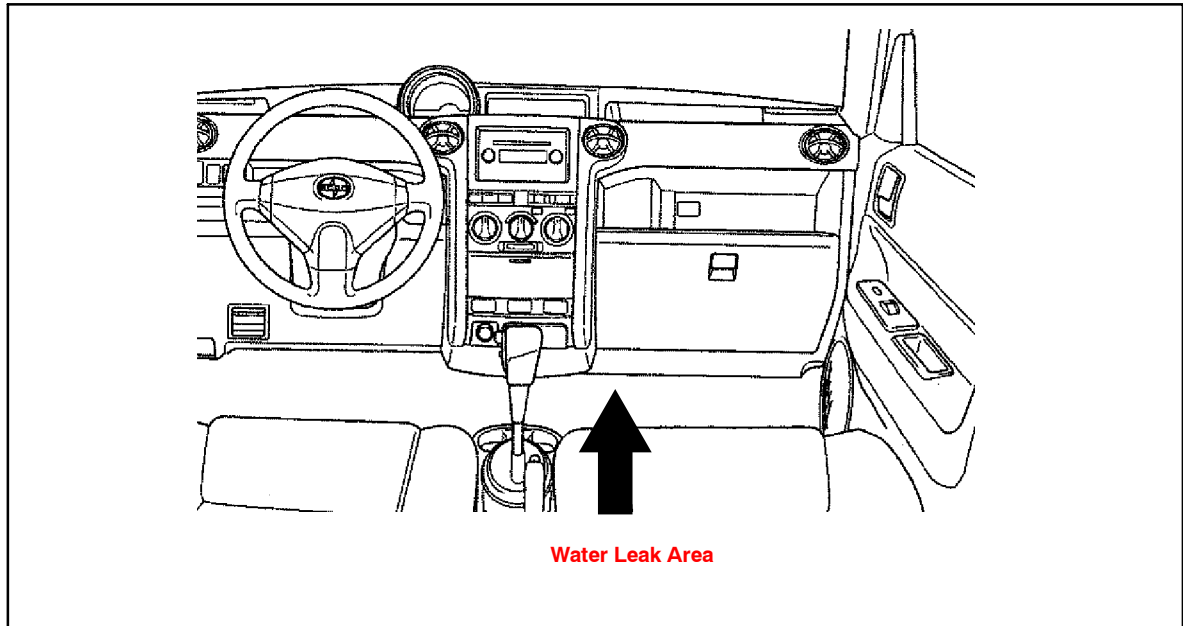
1. Inspect the evaporator drain hose to ensure that it is the cause of the water leak. If the evaporator hose is out of position, continue with this procedure.
