BTB 00387 (1411)

## Front Door Sash Outer Trim Is Loose, Warped, or Causing a Wind Noise

Year	Model	Trim	VIN Range
2014	RLX	ALL	ALL
2014	RLX Hybrid	ALL	ALL

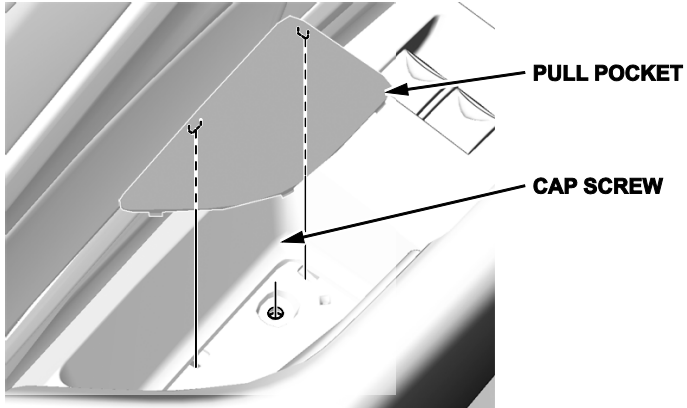
1. Remove the pull pocket and the cap screw.

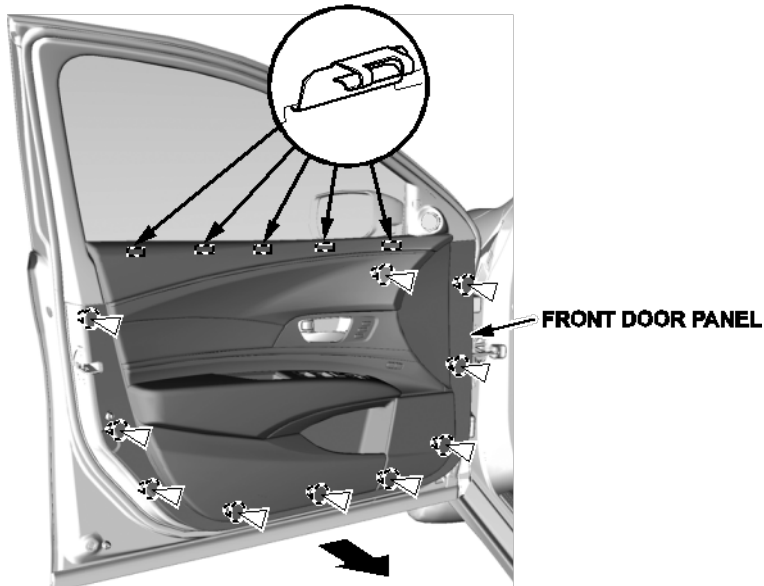
2. Starting at the bottom edge of the front door panel, remove the clips with a commercially available trim pad remover.

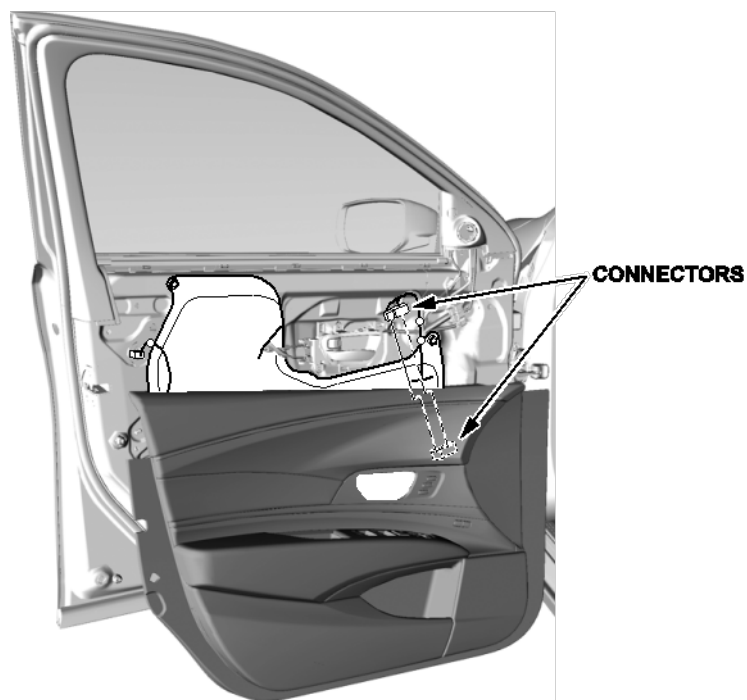
3. Starting at the rear, pull out on the door panel.

4. While holding the front door panel away from the door, disconnect the front door wire harness connectors.

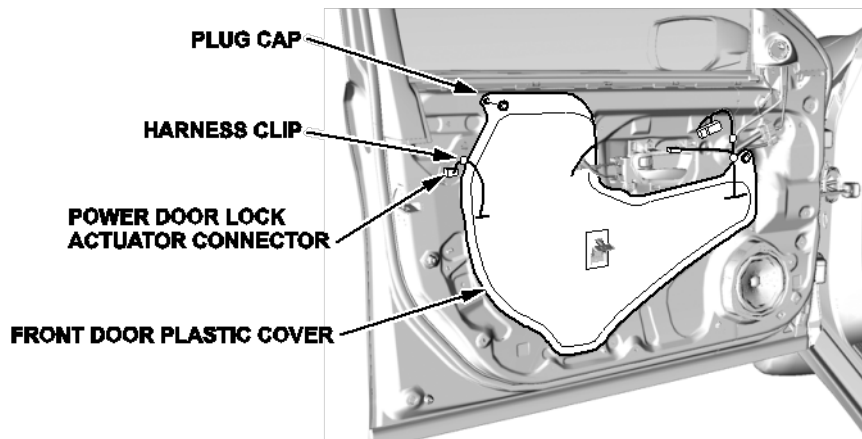
5. Disconnect the power door lock actuator connector and remove the harness clip.

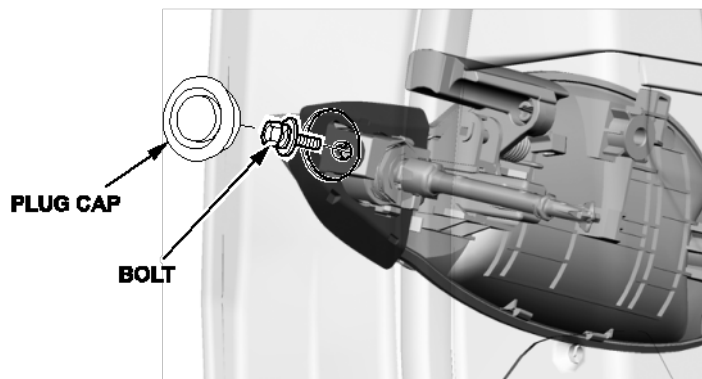
6. Remove the plug cap.  
7. Remove the front door plastic cover as needed.  
8. Remove the plug cap and the bolt.

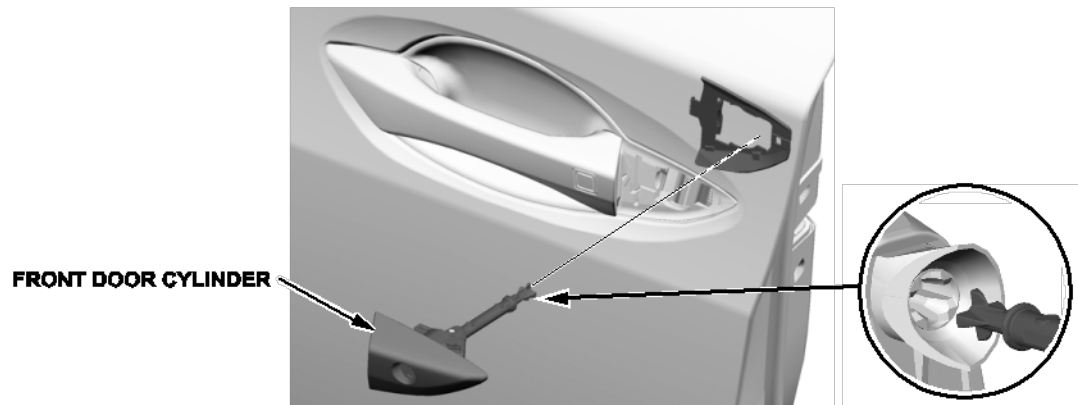
9. Remove the front door cylinder.

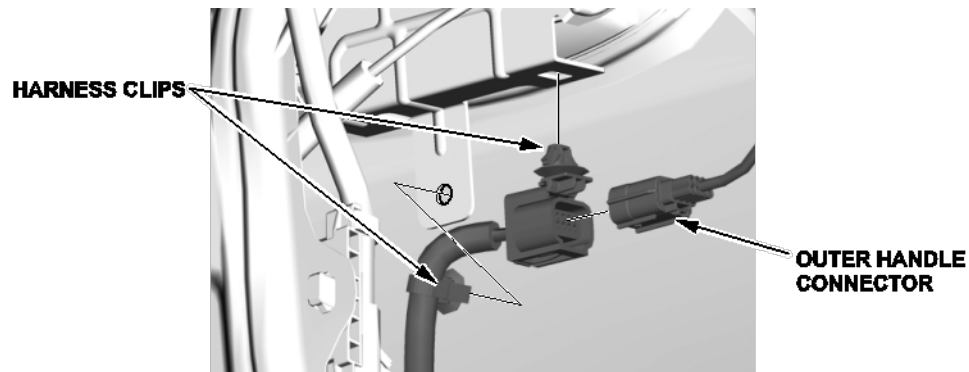
10. Disconnect the outer handle connector.

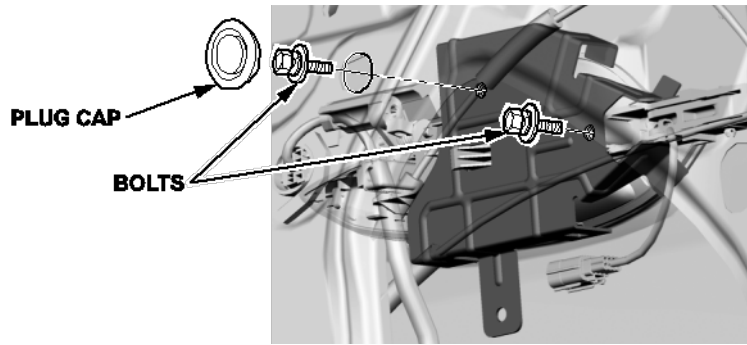
13. Remove the plug cap and the bolts.

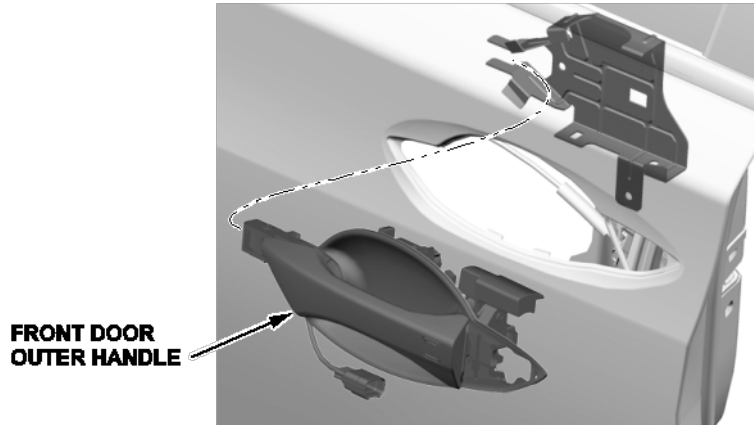
14. Remove the front door outer handle.

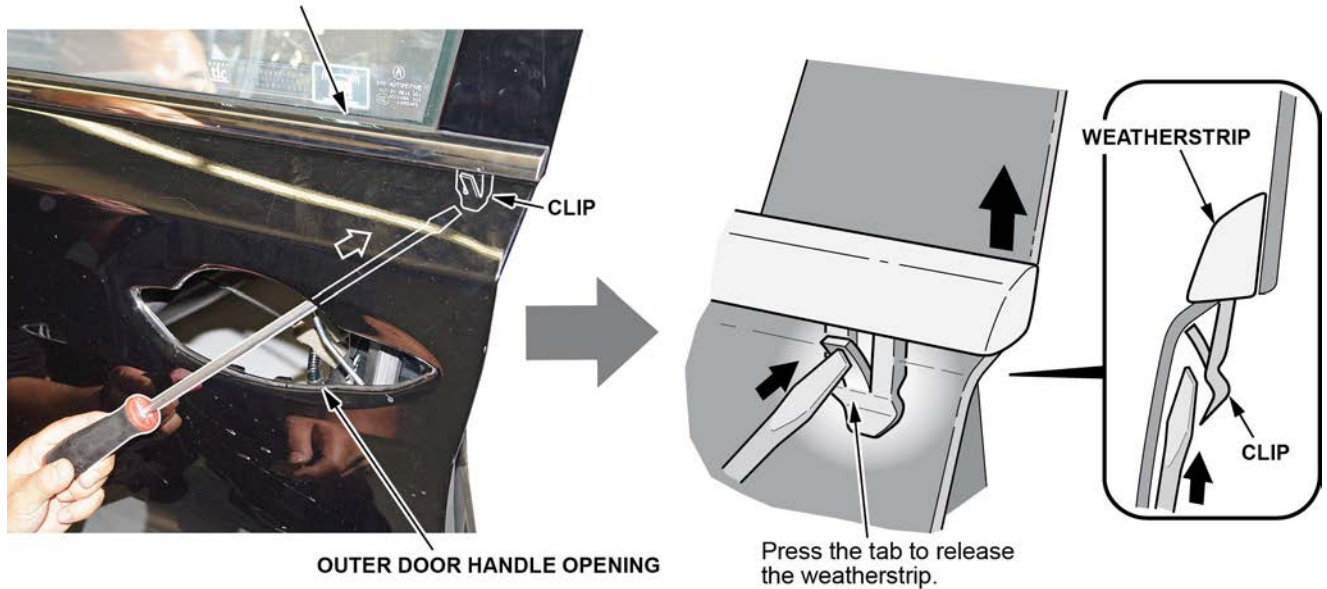
**FRONT DOOR GLASS OUTER WEATHERSTRIP**

15. Release the clip from the window trim using a flat edge screwdriver, then pull up on the trim to remove it.

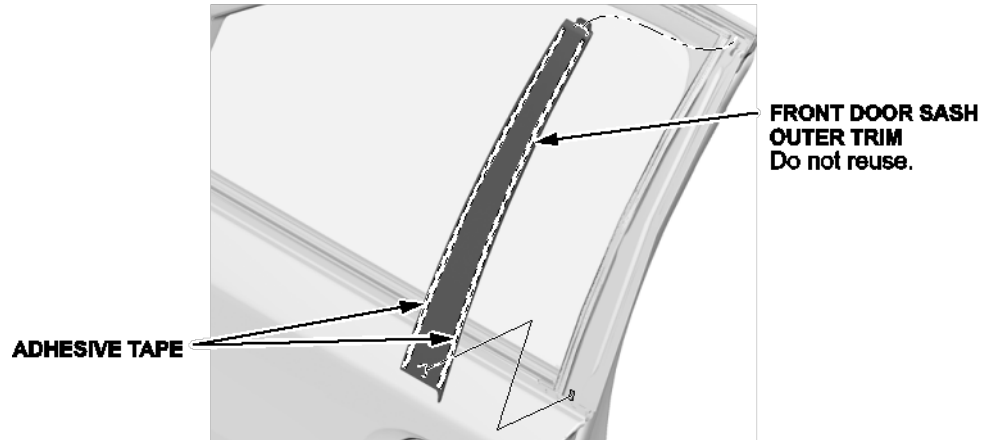
16. Pull out the upper edge of the front door sash outer trim from the edge of the sash and cut the double-sided adhesive tapes with a utility knife. Then remove the front door sash outer trim.

17. Carefully remove the remaining double-sided adhesive tapes from the sash, then clean the surface with a shop towel dampened with isopropyl alcohol.

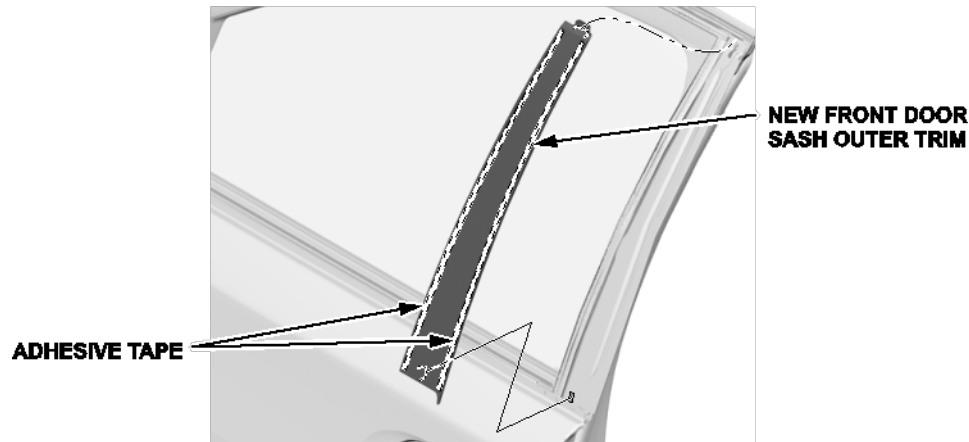
18. Remove the backing from the new front door sash outer trim, then install it to the door sash.
