September 18, 2015

02365 Version 1

Security System Sounds or May Not Set

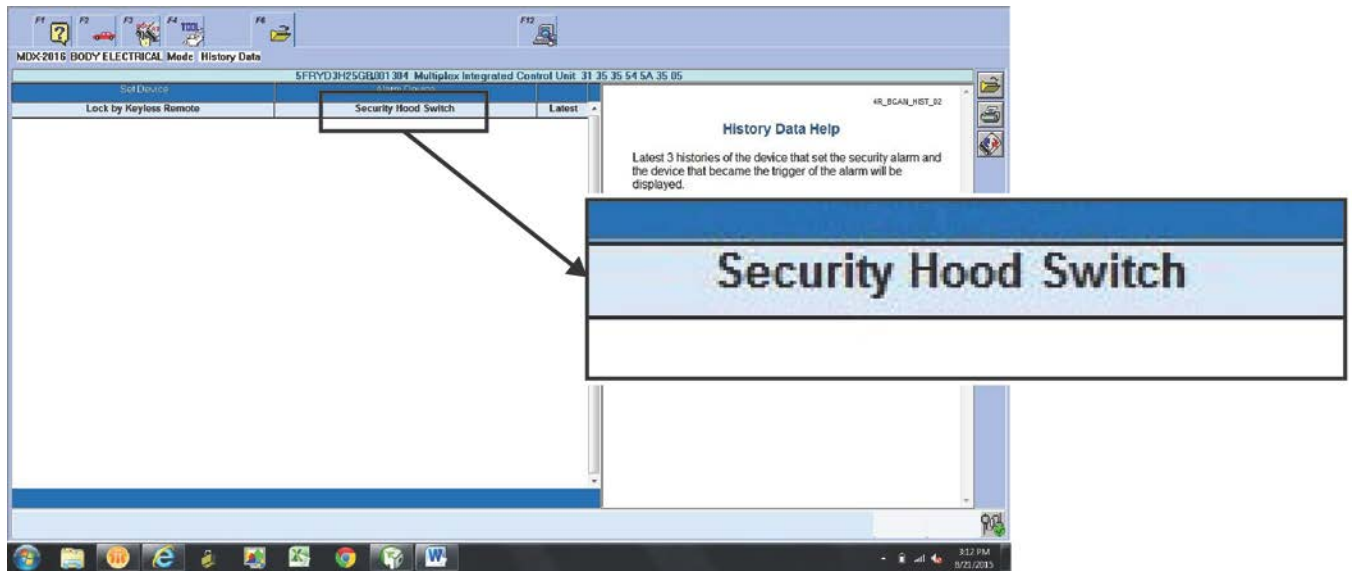
1. If the client complaint is alarm goes off by itself, check the security system history data using the HDS. If the **Alarm Device** shows **Security Hood Switch**, go to REPAIR PROCEDURE. If the history data does not show **Security Hood Switch**, this bulletin does not apply.

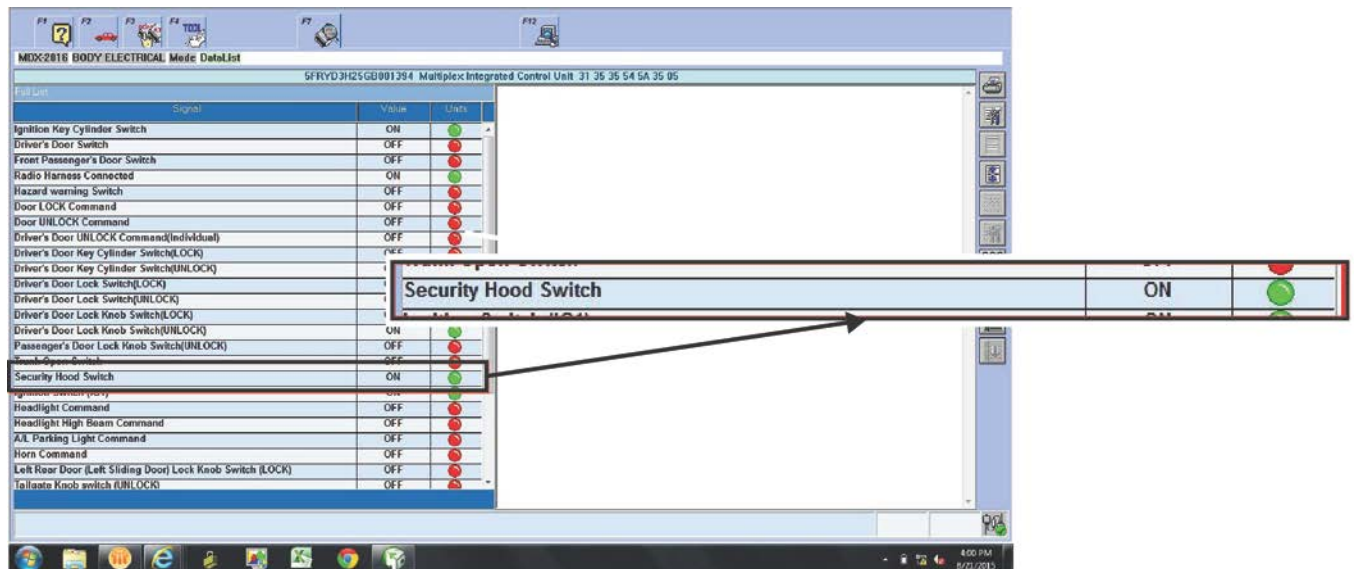
2. If the client complaint is "Security system will not arm", "Parking lights do not flash when setting security system", or "No feedback beep when pressing the lock button twice". Duplicate the complaint, then check the **Body Electrical Data List** using the HDS with the hood closed. If the Security Hood Switch signal reads **ON** (green) go to REPAIR PROCEDURE. If the Security Hood Switch **OFF** (red), this bulletin does not apply
