TECHNICAL BULLETIN
JTB00344NAS1
06 MAY 2014

SECTION: 501-00

Earth Stud Repair on Aluminum Body

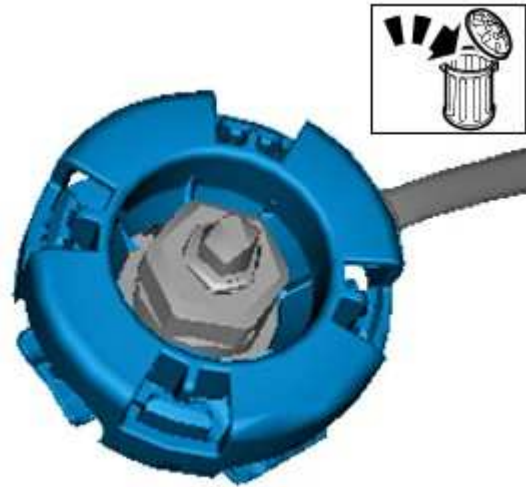
E161219

**NOTE: The plastic earth protection cradle is not compatible with the new stud.**

When fitting the repair earth stud, remove the harness cradle from the harness before re-attaching the eyelet to the stud and tightening.

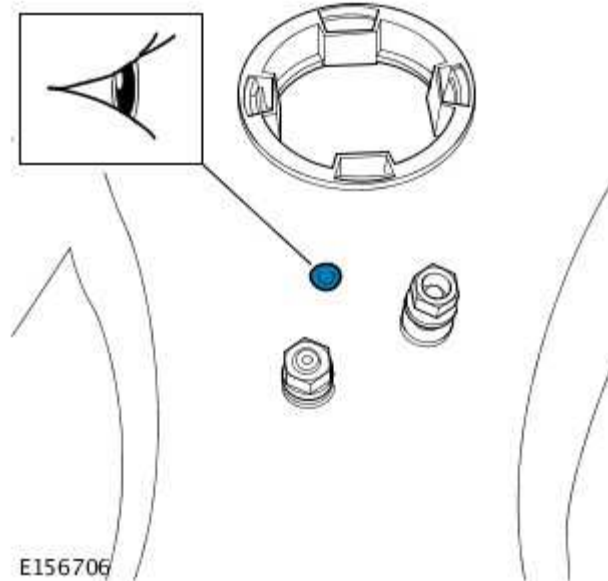
E156706

2. Locate broken/cross threaded earth stud.

3. Dress/file the broken stud to a safe and acceptable repair standard.

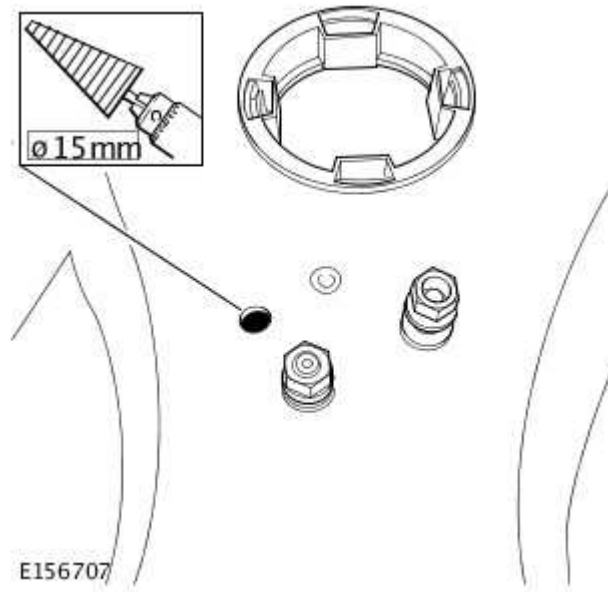
Using the stepped cutter supplied in the kit (MRPK4072), drill until you achieve a 15mm diameter hole.

**CAUTION: To prevent damage to other components, make sure there are no components in the area that may be damaged by the drilling process.**

**NOTE: Cleanliness is important to avoid galvanic corrosion.**

**NOTE: Make sure any swarf is removed/cleaned away.**

**NOTE: Carry out drilling in close proximity to the broken/cross threaded stud.**

**NOTE: The stepped cutter should not be used for any other procedure to avoid galvanic corrosion.**

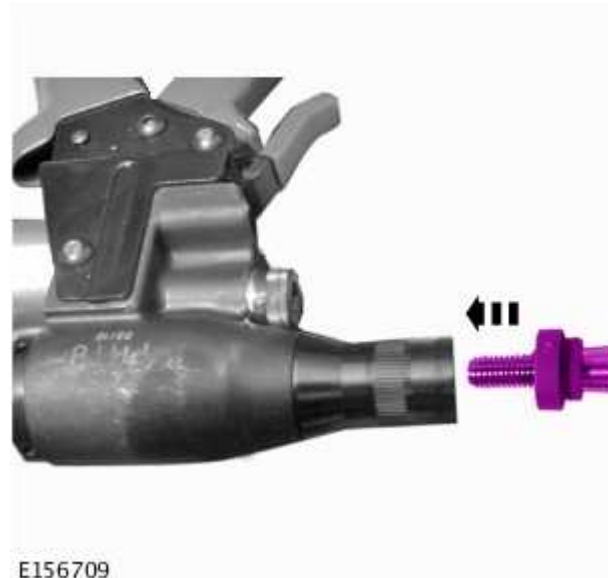
5. Load the new earth stud into the stud applicator gun.

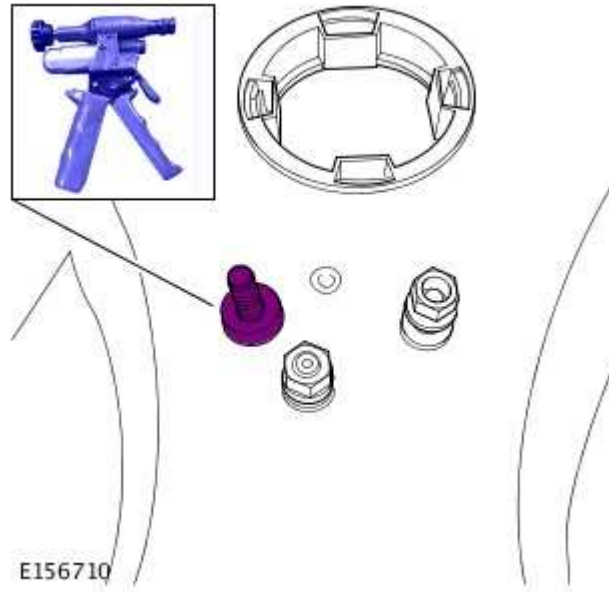
**NOTE: The earth stud bond is totally self-sealing and watertight; there is no need to dress the hole with any primer before fitting.**

Install the new earth stud: Apply pressure to the trigger of the applicator gun until the pressure reduces, this will indicate the applicator gun has reached the end of its cycle.

- Place the new stud into the drilled hole.
- Apply pressure to the trigger of the applicator gun until the pressure reduces, indicating the applicator gun has reached the end of its cycle.

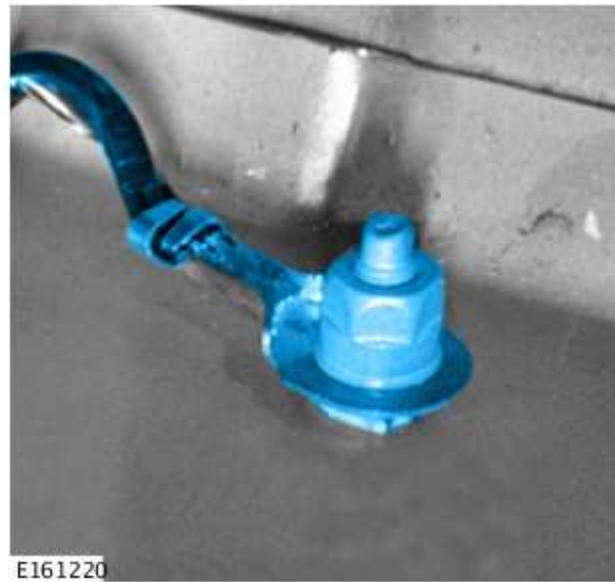
7. Repaired earth stud with harness fitted.

- Torque 9Nm
