**Subject**

Glass engine bonnet replacement

Lamborghini Huracán, model year 2015 sold in **Brazil; Canada; Mexico and USA**, included in one of the two list below:

In the course of continuous product monitoring and internal tests, Automobili Lamborghini S.p.A. has determined that, in rare cases, incorrect tensioning during the factory mounting of the rear engine bonnet safety glass can result in cracking of the rear bonnet glass.

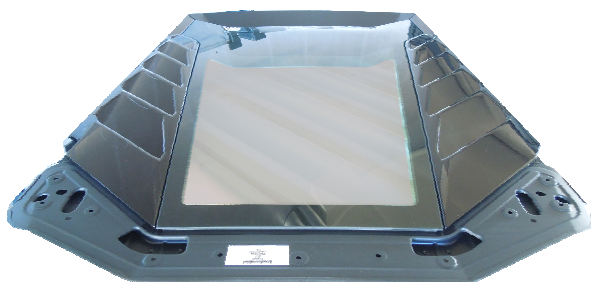
Bonnet with pre-installed glass and grille (gloss or matt depending on the “Style package” presence).

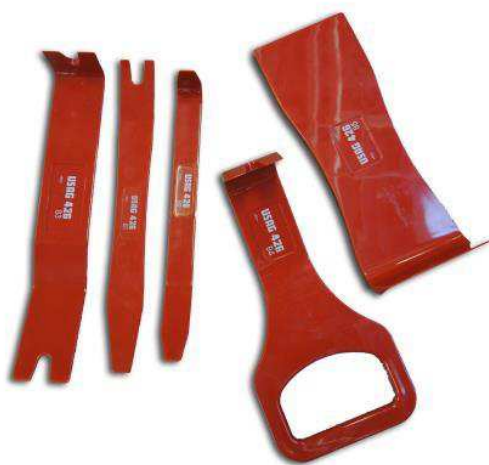
62x15_0003261

Plastic tools such as those shown in the figure should be used to avoid damaging the painting of the cover.
