L624-
A.03.16

Subject.
Cowl cover update .

Model.
Huracàn Coupè

VIN identification
 From **FLA00163** to **FLA03641**.

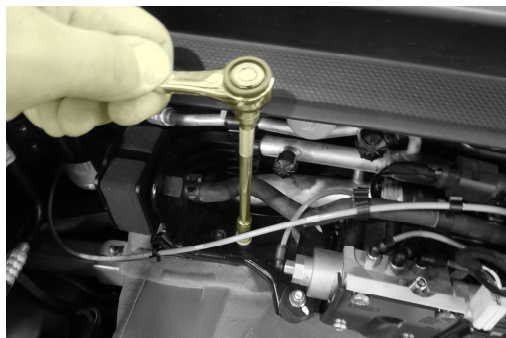
3. Compressor fastener removal.

Remove the compressor screw which is present over the unit's right side close to the intake filter.

Screw tightening;
torque: **30Nm**

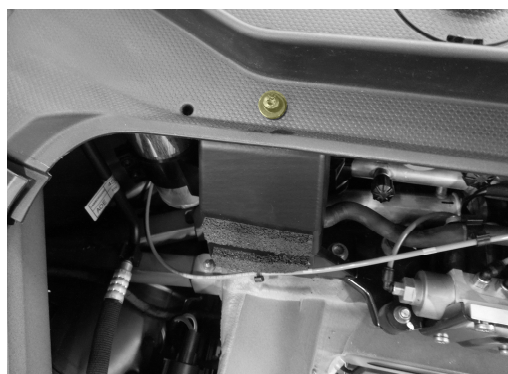
8. Fix the cover to the cowl cover with the screw provided in the kit.

Screw tightening;
Torque: **2,5Nm**

Complete the cover and compressor fastening with the screw removed at point 3.
