L624-A.04.16	To: Official After Sales Network Subject: TPMS control unit holder replacement Date: March 18,2016 Pages 2

TPMS control unit holder replacement .

Huracàn Coupè.

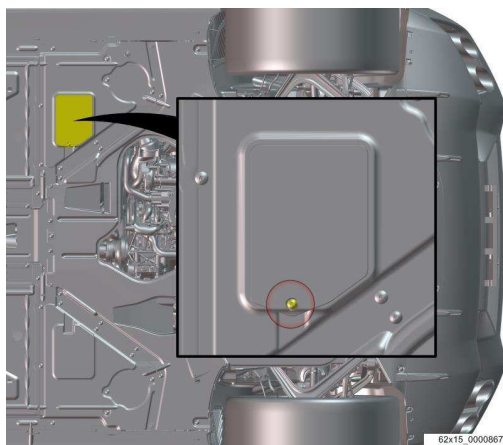
1. Place the car on a suitable lift.
2. TPMS control unit holder disassembling.

Remove the screw that fasten the TPMS plastic cover and then consequentially the cover itself.

Fixing Screw.

Torque: **4 Nm.**

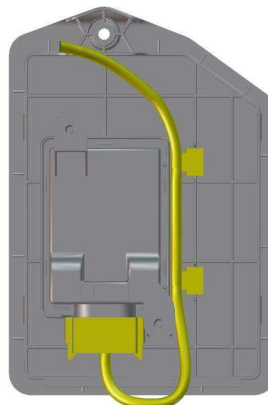
62x15_0000868

3. Wiring disconnection.

Ensure you the car is at Key off and the instrument panel is switched off.

Remove the fastening clip from the cover and then unplug the connector from the TPMS control unit.
