L624-  
A.05.16

**Subject.**  
Haldex control unit cover.

**Model.**  
Huracàn Coupè

**VIN identification**  
 From **FLA00163 to FLA04027**

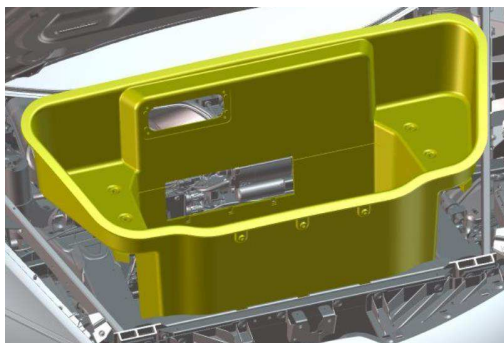
1. Secure the vehicle by engaging the parking brake.
2. Luggage compartment disassembling.

Disassemble the luggage compartment following the instructions reported at the Chapter 08, paragraph 63 from the workshop manual related to the subject vehicle market.

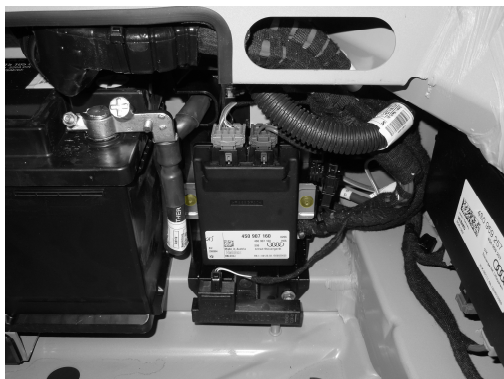
3. Haldex control unit fixing elements removal.

Remove the screws which secure the Haldex control unit.

Screw tightening;  
torque: **30Nm**

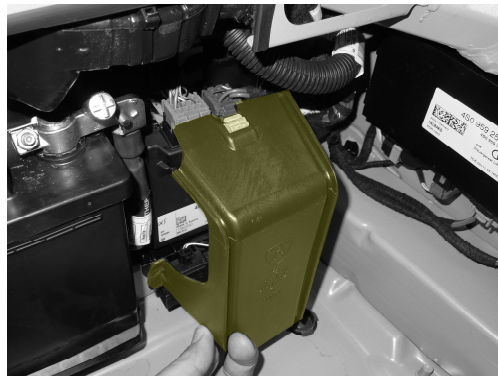
4. Fit the cover with the clip as shown below.

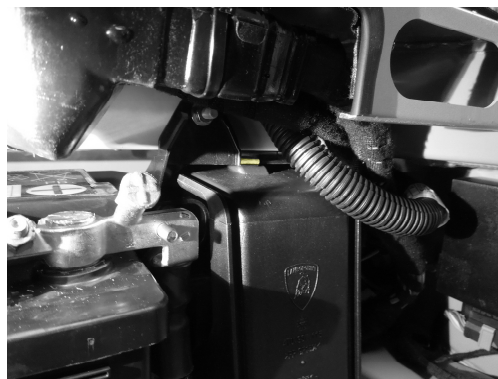
5. Install the cover on the Haldex control unit and check the clip is correctly embedded.
