To All Lamborghini Dealers and Licensed Service Point  
From Customer Service Department  
Subject Rework for the setscrew of the rear bonnet  
Group LB715.8.27  
Attachments -  
Date 01.06.2006  
Pages 7

Rework for the setscrew of the rear bonnet.

All MY '06 Gallardo Spyder from VIN 2623 until VIN 3836.

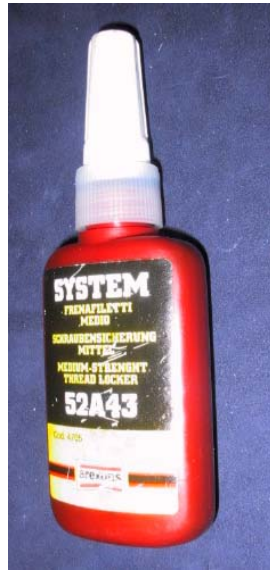
Pict.1

- 1.1 Allen spanner and Arexons threadlockers 52A43 (picture 1) or Loctite moderate strength (blue stuff).

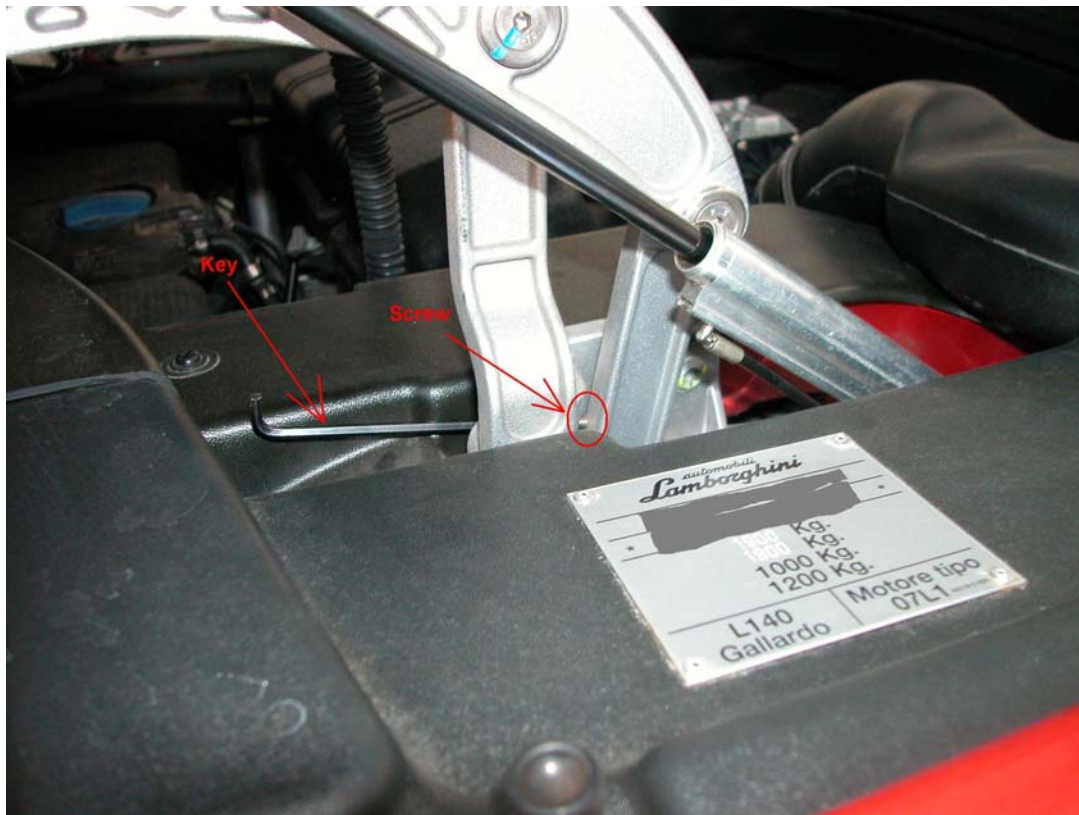
Pict. 2

- 1.2 Adopt all precautions to work safe and prevent car damages.
- 1.3 Open the rear bonnet in service position.
- 1.4 Find the setscrew on the arms of the rear bonnet and unscrew it, as in picture 2 and 3.

- 1.5 If the screw is loosened, unscrew it completely.
- 1.6 Use Arexons breaking thread 52A43 or Loctite (blue stuff) solution on the thread of the setscrew and reassemble it.
- 1.7 The setscrew should be about 4 mm out of the arm as in picture 4.

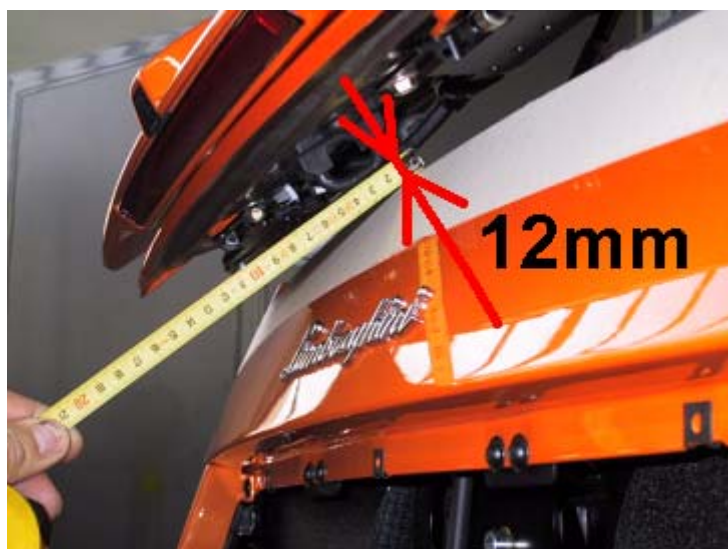
Pict. 5

**1.9** Verify that from the upper rear panel, the bonnet lock has a distance of at least 12 mm (picture 5).

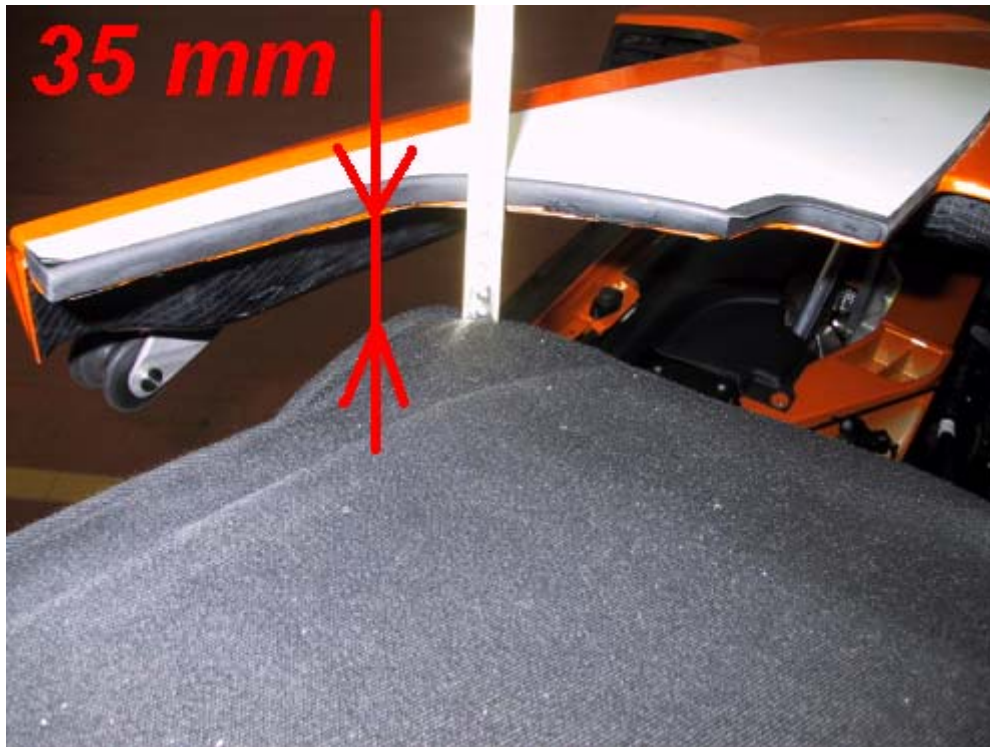
Pict. 6

**1.10** Check that the minimum distance from the soft-top and the rear bonnet during the movement is at least 35 mm, as in picture 6.

**1.11** Test the opening and closing procedures of the soft-top.
