Subject Repositioning of the SDARS antenna

Group 824.0.35 Date 25.11.2008

All Murcielago LP 640 Coupès and Roadsters. From VIN B93254 to VIN B83392 inclusive.

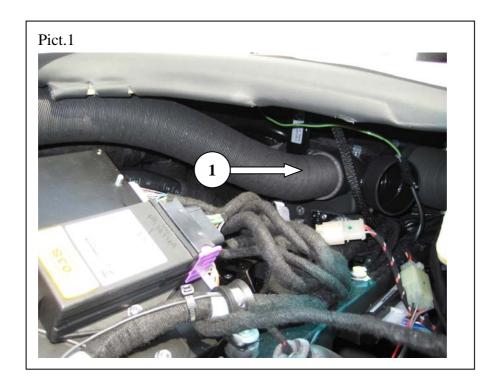
- **1.1** Please observe all safety precautions in order to prevent personal injury or damage to the vehicle.
- **1.2** Remove the instrument panel, the left side and the left central air intake (see also workshop manual instructions 08 68 03).
- **1.3** Disconnect the air condition hose (1-Pict.1) in the central zone of the passenger compartment.

- **1.7** Re connect the air condition hose (1-Pict.1) in the central zone of the passenger compartment.
- **1.8** Reassemble the instrument panel, the left side and the left central air intake (see also workshop manual instructions 08 68 05).

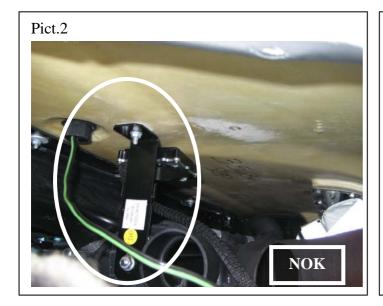
1.4 Check the position of the SDARS antenna: incorrect (Pict.2) or correct (Pict.3).

1.5 If the SDARS antenna is in the wrong position (Pict.2), unscrew the bolt (1-Pict.3) and remove the bracket with SDARS antenna (1-Pict.4).

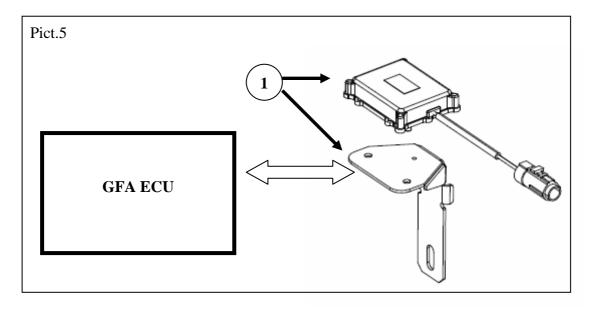
1.6 The plate of the bracket with the SDARS antenna must to be positioned in front of the GFA ECU (see also the Pict. 3 and 4).
