ToAll Lamborghini Dealers and Licensed Service PointsFromCustomer Service DepartmentSubjectReplacement of the front luggage lamp housingGroup824.8.63Date18.11.2008Pages4

Replacement of the front luggage lamp housing.

All Murcileago Coupè and Roadster MY 09 as indicated below:

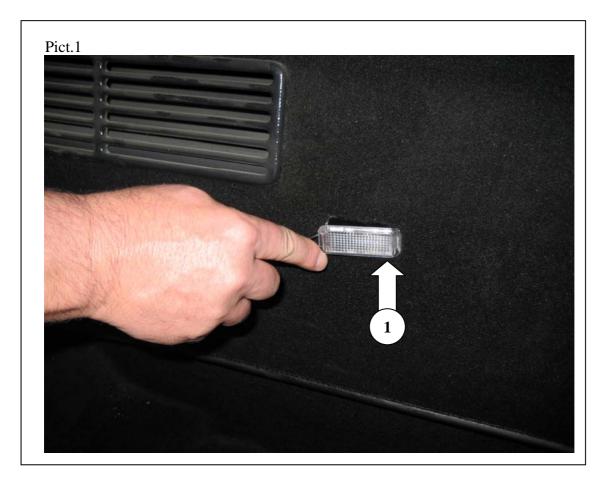
- **1.1** Please observe all safety precautions in order to prevent personal injury or damage to the vehicle.
- **1.2** Pull out the lamp housing of the front luggage (1-Pict.1) of the vehicle.

1.4 Replace the old lamp housing (1-Pict.1) with the new lamp housing (p/n 3B0947415B).

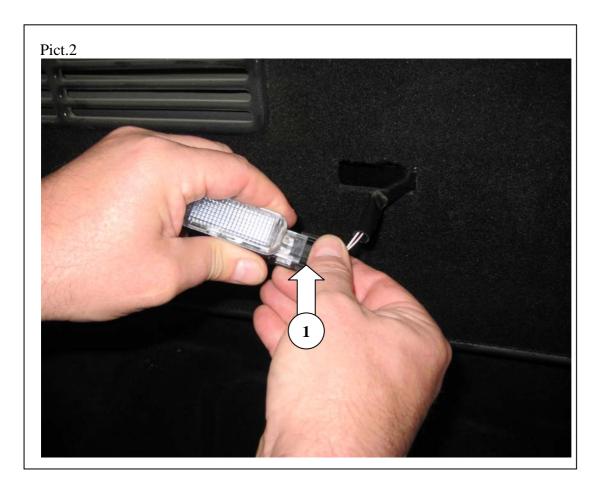
1.3 Disconnect the connector (1-Pict.2) of the front luggage lamp from its housing.
